## **Customer Complaint \_ Visit report**

**Customer Name:** M/s. Sunrack

## Visit report: M/s. JLM Automative, Bangalore

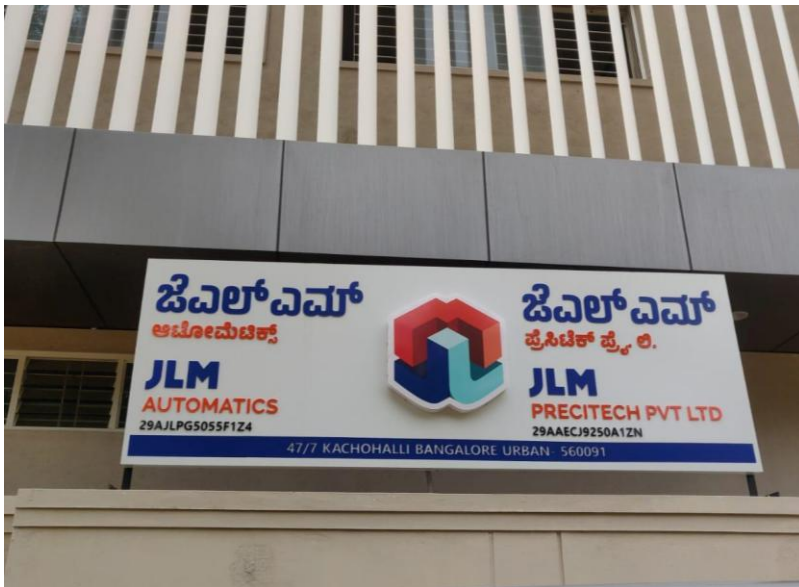
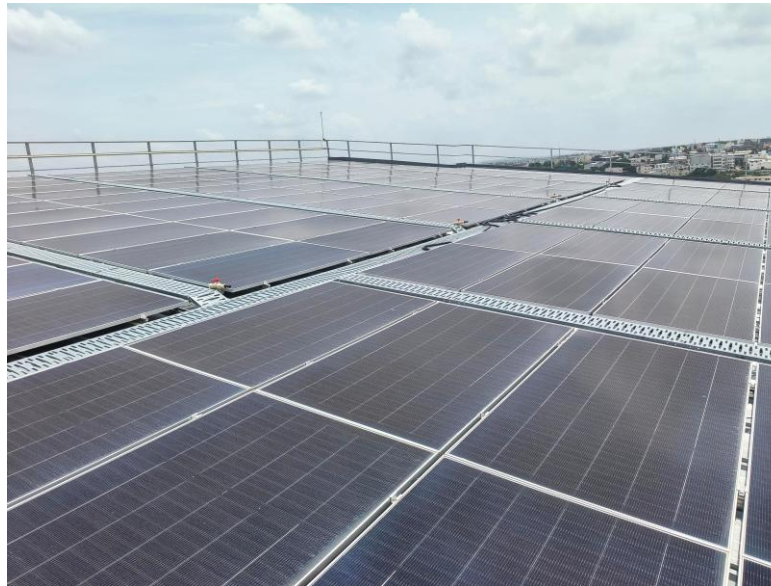
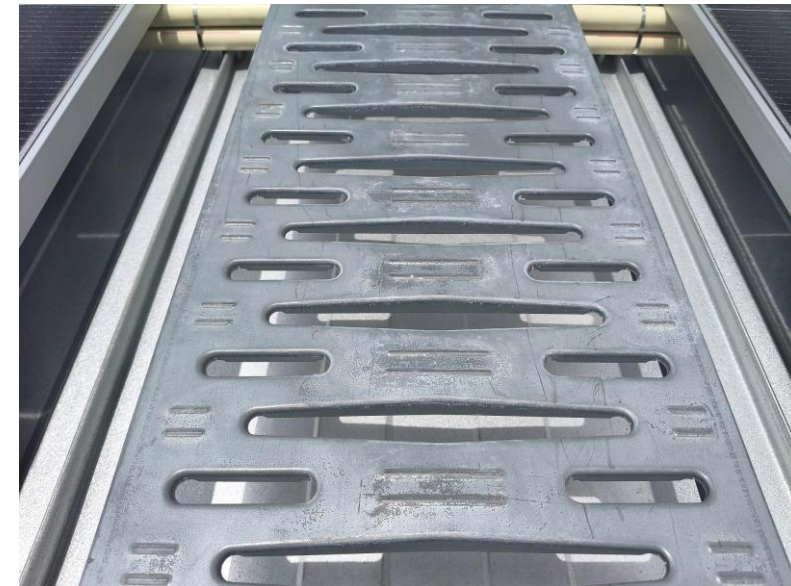
Rusting accompanied by liquid stains is evident in all rusted trays

- Supplied material to Sunrack is of acceptable quality and free from inherent defects. No complaints received from sunrack during processing.
- Rusting limited to 10 out of 75 components and localized liquid spillage observed; likely due to improper handling, storage or transportation leading to coating damage and corrosion.
- Excess forming flash observed at supporting frame edges, identified as primary cause for red rust.
- Self-healing is applicable only for scratches or properly sheared edges over time; coating damage areas due to improper handling or craftsmanship are not guaranteed for protection.

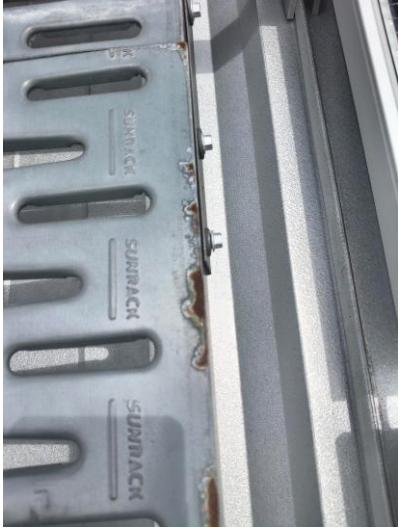
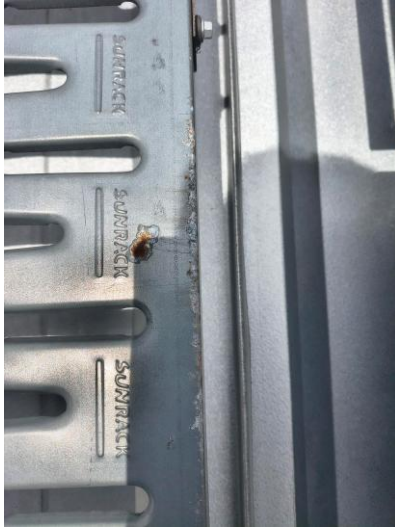
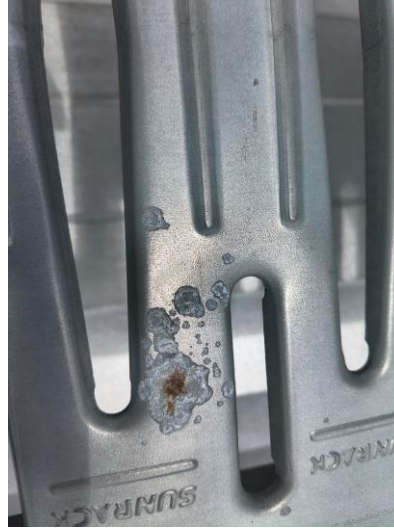
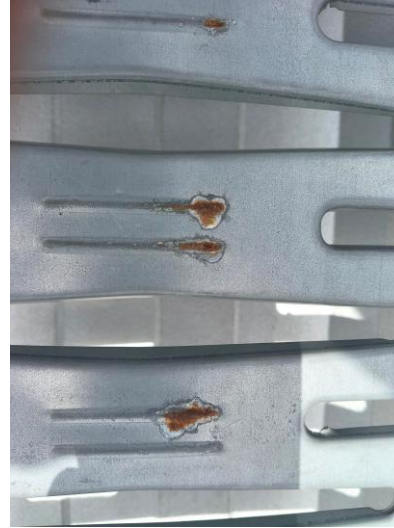
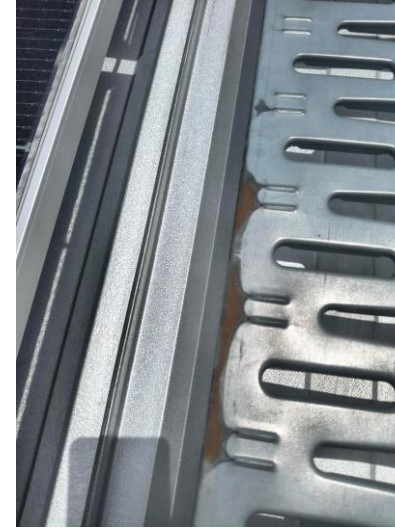
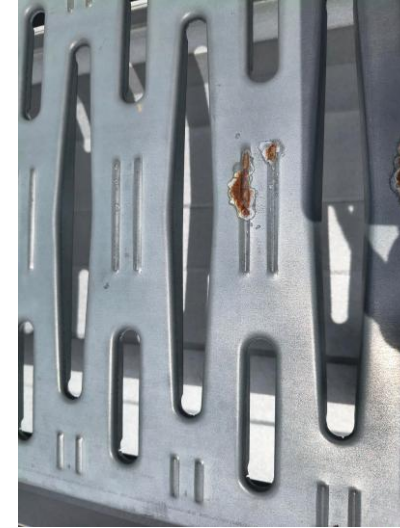
Shoe marks with some  
liquid stain evident

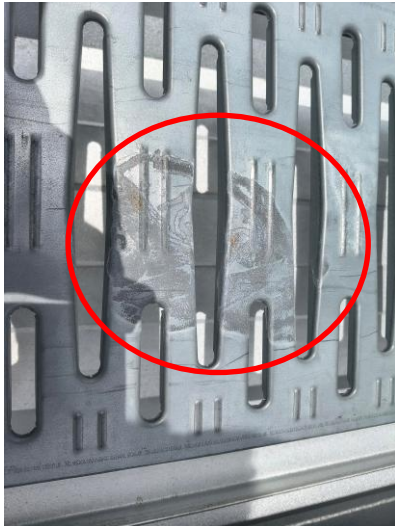
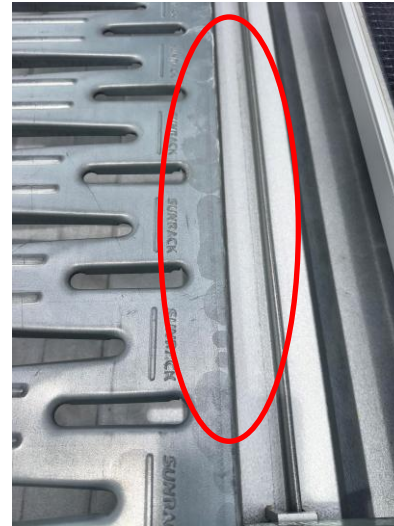
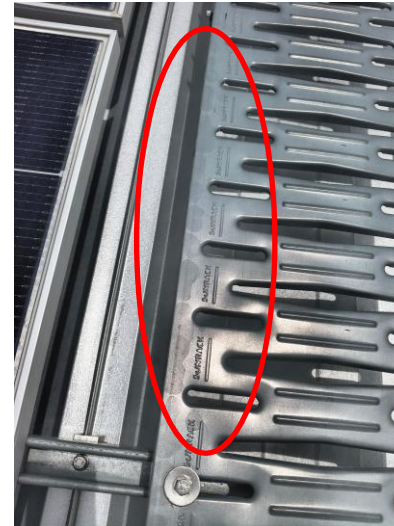
Liquid stains is evident in some rusted trays

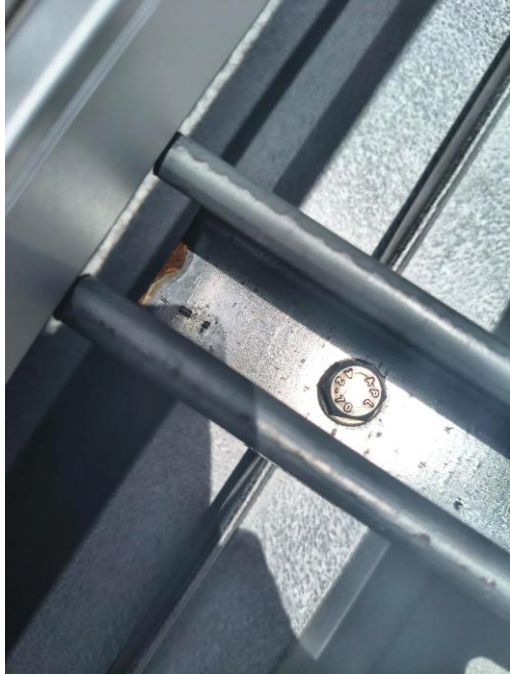
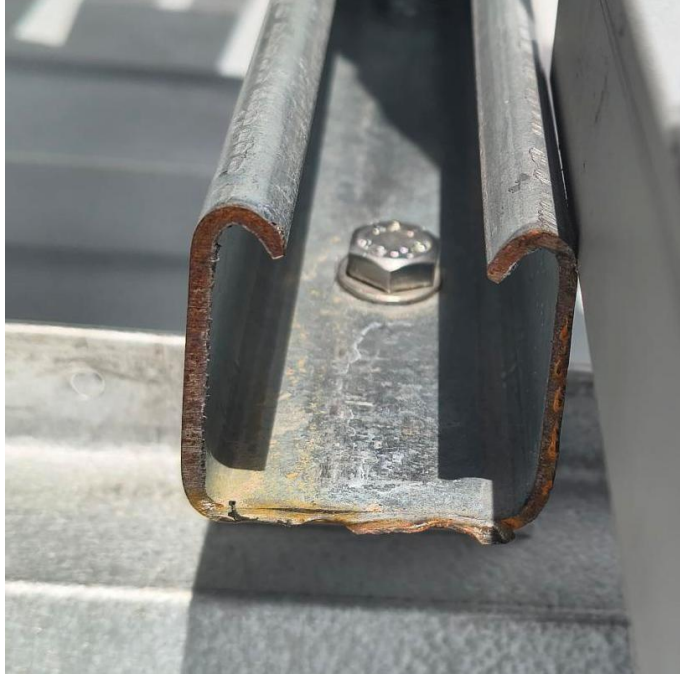
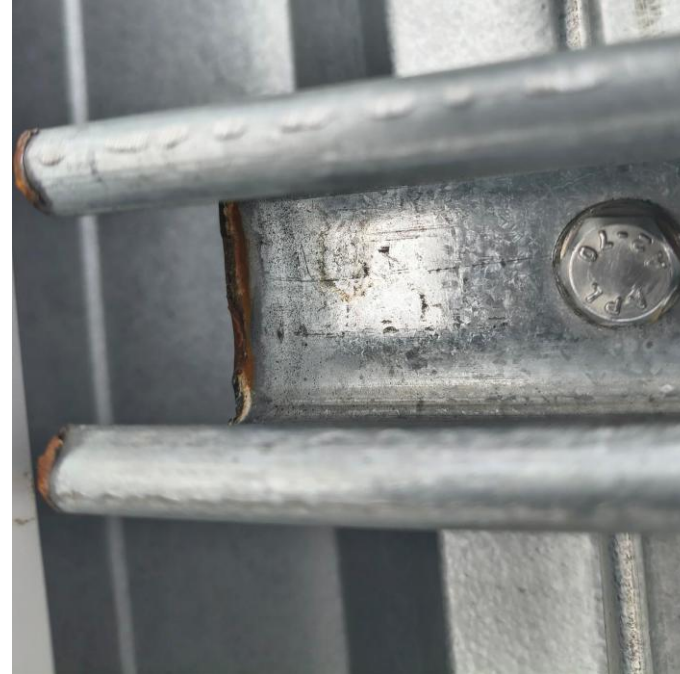
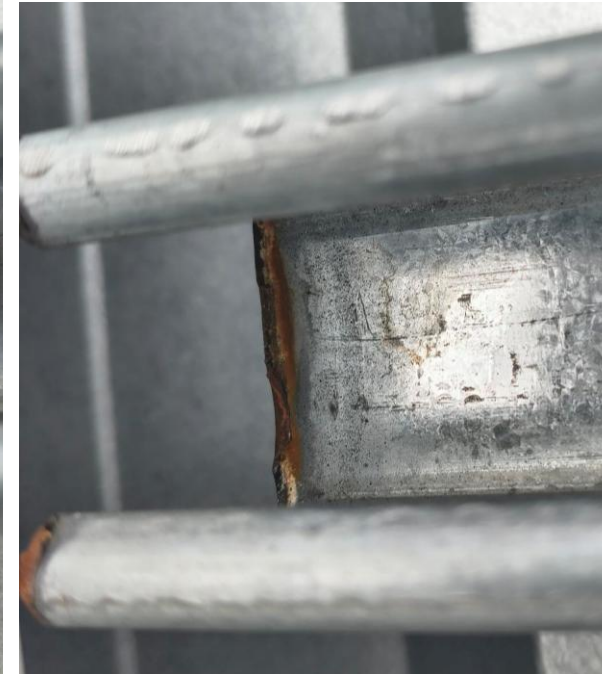
Excess Forming Flash was noticed in support frame edges which has led to the red rust in edges

- Site visit conducted on 11.06.2026 jointly with Suntrop team.
- Total 75 walk trays (total length ~150 m) installed; out of which 10 trays found with rust.
- Supporting frame edges also observed with red rust.
