RPT-20260512-1848

# Damage Assessment Report

**Daihatsu**

**Cuore**

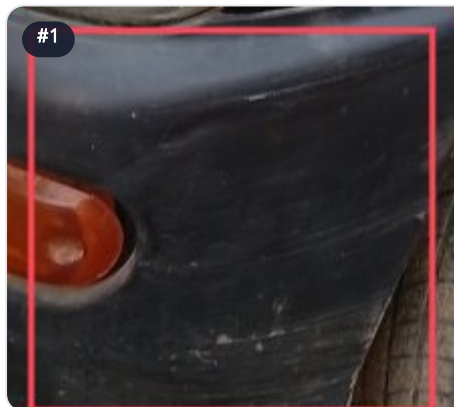
### Scratch

Front Bumper

Moderate

Repair

Spot Paint
