## ROTATING EQUIPMENT MAINTENANCE AND SERVICES – PACKAGE 2 No. SPHR01230A

# VIBRATION REPORT

## MINAS GS-1

## SB 1.3

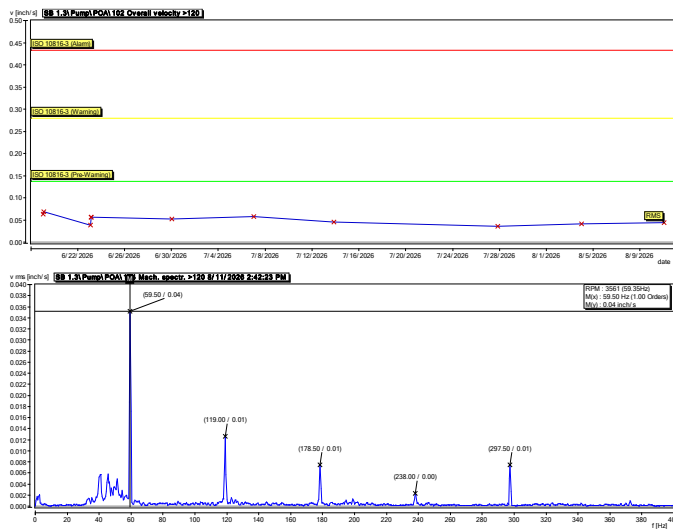
## POA - Pump Outboard Axial

| <b>Measurement Point</b> | <b>OVERALL LEVEL</b> |
|---|---|
| POA - Pump Outboard Axial | 0.04 in/s RMS |
