COUPLING FAILURE

ANALYSIS

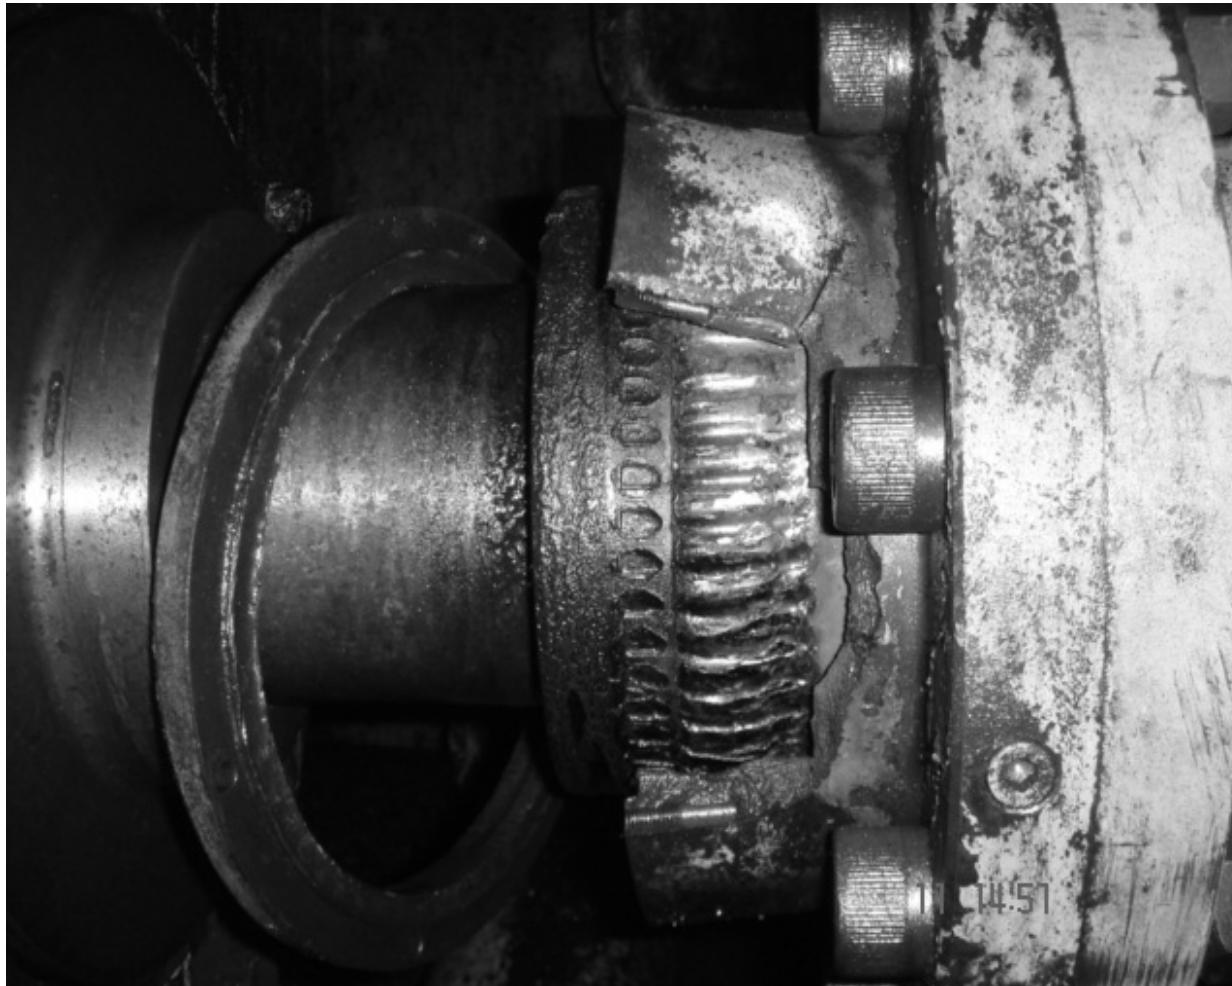
Disc Failure

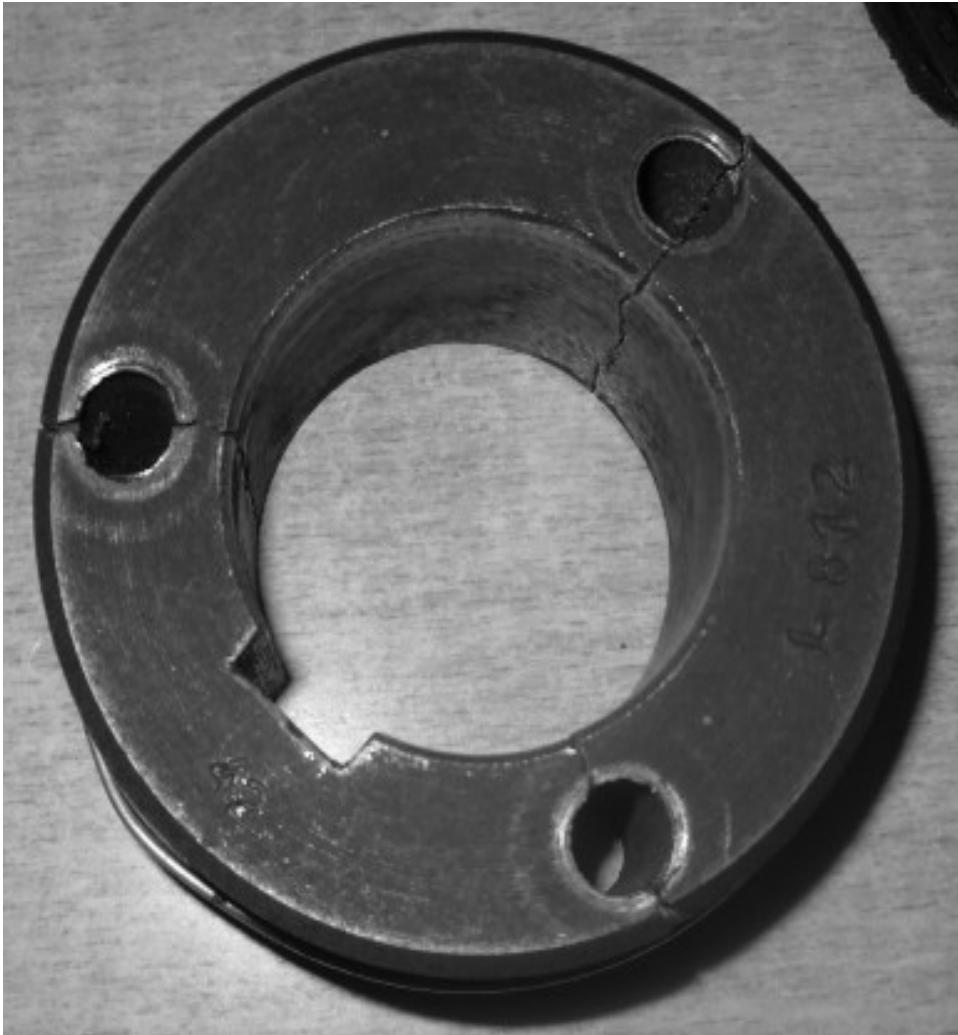
**Excessive angular
mis-alignment**

– Beyond limits

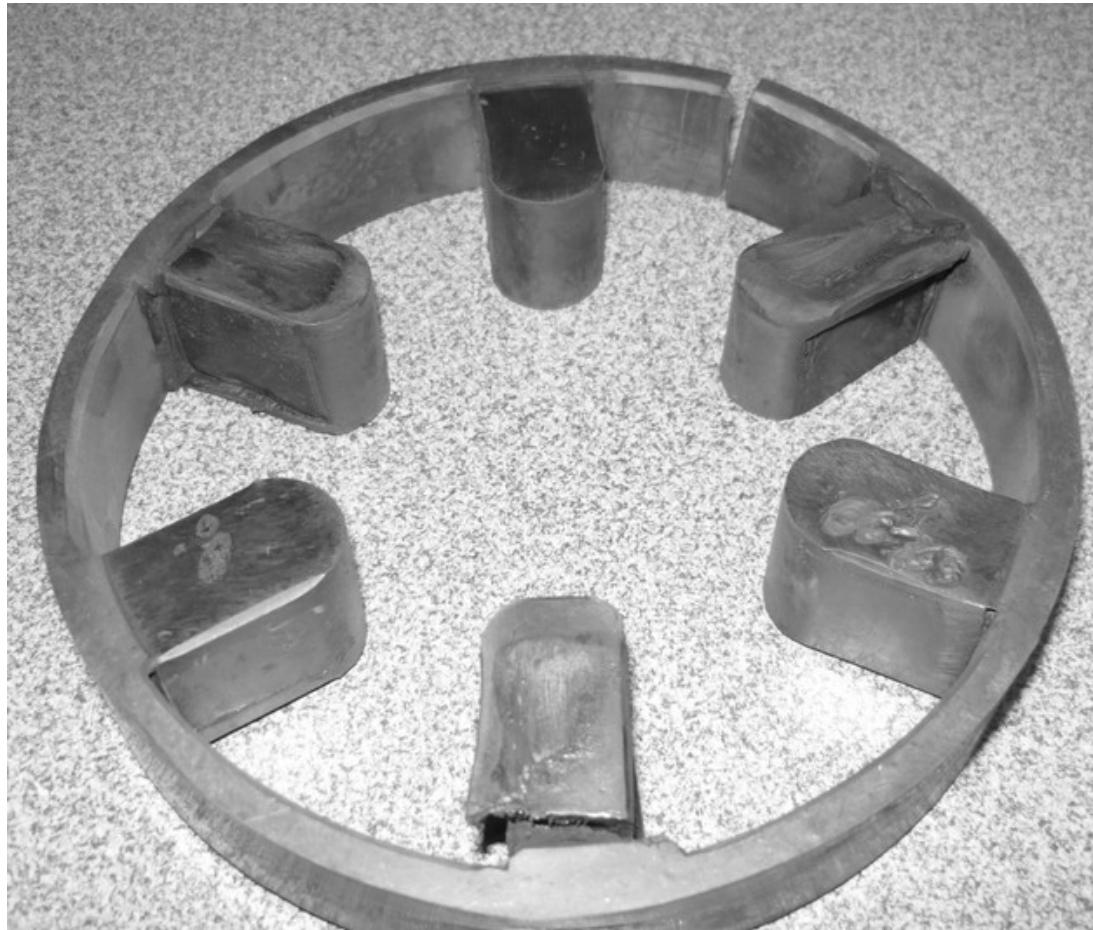
SWQ- 226 Adapter

- Excessive Interference Fit

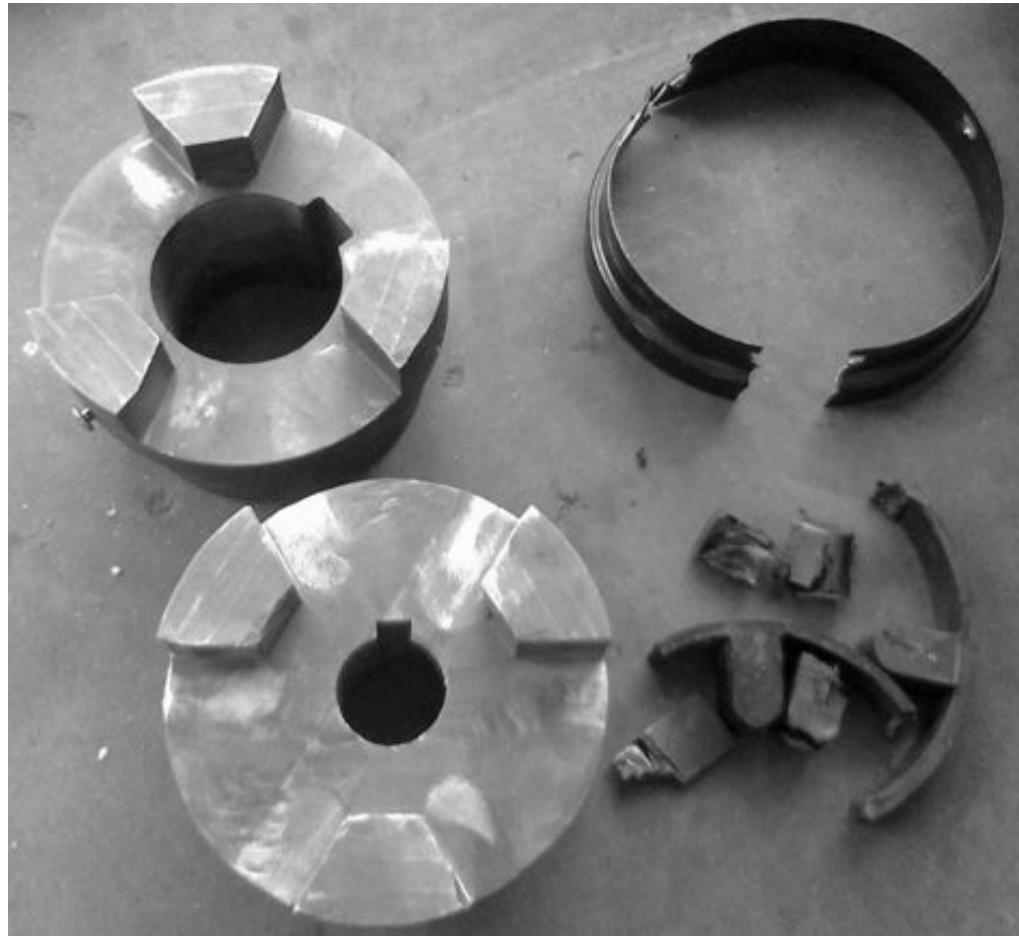
**Mis-aligned Coupling
- Vibration**

- Causes
 - A) Human Errors
 - B) Corrosion Induced Failures
 - C) Failure Caused by Wear
 - D) Fatigue Failure
 - E) Hardware Failure
 - F) Shaft Failures
- Majority of the problems : Caused by Vibrations
- & Misalignment is the Source of Vibrations
