TITLE: NITRILE PINHOLE ROOT CAUSE & CORRECTIVE / PRESENTATION ACTION

Date: 15 August 2011

TOP GLOVE, TOP QUALITY, TOP EFFICIENCY, GOOD HEALTH, SAFETY FIRST & BE HONEST FACTORY 11 Strictly P&C and for Internal Use only PRODUCTION DEPARTMENT FISH BONE CHART FOR BF DEFECT F11 Root Cause

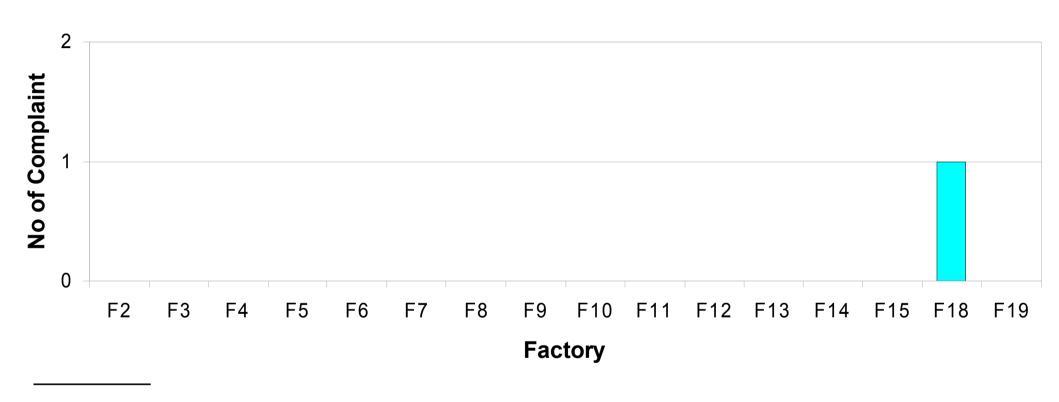
Nitrile Glove Pinholes Complaint Analysis from 2010 - 2011(By Factories)

Year 2010 – 0 Complaint received from F2/9/11/18 (Nitrile Manufacturer)

Year 2011 – 1 Nitrile Pinholes Complaint Received by F18
