TOP GLOVE, TOP QUALITY, TOP EFFICIENCY, GOOD HEALTH, SAFETY FIRST & BE HONEST F4 & F12

TEARING DEFECT

(Root Cause, Corrective & Preventive Action)

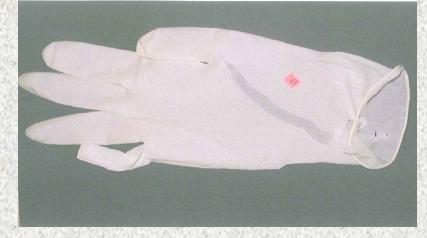
b. Torn Glove

- Found in glove inner case
- Already shipped out by TG
