STRUCTURAL REPAIR QUALITY ANALYSIS

Comprehensive Report

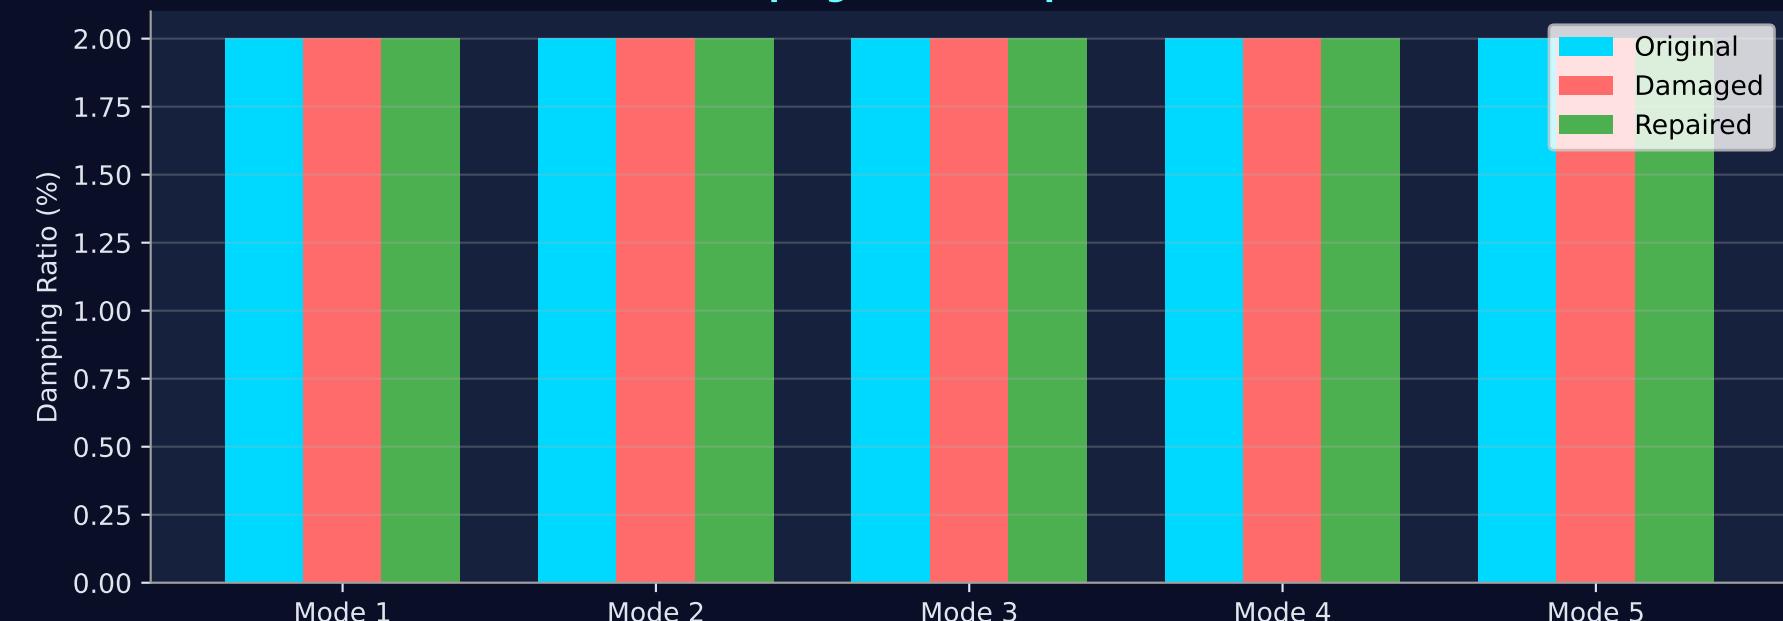
Damping Ratio Comparison (%)

Damping Recovery 100.0%
Measures how well energy dissipation characteristics recovered

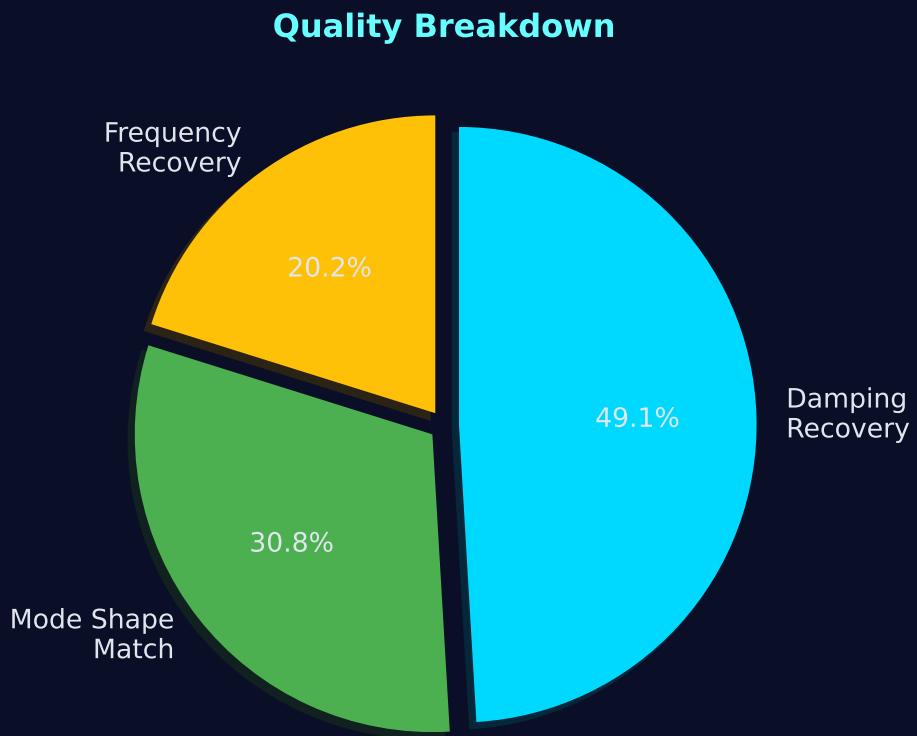
Quality Breakdown

Overall Quality - FAIR
Fair - Partial Improvement

OVERALL ASSESSMENT: Fair - Partial Improvement
