# STRUCTURAL REPAIR QUALITY ANALYSIS

## Comprehensive Report

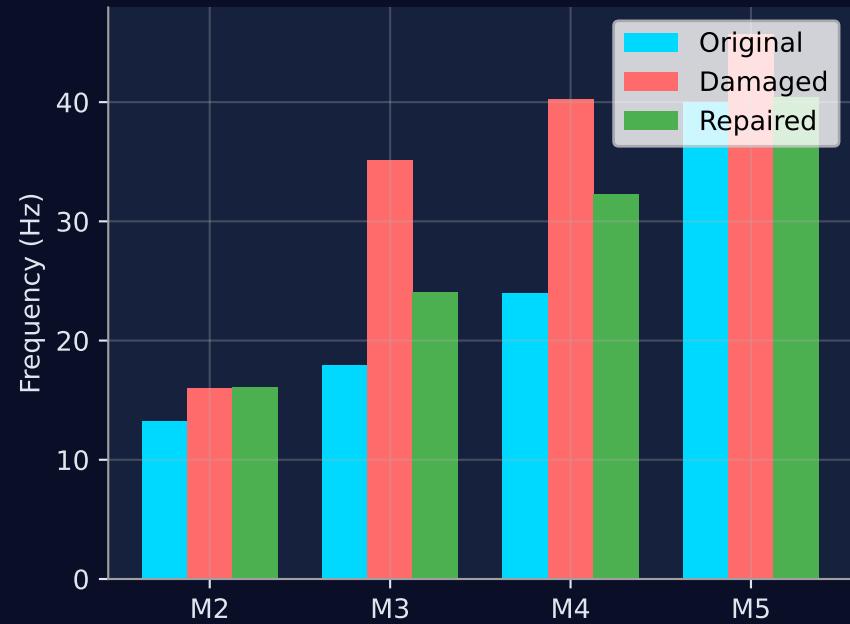
## Natural Frequencies

Frequency Recovery ..... 41.1%  
Measures how well structural frequencies recovered after repair

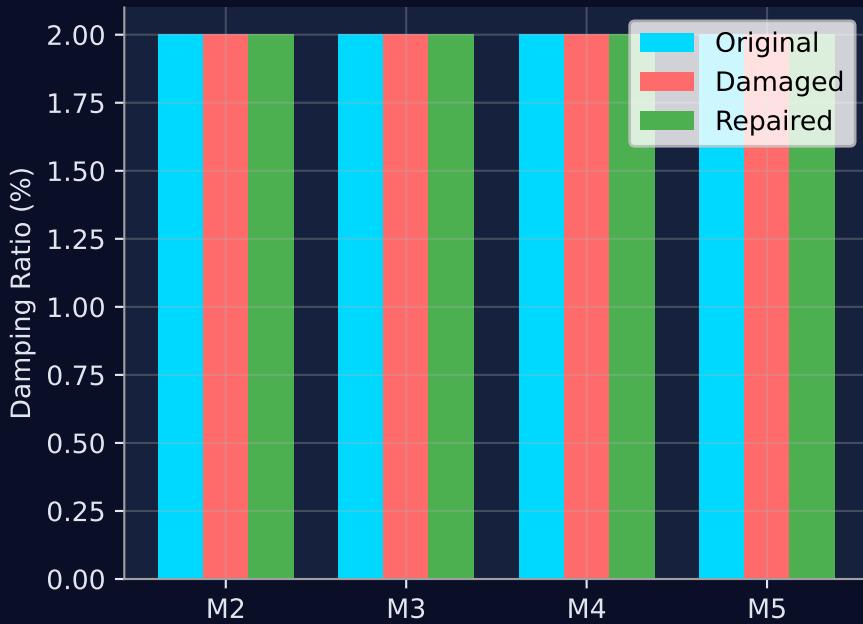
## Damping Ratios

Damping Recovery ..... 100.0%  
Measures how well energy dissipation characteristics recovered
