## Service report

## SERVICE CALL

No. 260921-01

| Machine / equipment<br>Presse hydraulique 120 T | Model<br>PH-120/4D |

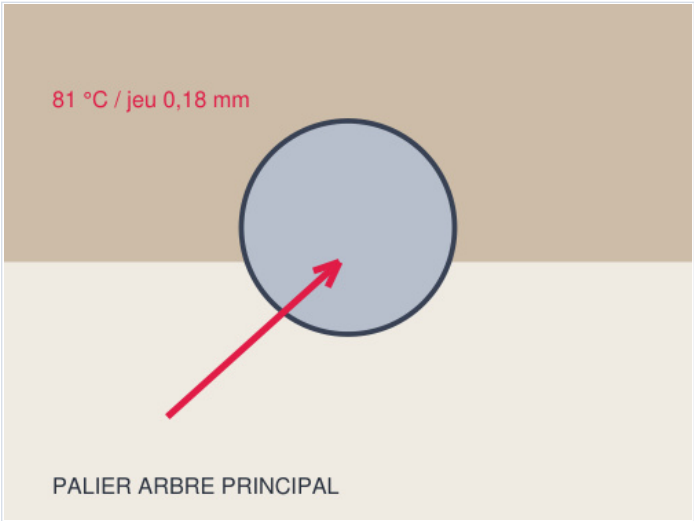
Photo 1

Main shaft bearing at end of life: axial play measured with a dial gauge 0.18 mm (0.05 mm max.), temperature rise recorded at 81 °C and characteristic noise at 1,450 rpm. Replacement to be scheduled within 48 h - risk of seizure within 250 production hours.

| 1) Replace the main shaft bearing within 48 h (part ref. 63-2216-C3) - estimated labour 4 h, machine downtime 1 day. |

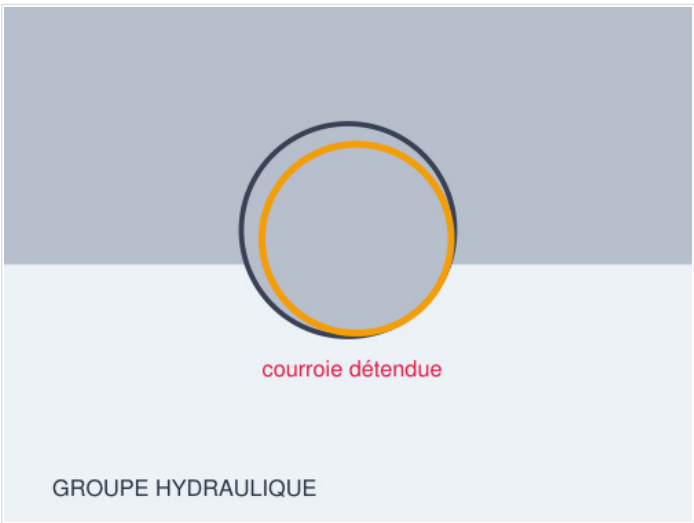
Photo 2

Pump drive V-belt slack: measured deflection 12 mm against a maximum of 8 mm. Visible cracking and rubber deposits in the pulley groove. Belt replaced (XPB 2360) and tension set to 7 mm.

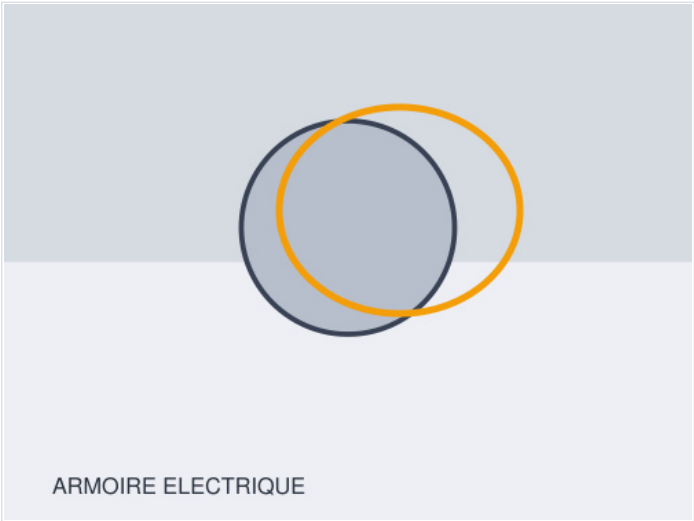
Photo 3

| Electrical cabinet: ventilation filter clogged with dust and two cable glands loose at the bottom. Filter vacuumed, glands retightened. No insulation fault found on the motor and control circuits. | | |
