## **Service report** **21/09/2026**

| SERVICE CALL | | No. 260921-01 | |
| Machine 1 : Presse hydraulique 120 T<br>Model : PH-120/4D Serial number : PH1204D-2011-0387 | | | |
| Subject / request<br>Full mechanical audit requested by maintenance:<br>abnormal noise and increasing vibration on the<br>hydraulic power unit, output down by about 15%. | | Location<br>Atelier 2 — ligne d'emboutissage 4 | |

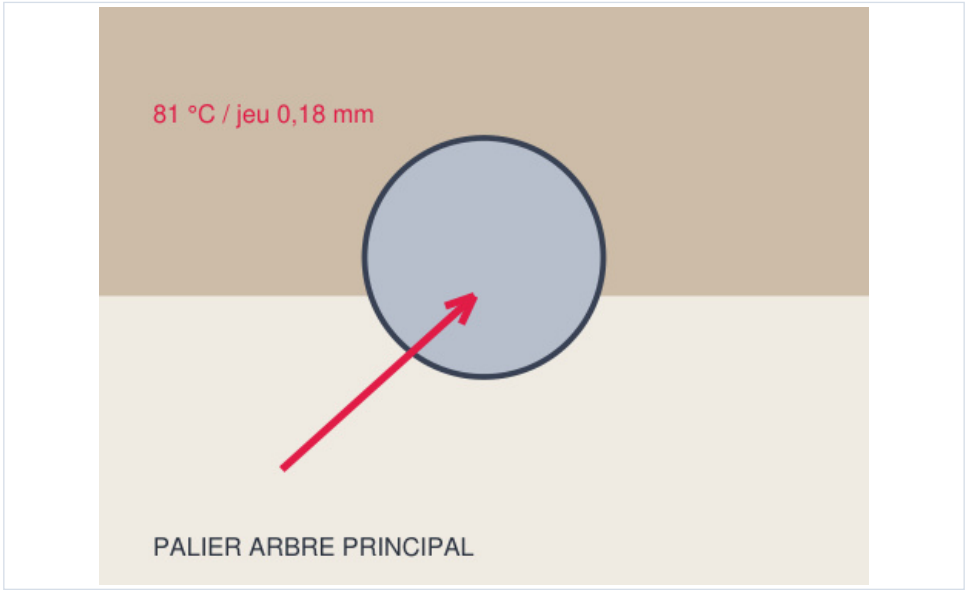
Photo 1

Full audit of the hydraulic power unit as requested. The loss of output is explained by slippage of the slack belt (estimated slip 8 to 10%) and by the thermal drift of the oil (68 C), which lowers the volumetric efficiency of the pump. The noise and vibration come from the main shaft bearing at end of life. After the work, the machine returned to its rated output; two outstanding items remain: the main bearing and the leak at the discharge fitting.

Main shaft bearing at end of life: axial play measured with a dial gauge 0.18 mm (0.05 mm max.), temperature rise recorded at 81 C and characteristic noise at 1,450 rpm. Replacement to be scheduled within 48 h - risk of seizure within 250 production hours.

- 1) Replace the main shaft bearing within 48 h (part ref. 63-2216-C3) - estimated labour 4 h, machine downtime 1 day.
- 2) Replace the 4 motor bushes within 1 month.
- 3) Fit a drip tray and an absorbent mat under the hydraulic power unit (safety).
- 4) Schedule replacement of the hydraulic power unit at 2,000,000 cycles.
- 5) Set up a periodic lubrication schedule and a monthly vibration reading.

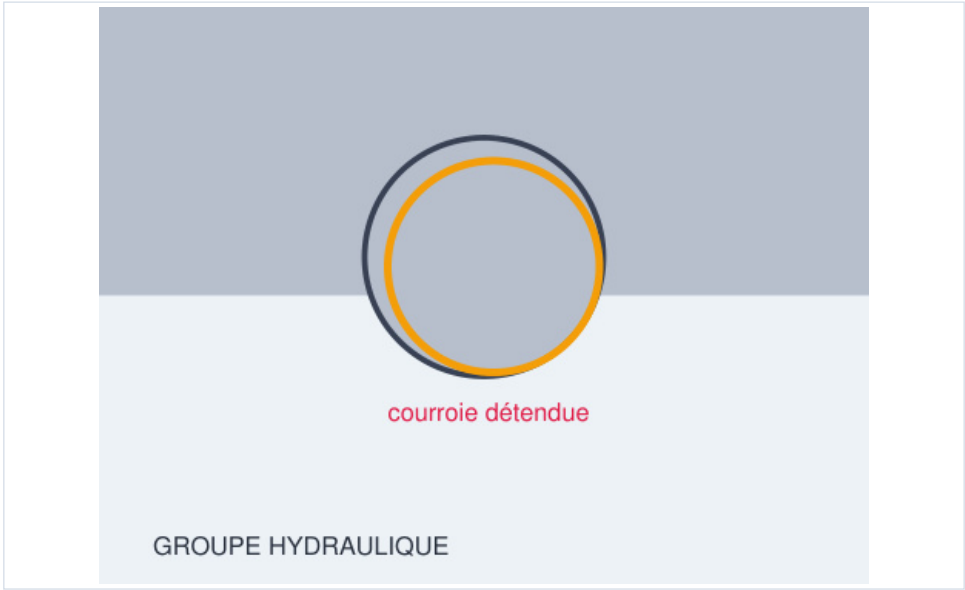
Photo 2

Pump drive V-belt slack: measured deflection 12 mm against a maximum of 8 mm. Visible cracking and rubber deposits in the pulley groove. Belt replaced (XPB 2360) and tension set to 7 mm.

Replacement of the V-belt and cleaning of the pulley groove; tension set to 7 mm. Full lubrication of the bearings and the connecting-rod head. Torque retightening of the frame bolts and motor mountings. Cleaning of the oil cooler core and of the cabinet filter. Check and refurbishment of the cartridge filtration. No-load then on-load test: rated output restored, oil temperature stabilised at 61 C.

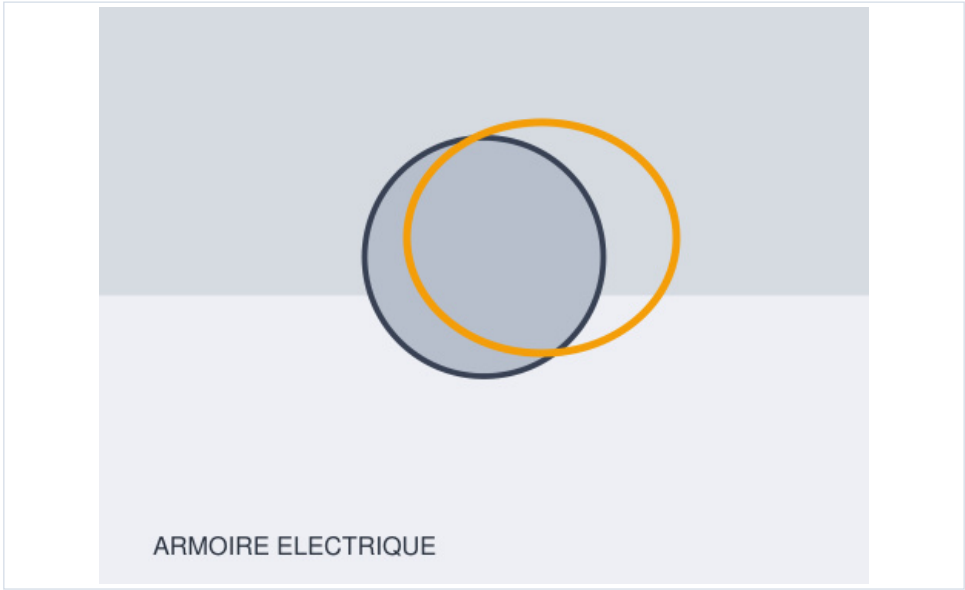
Photo 3

Electrical cabinet: ventilation filter clogged with dust and two cable glands loose at the bottom. Filter vacuumed, glands retightened. No insulation fault found on the motor and control circuits.

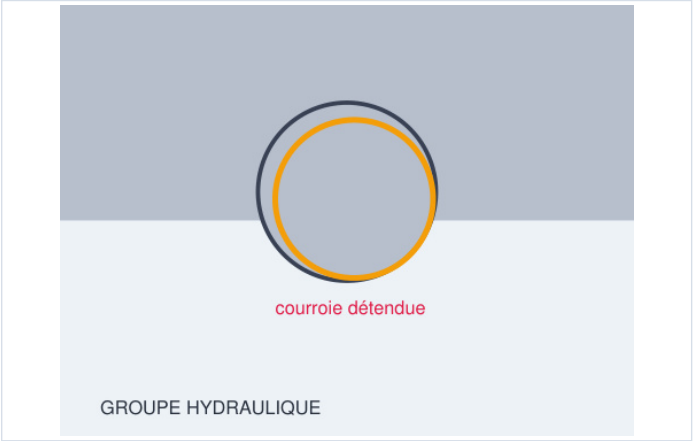
Photo 4 — Overall view of the hydraulic power unit

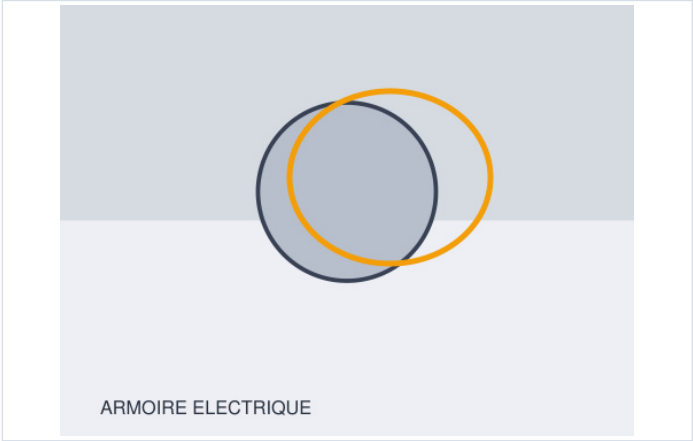
Photo 5 — Electrical cabinet - general condition
