## Service report

SERVICE CALL

No. 260921-01

Machine 1 : Presse hydraulique 120 T  
Model : PH-120/4D | Serial number : PH1204D-2011-0387

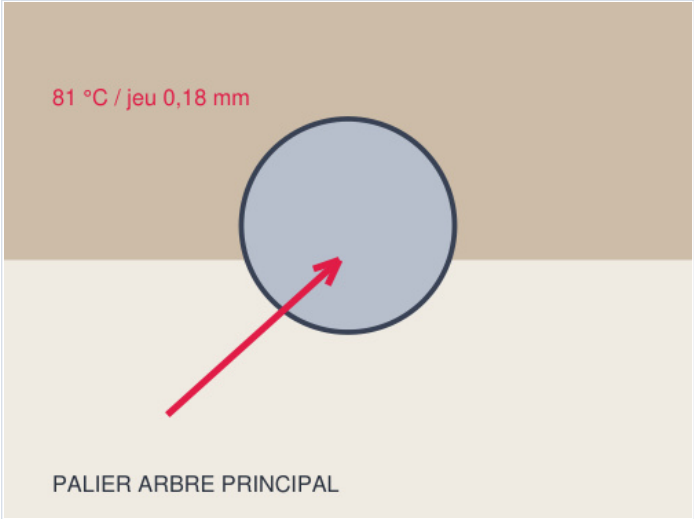
Photo 1

**Mechanical — Presse hydraulique 120 T** 09:20 **URGENT**  
Main shaft bearing at end of life: axial play measured with a dial gauge 0.18 mm (0.05 mm max.), temperature rise recorded at 81 °C and characteristic noise at 1,450 rpm. Replacement to be scheduled within 48 h - risk of seizure within 250 production hours.

- 1) Replace the main shaft bearing within 48 h (part ref. 63-2216-C3) - estimated labour 4 h, machine downtime 1 day.
- 2) Replace the 4 motor bushes within 1 month.
- 3) Fit a drip tray and an absorbent mat under the hydraulic power unit (safety).
- 4) Schedule replacement of the hydraulic power unit at 2,000,000 cycles.
- 5) Set up a periodic lubrication schedule and a monthly vibration reading.

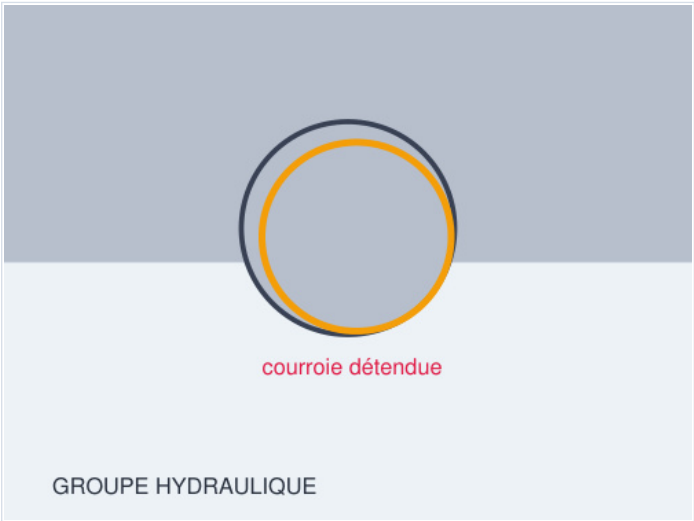
Photo 2

**Mechanical — Presse hydraulique 120 T** 10:05 **HIGH PRIORITY**  
Pump drive V-belt slack: measured deflection 12 mm against a maximum of 8 mm. Visible cracking and rubber deposits in the pulley groove. Belt replaced (XPB 2360) and tension set to 7 mm.

Replacement of the V-belt and cleaning of the pulley groove; tension set to 7 mm. Full lubrication of the bearings and the connecting-rod head. Torque retightening of the frame bolts and motor mountings. Cleaning of the oil cooler core and of the cabinet filter. Check and refurbishment of the cartridge filtration. No-load then on-load test: rated output restored, oil temperature stabilised at 61 C.

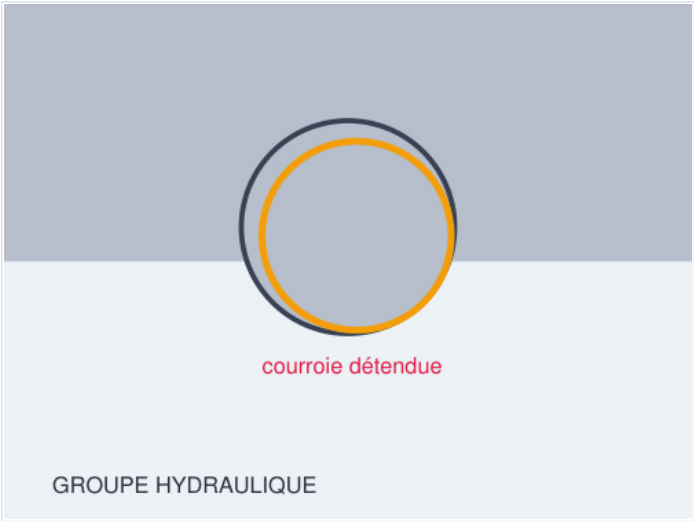
Photo 4 — Overall view of the hydraulic power unit

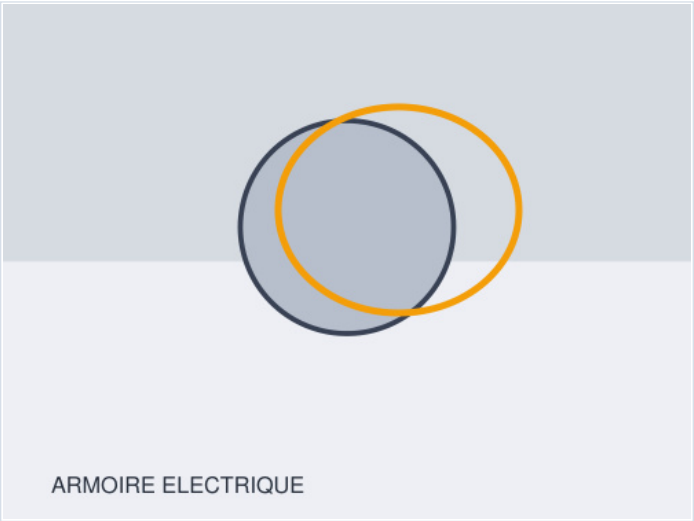
Photo 5 — Electrical cabinet - general condition
