## Service report 21/09/2026

| SERVICE CALL | | No. 260921-01 | |
| Machine 1 : Presse hydraulique 120 T<br>Model : PH-120/4D Serial number : PH1204D-2011-0387 | | | |
| Subject / request<br>Full mechanical audit requested by maintenance: abnormal noise and increasing vibration on the hydraulic power unit, output down by about 15%. | | Location<br>Atelier 2 — ligne d'emboutissage 4 | |

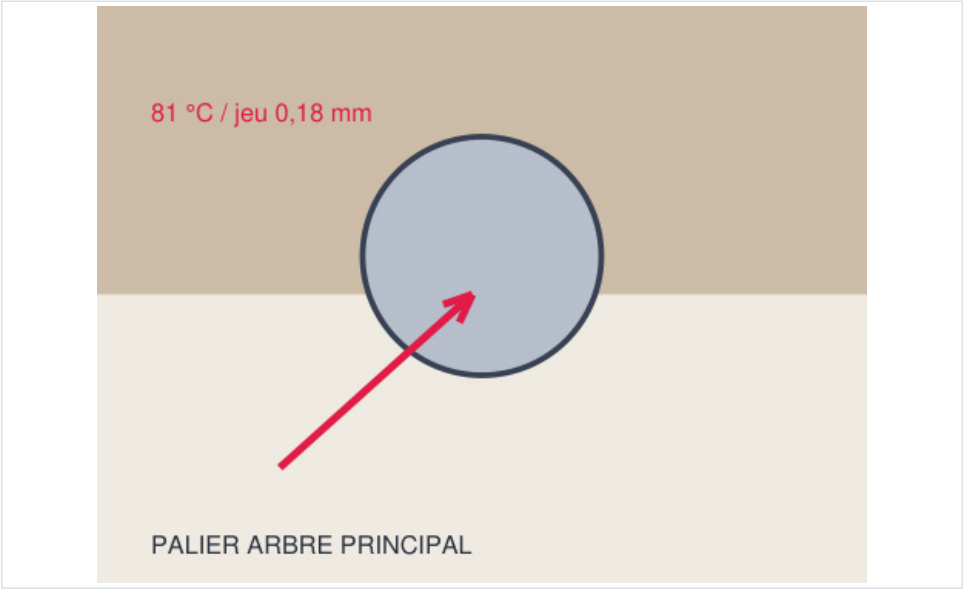
Photo 1

Main shaft bearing at end of life: axial play measured with a dial gauge 0.18 mm (0.05 mm max.), temperature rise recorded at 81 C and characteristic noise at 1,450 rpm. Replacement to be scheduled within 48 h - risk of seizure within 250 production hours.

- 1) Replace the main shaft bearing within 48 h (part ref. 63-2216-C3) - estimated labour 4 h, machine downtime 1 day.
- 2) Replace the 4 motor bushes within 1 month.
- 3) Fit a drip tray and an absorbent mat under the hydraulic power unit (safety).
- 4) Schedule replacement of the hydraulic power unit at 2,000,000 cycles.
- 5) Set up a periodic lubrication schedule and a monthly vibration reading.

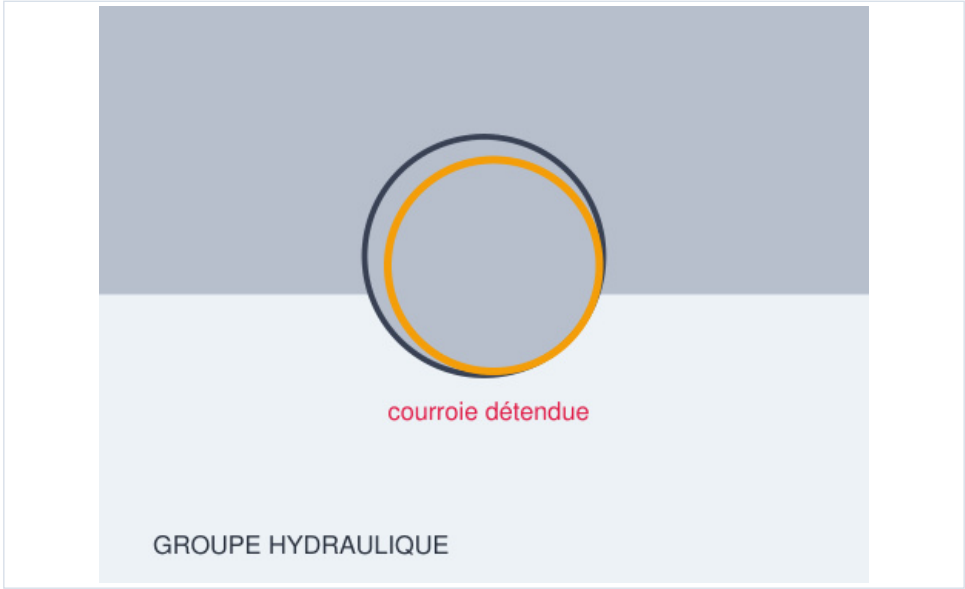
Photo 2

Pump drive V-belt slack: measured deflection 12 mm against a maximum of 8 mm. Visible cracking and rubber deposits in the pulley groove. Belt replaced (XPB 2360) and tension set to 7 mm.

Replacement of the V-belt and cleaning of the pulley groove; tension set to 7 mm. Full lubrication of the bearings and the connecting-rod head. Torque retightening of the frame bolts and motor mountings. Cleaning of the oil cooler core and of the cabinet filter. Check and refurbishment of the cartridge filtration. No-load then on-load test: rated output restored, oil temperature stabilised at 61 C.

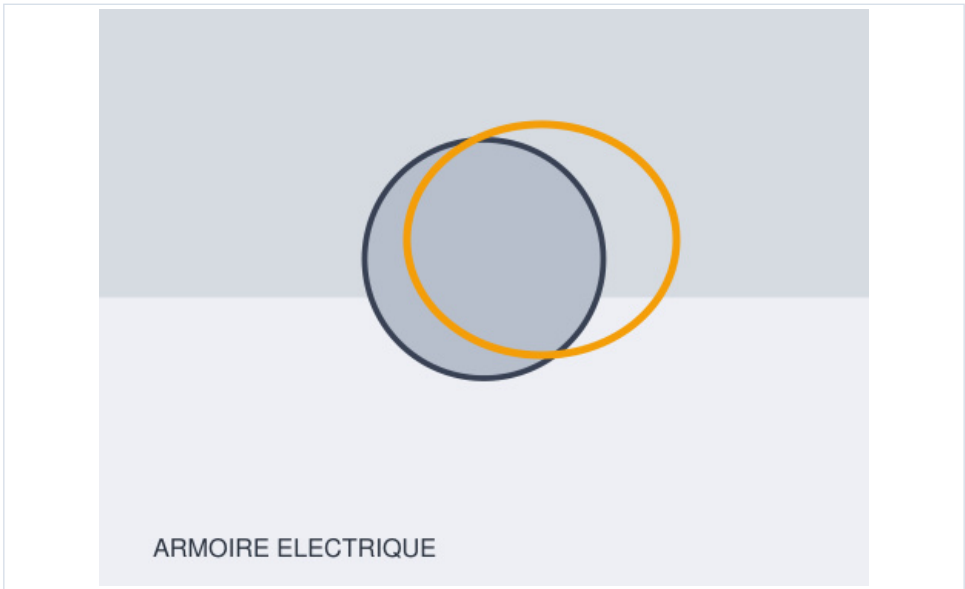
Photo 3

Electrical cabinet: ventilation filter clogged with dust and two cable glands loose at the bottom. Filter vacuumed, glands retightened. No insulation fault found on the motor and control circuits.

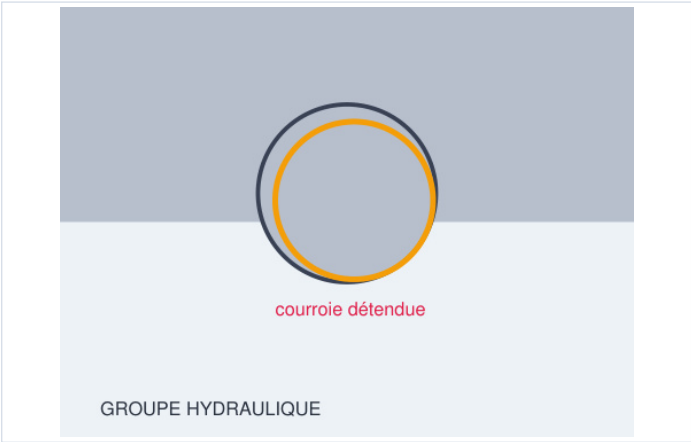
Photo 4 — Overall view of the hydraulic power unit

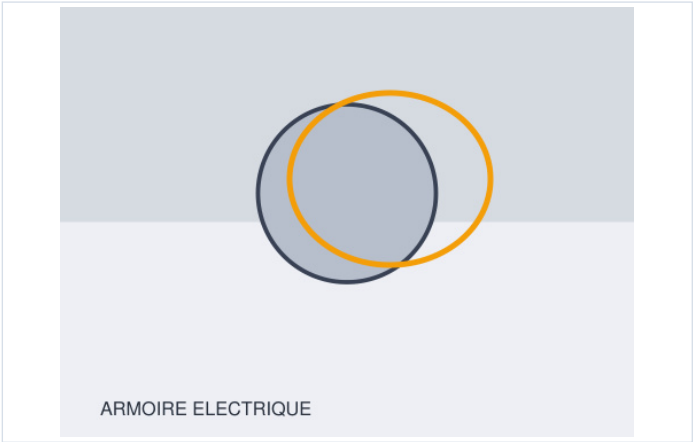
Photo 5 — Electrical cabinet - general condition
