**I.A. Lewin, P.E. and Associates**

May 18, 2020

Re: Floor Slab Investigation  
High School  
Brecksville Broadview Heights School District  
IAL No. 20053A

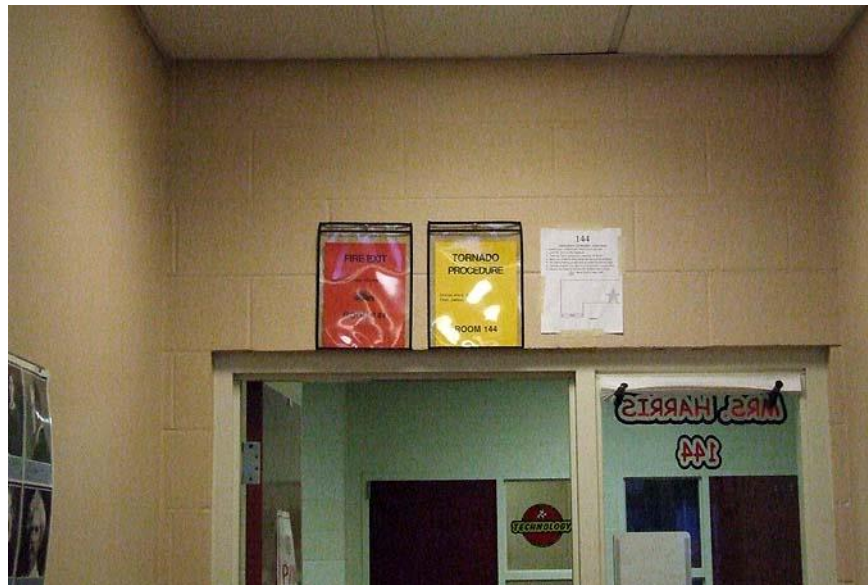
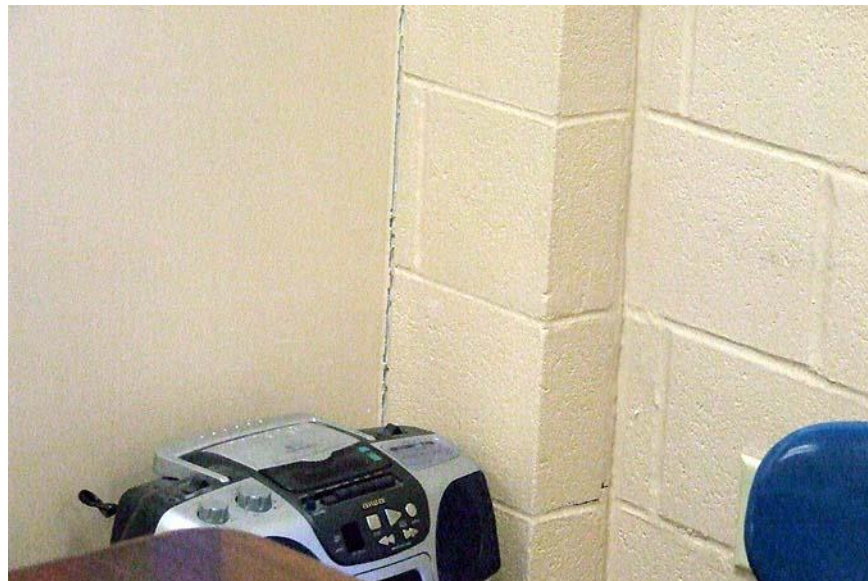
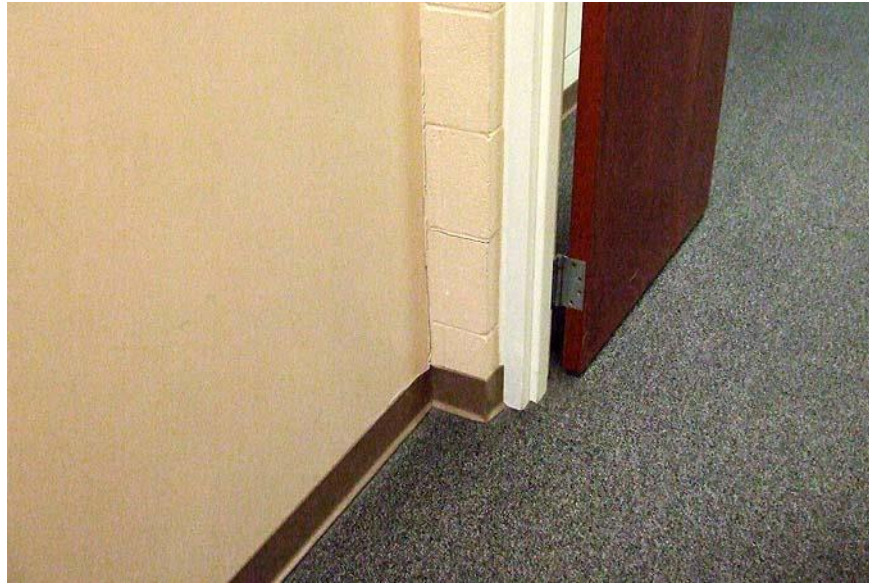
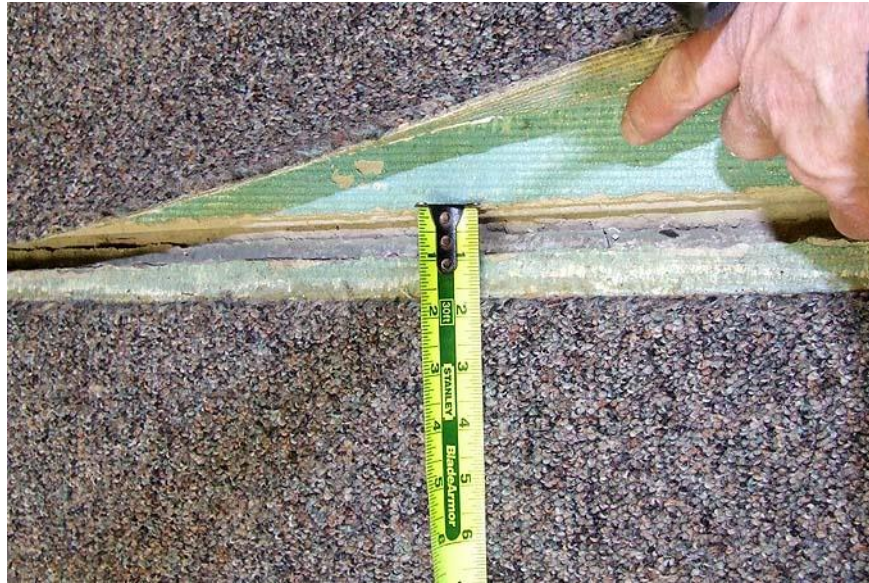
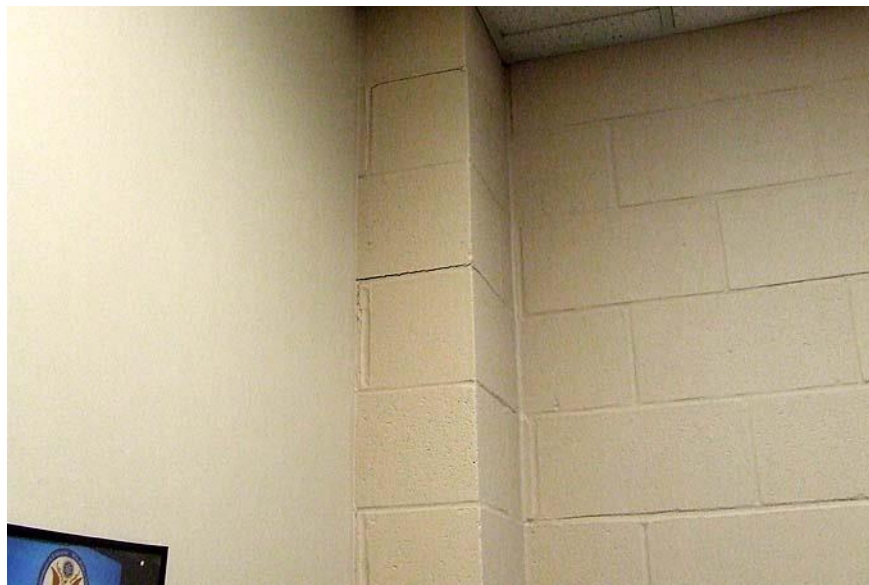
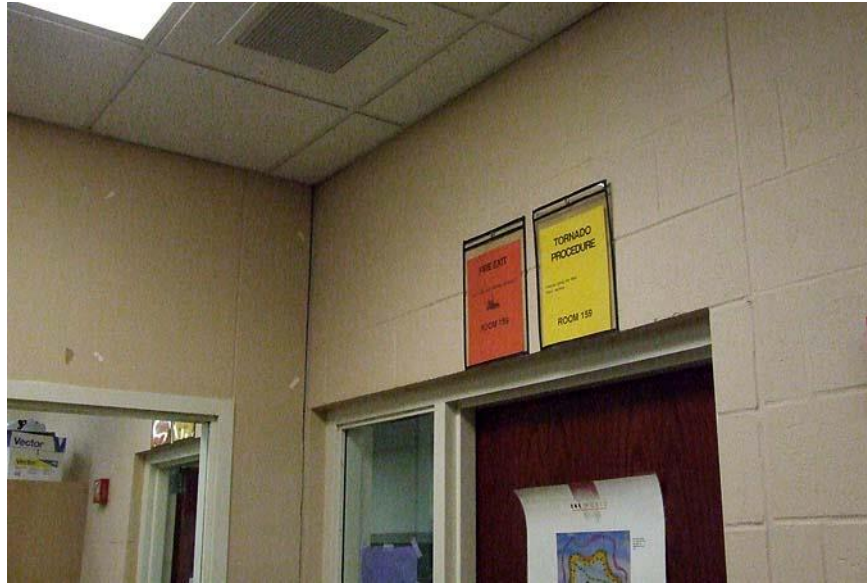
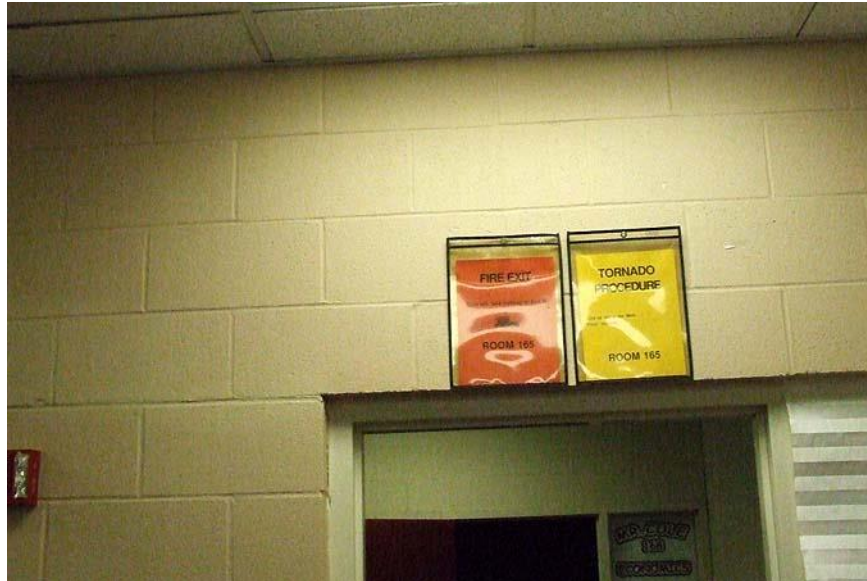
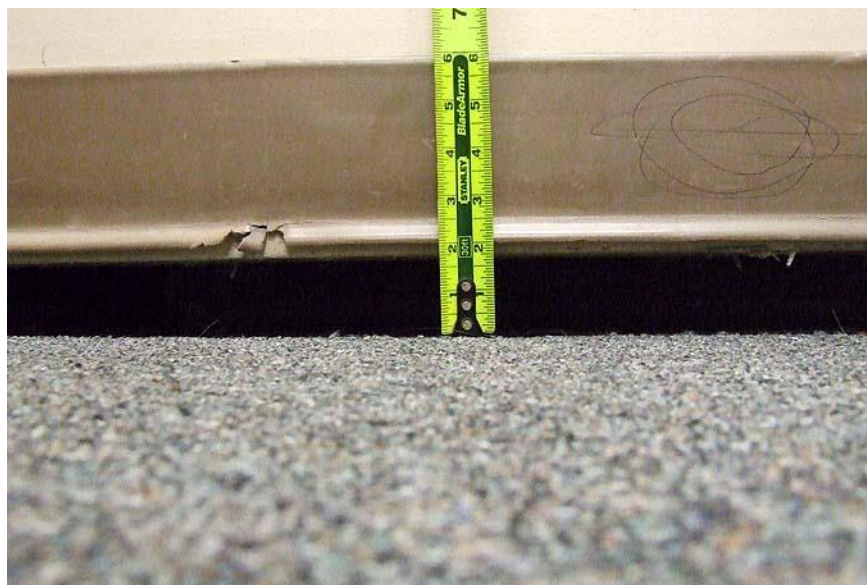
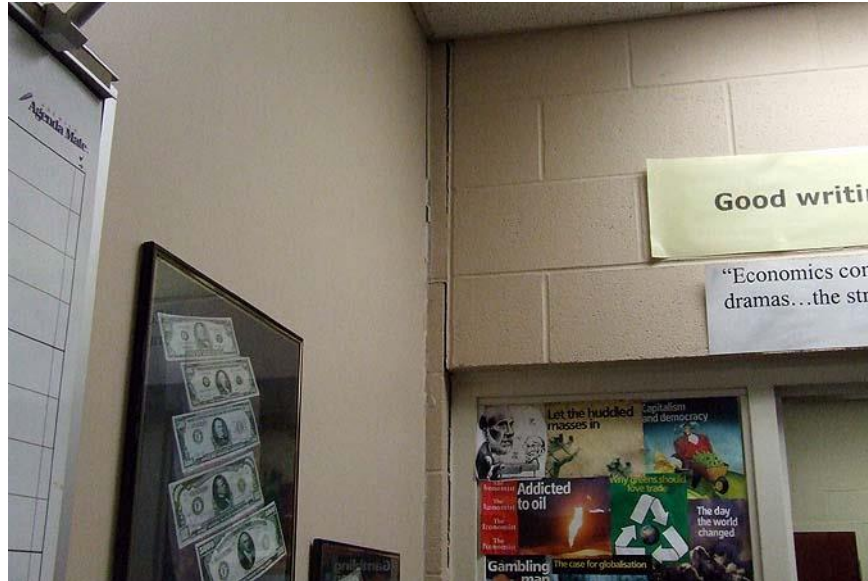
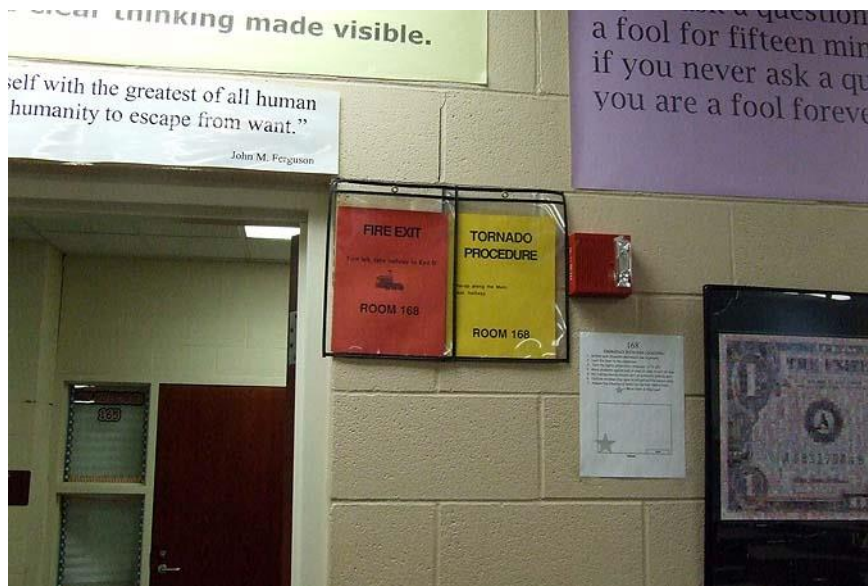
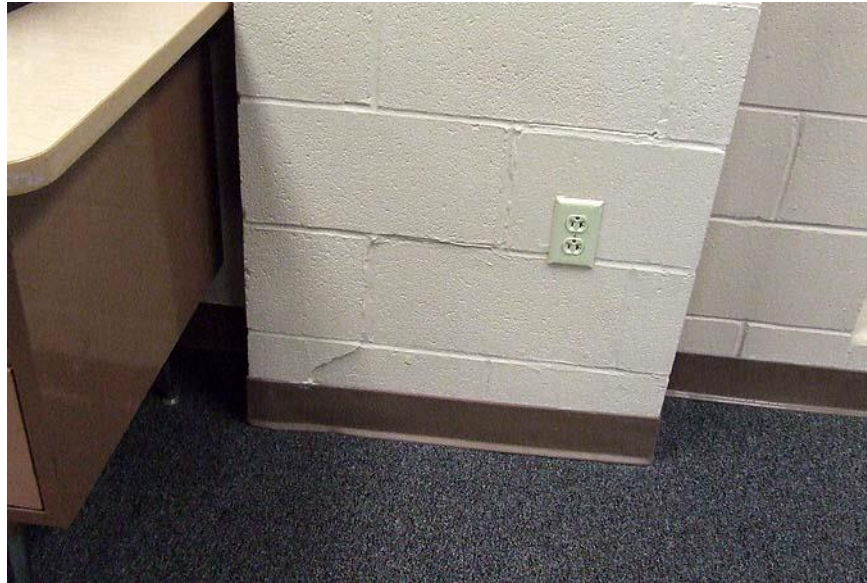
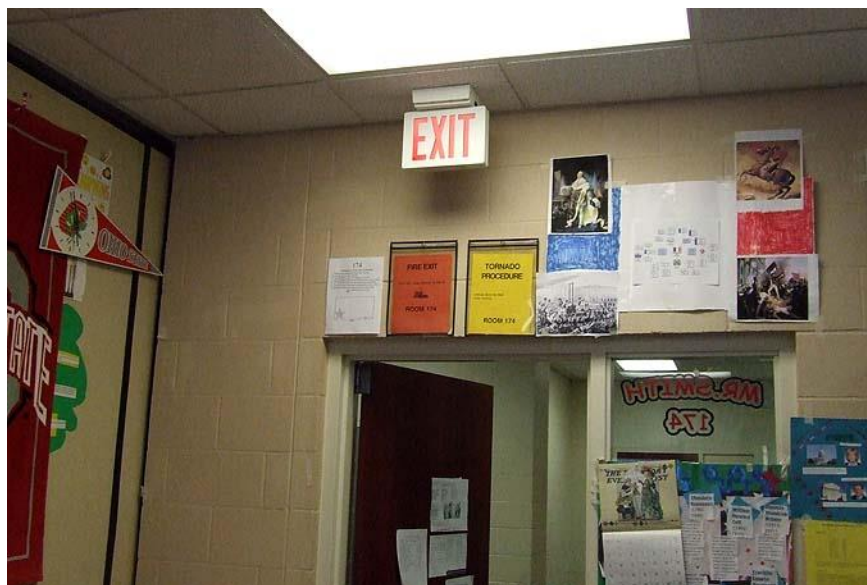
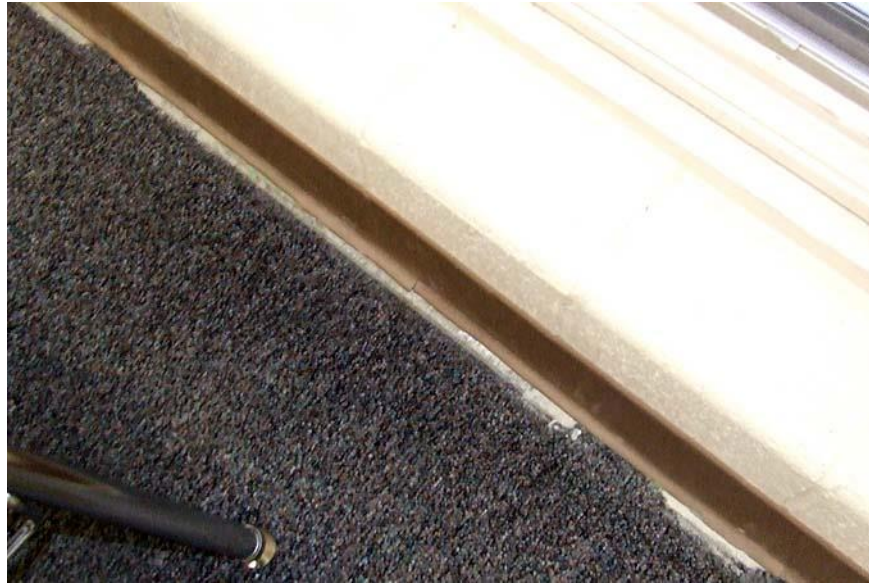
**2010 Photographs Using Past Room Numbers  
Room Number followed by Typical Interior Condition**

In late 2010, I A Lewin PE and Associates was authorized to investigate the on going slab settlement in the Units D and E of the building. An extensive documentation of the existing conditions at the time was made and a report prepared. A copy of that report is attached to this report. We found that the slabs had settled anywhere between ¼ inch up to two inches and the slabs were moving so much

that the control joints, usually and 1/8 to 1/4-inch-wide, were open as much as 1 inch. Also, in many rooms on both the first and second floors any masonry walls that were supported on the concrete floor slabs developed cracks. Some were very significant.

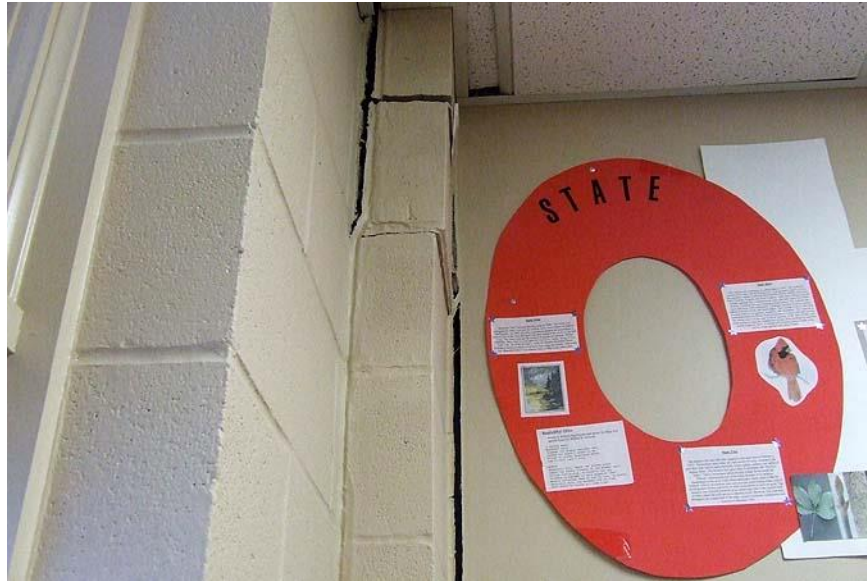
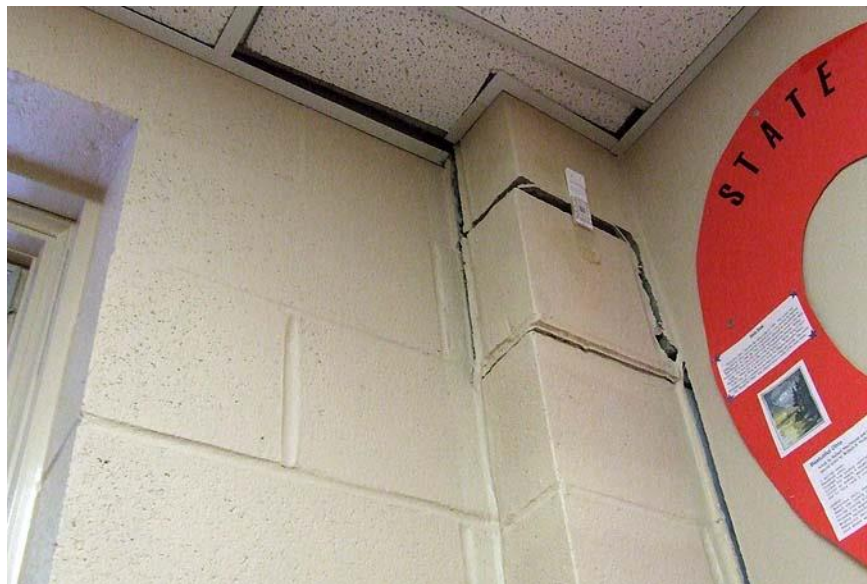
For the following photographs, page 13 for current conditions
