# Guidance for Service Termination Issue Reporting

A guide for MEMs on reporting and  
acting on Distribution Business asset  
condition issues

April 2024

V3.9 Final

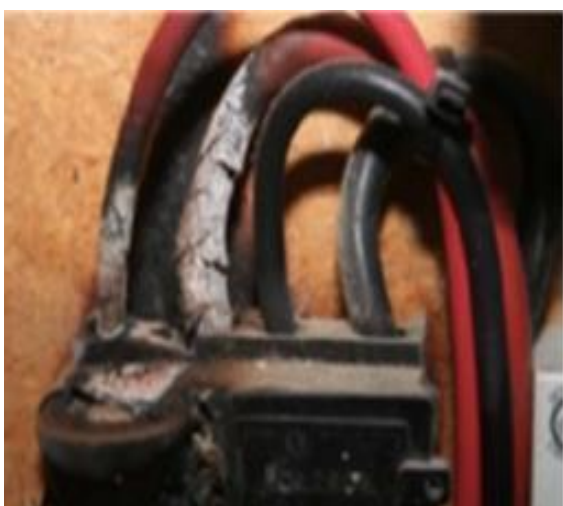
**Cut-out with visual signs of overheating**

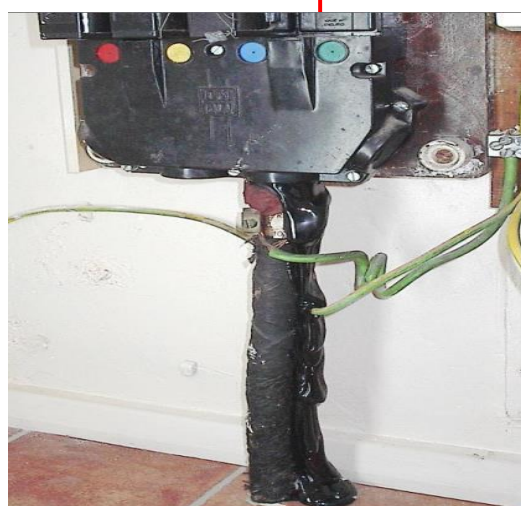
**Cut-out with signs of bitumen leaking**

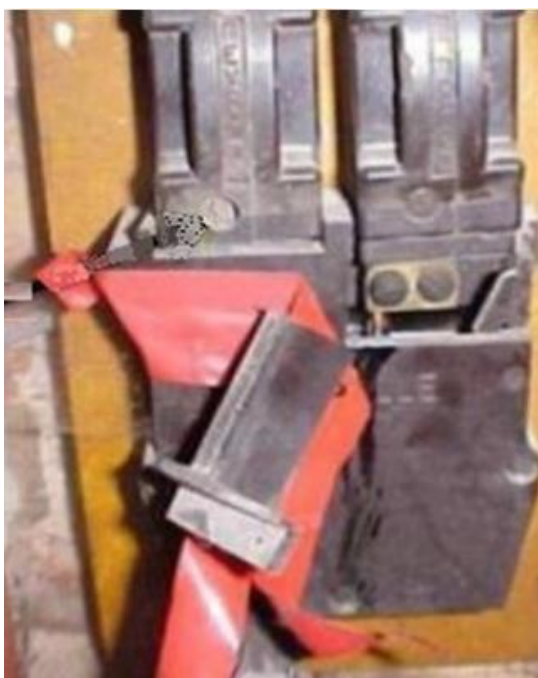
**Severely damaged cut-out casing**

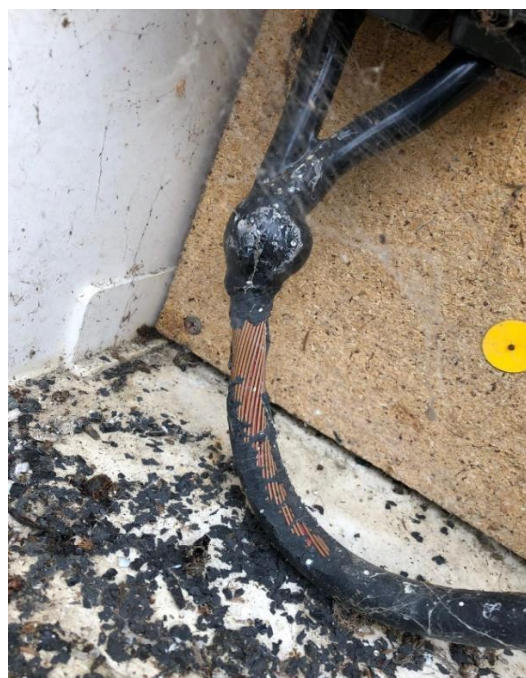
**Severely damaged service cable**

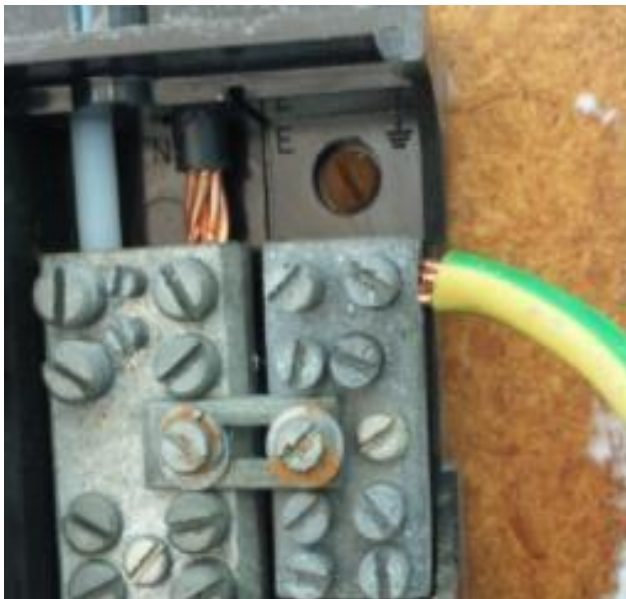
PME cut-out damaged (but not requiring immediate action) with neutral-earth terminal exposed by missing cover – report as Code C20

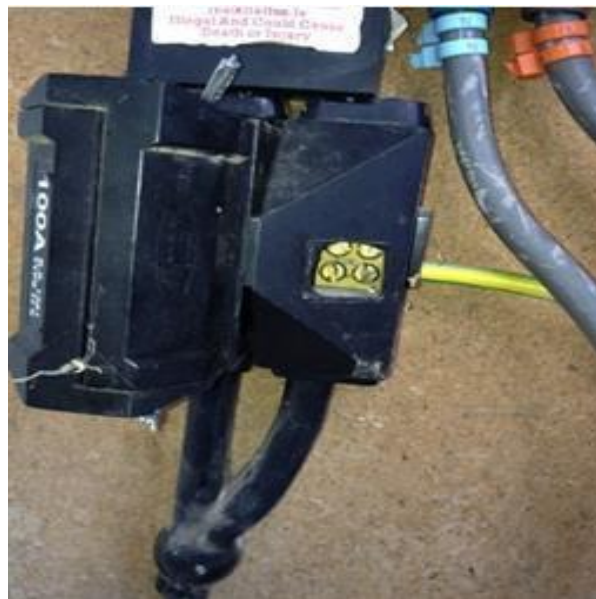
Knock out missing and the neutral-earth is exposed – do not report

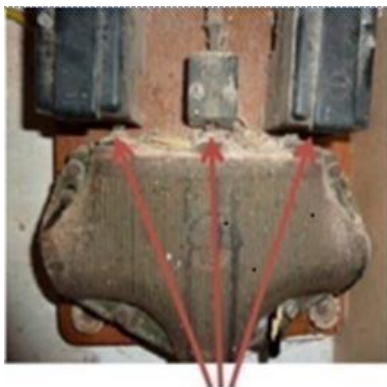
Visible bare conductors

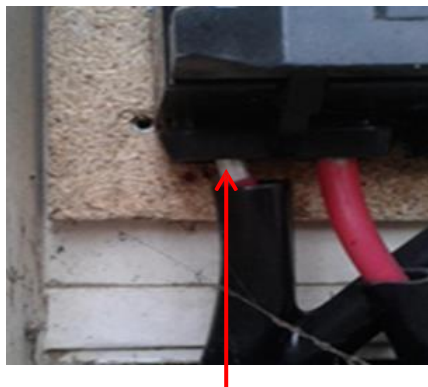
Exposed live conductor where the insulated trousers have slipped exposing the live conductor

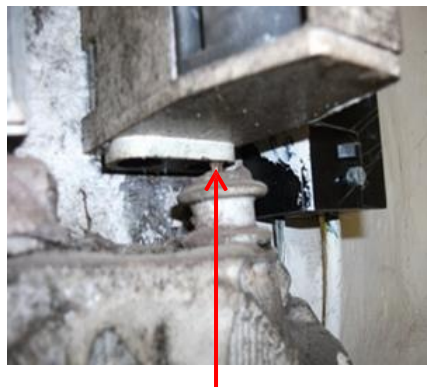
Visible bare conductors

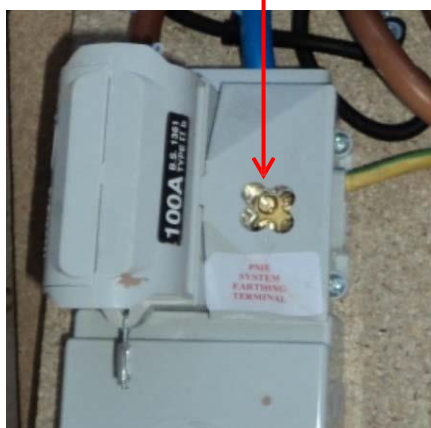
Earth terminal cover missing and the neutral-earth is exposed – do not report

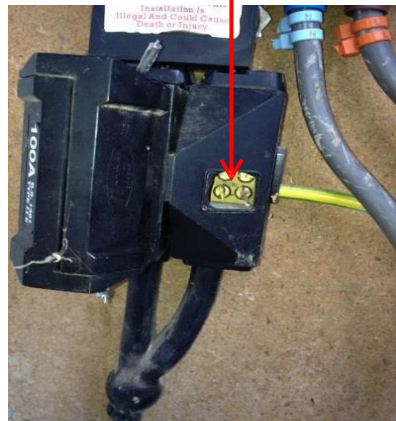
Knock out missing and the neutral-earth is exposed – do not report

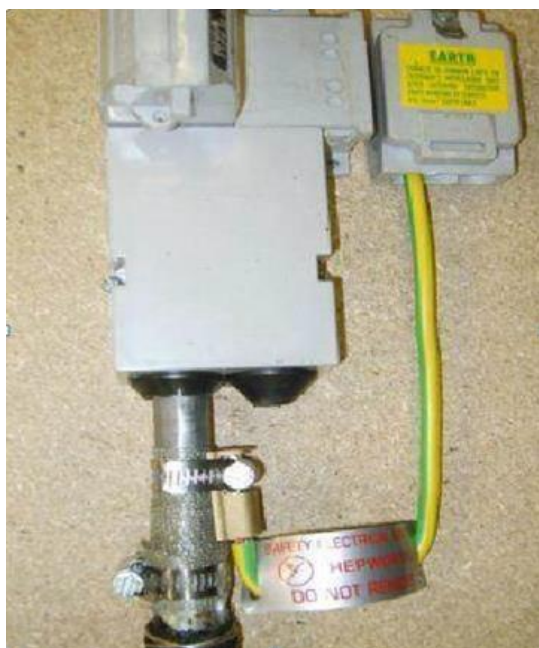
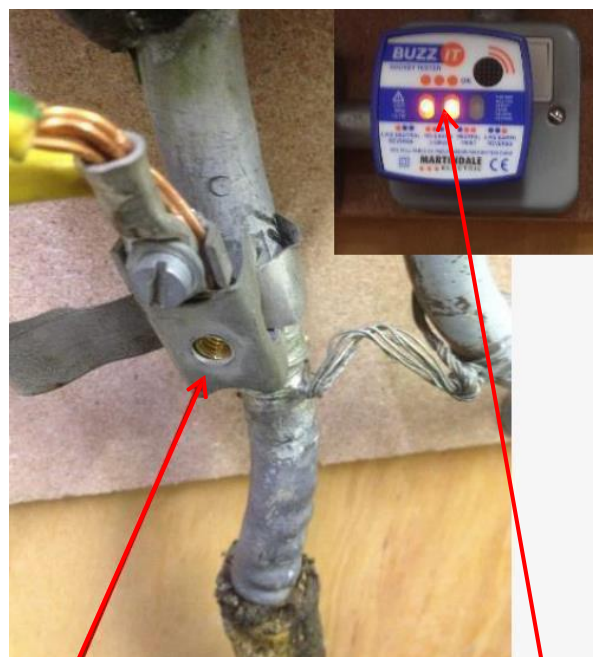
Screw missing from the earth clamp.

Socket tester indicates an earthing issue but further tests are required to confirm that the whole installation is not adequately earthed. If confirmed. Report as Code A10.

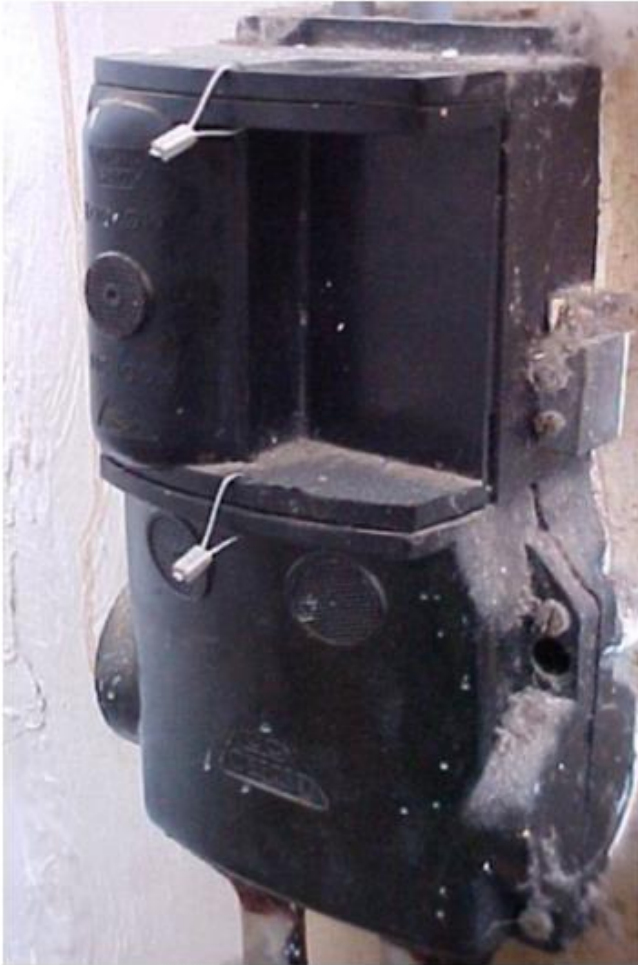
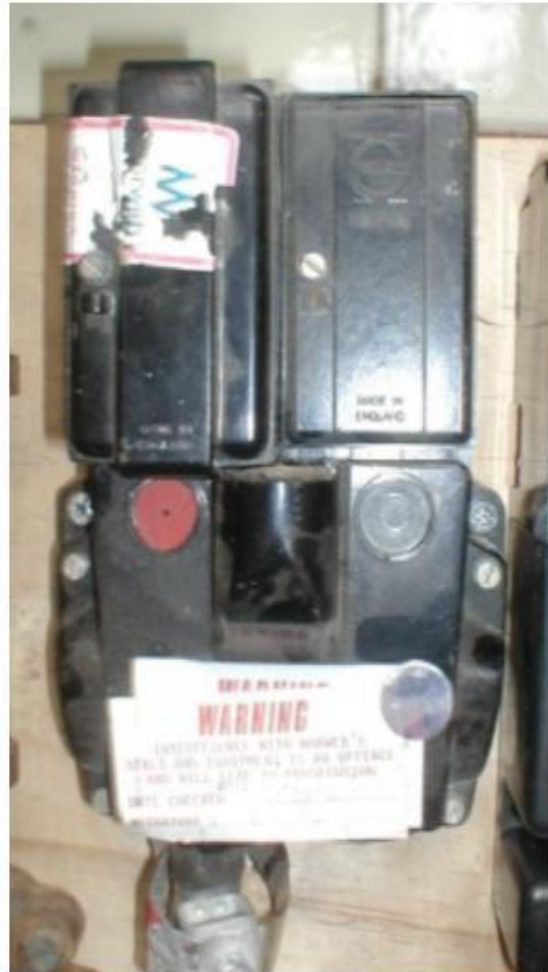
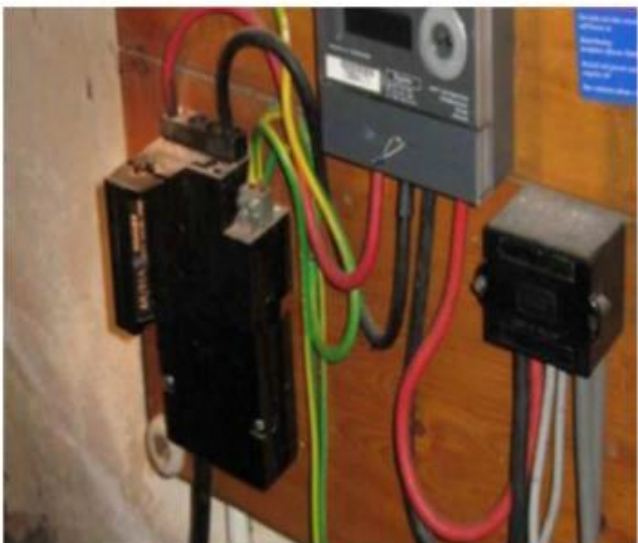
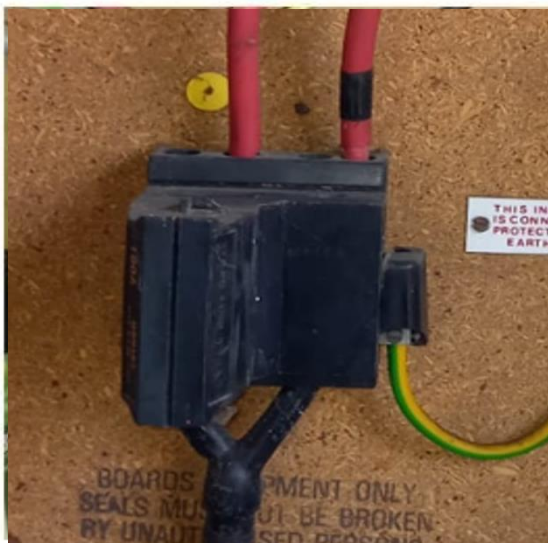
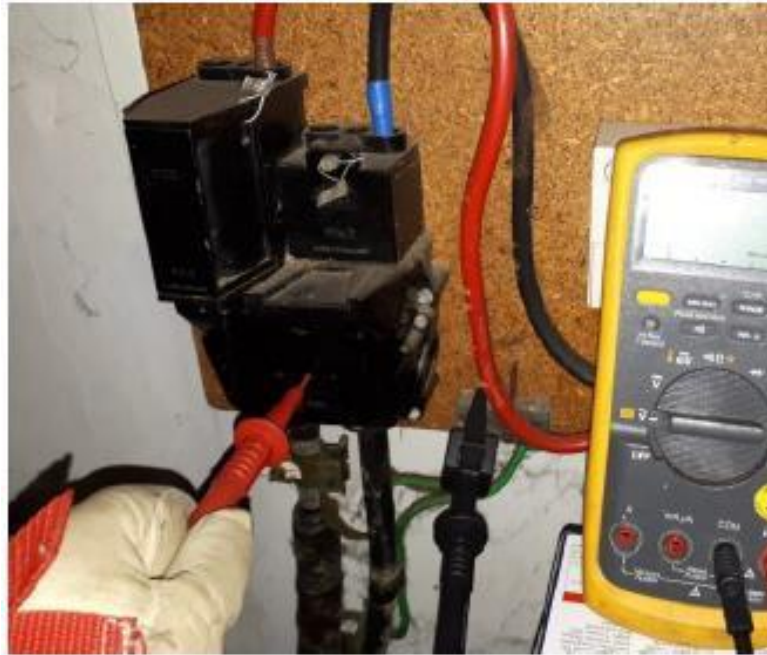
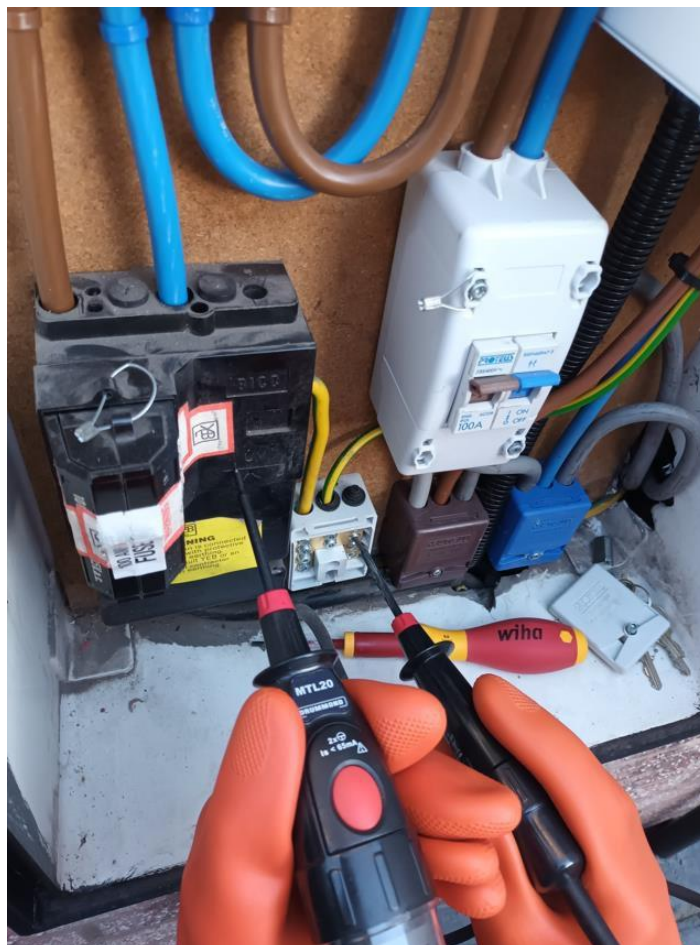
### **Black plastic cut-out**

Testing of the cut-out surface with a two-pole voltage testing device to confirm the existence of sustained voltage.

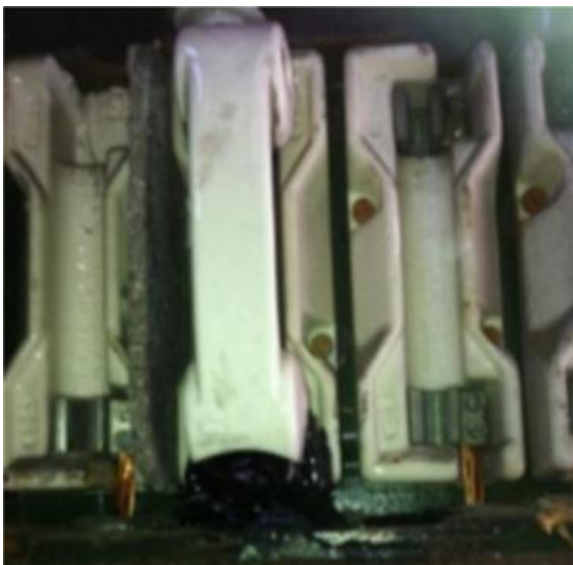
### **Fuse carrier welded into cut-out base**

A fuse has become stuck due to bitumen compound rising up from the cable box beneath and “gluing” the fuse contacts

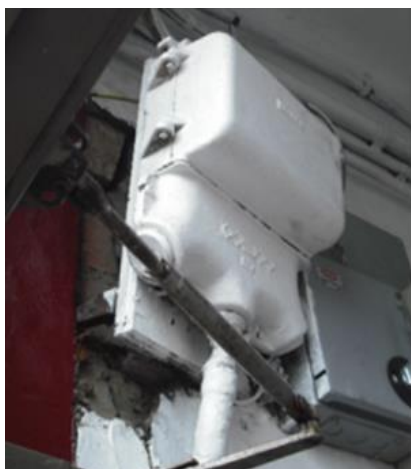
Examples of a cut-out that is clearly not securely fixed onto a wall

- Wherever possible, for safety and security reasons ensure the DNO equipment is sealed before leaving site;
- Stop work and do not commence your meter installation activity;
- Report the issue to the DNO via the data flow system – report as Code B02;
- Within the free text field on the data flow, please identify what equipment is located on the meter/backboard (including any customer equipment);
- Provide the DNO with the customer's name and contact number using the data flow system;
- To ensure the customer is fully aware of next steps, leave a Category B Customer Notification Card (or equivalent) to advise the customer to expect communication from the DNO requesting an appointment to visit site to inspect the DNO equipment.

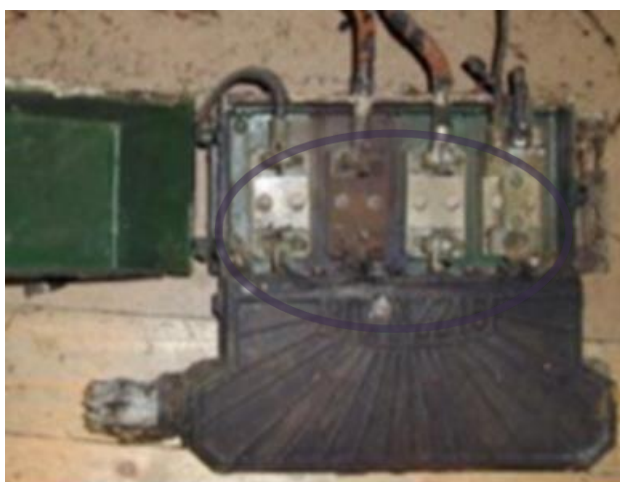
Missing phase barriers. Note the proximity of the incoming "stalks" to the metal cover

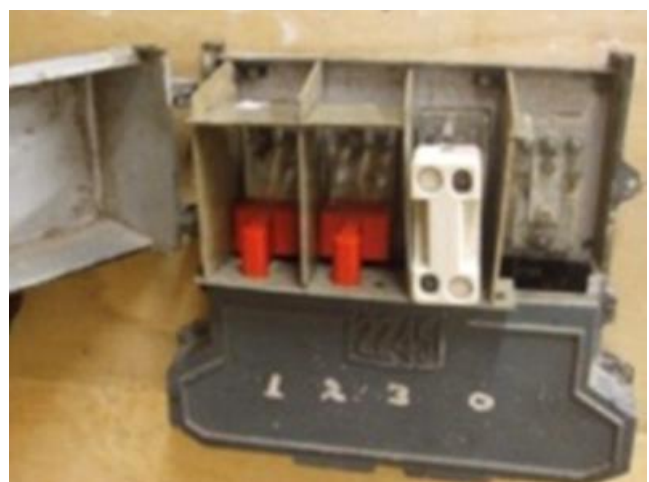
Missing phase barrier. Shrouds (in red) have been used by the Meter Operative to cover the live terminals

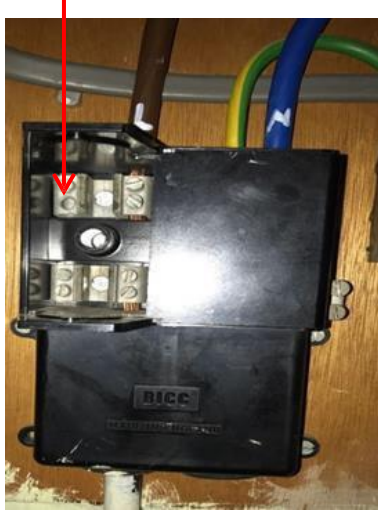
Missing screw. Meter Operative able to continue with work - do not report

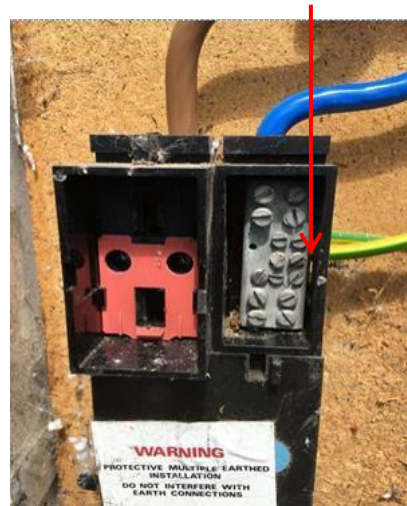
Screw sheared off. Meter Operative able to continue with work - do not report

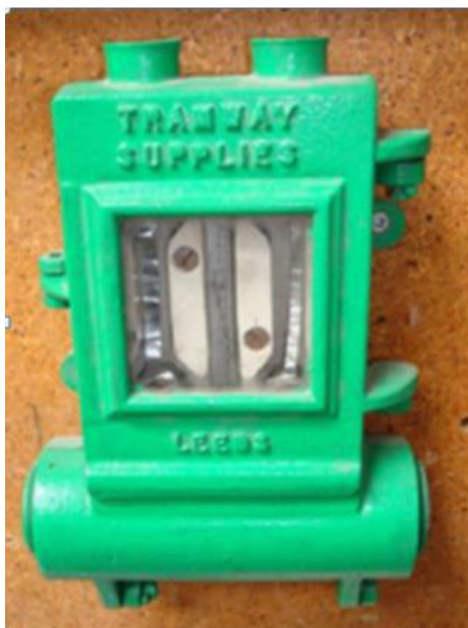
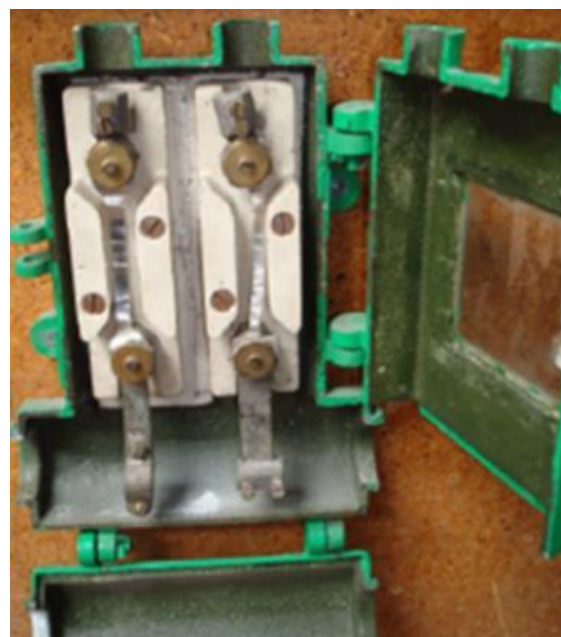
The photos below show an example of a cut-out where the fuse wire terminals are attached to the cut-out, hence the fuse is non-withdrawable by design. Although note that this particular cut-out also contains a fused neutral and would therefore be reported under as Code B11.

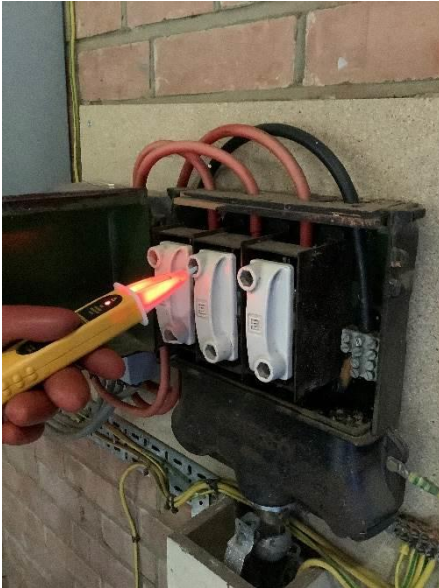
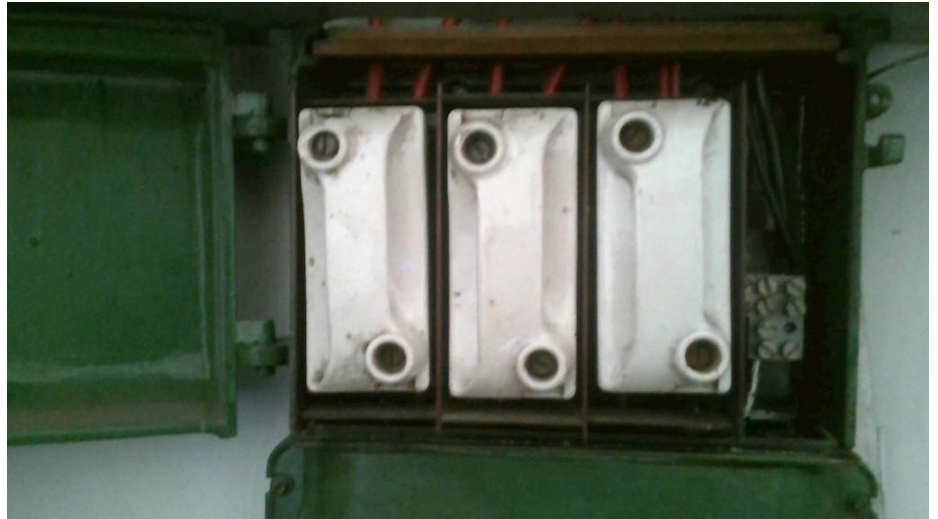
The photos below show an example of a cut-out where the fuse carriers can only be withdrawn by loosening the live screws integral to the porcelain carriers. This is considered live working and is not within the scope of Meter Operative activity.

If the withdrawal of the above fuse carrier types is required to continue with your work, you should report the issue to the DNO via Code B05. The DNO will decide to take one of the following actions:

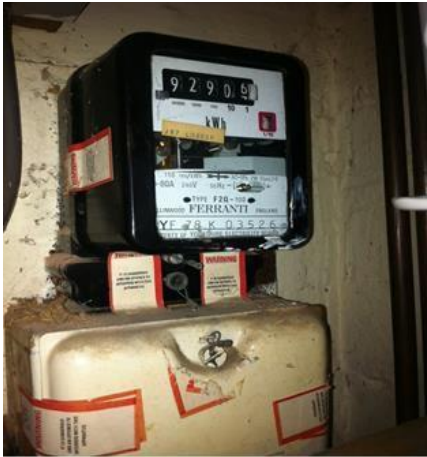
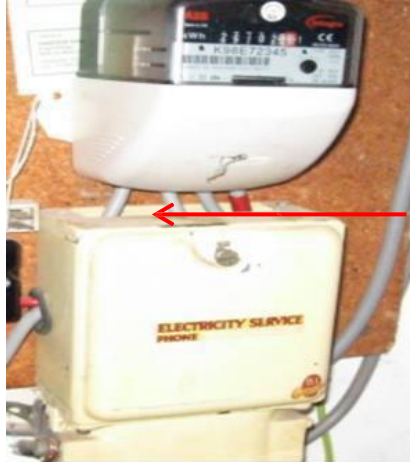
Raised position of meter could create a potential category A issue by leaving exposed live conductor(s) through the cut-out cable entry slot that were previously covered by the meter placed directly on top of the cut-out

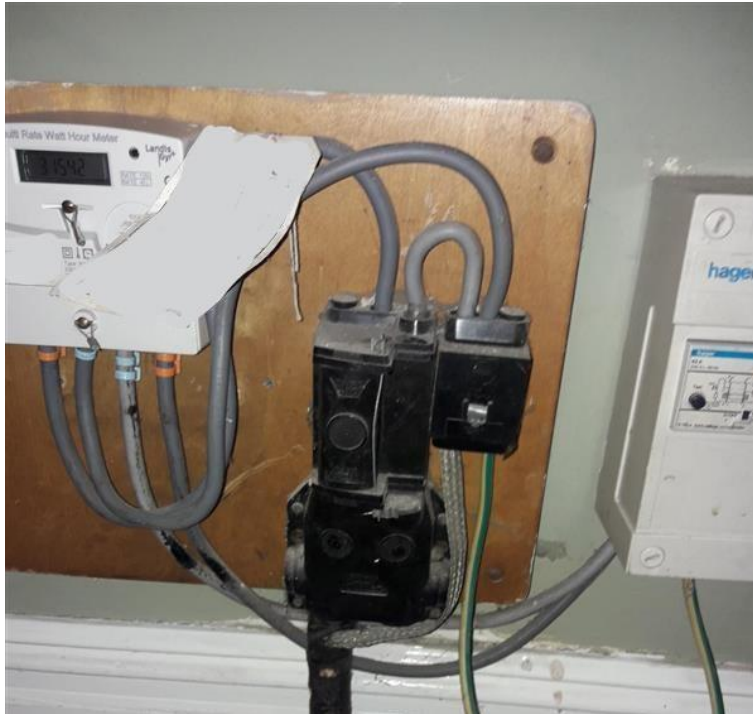
The photo below shows an example of the scenario that is reportable to the DNO.

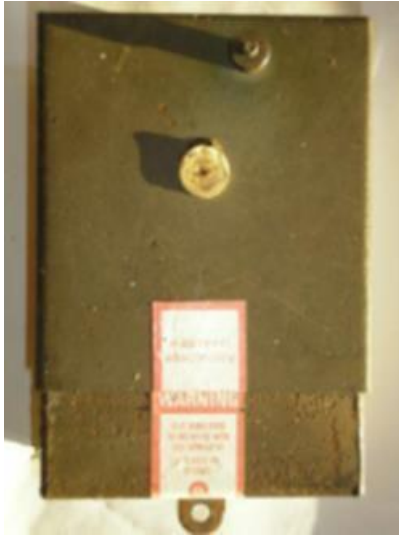
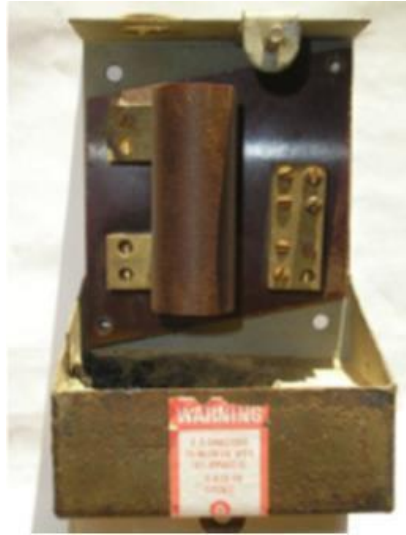
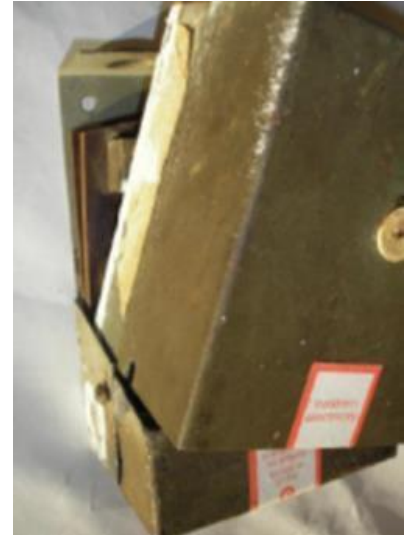
An uncommon type of pressed steel metal-encased cut-out, probably from the 1940s.

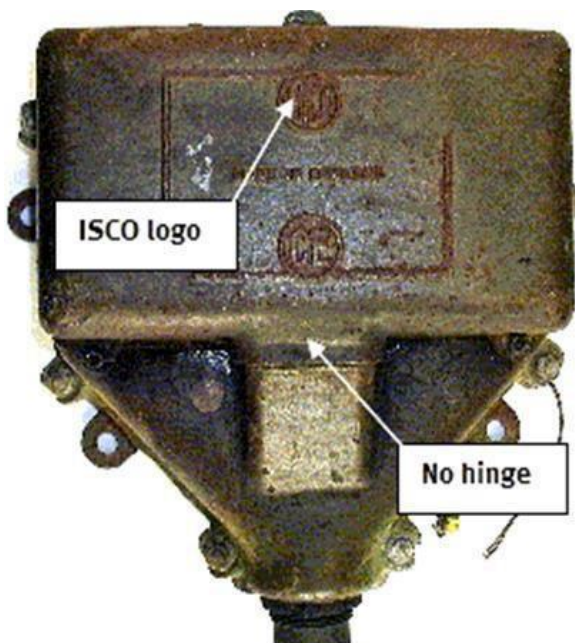
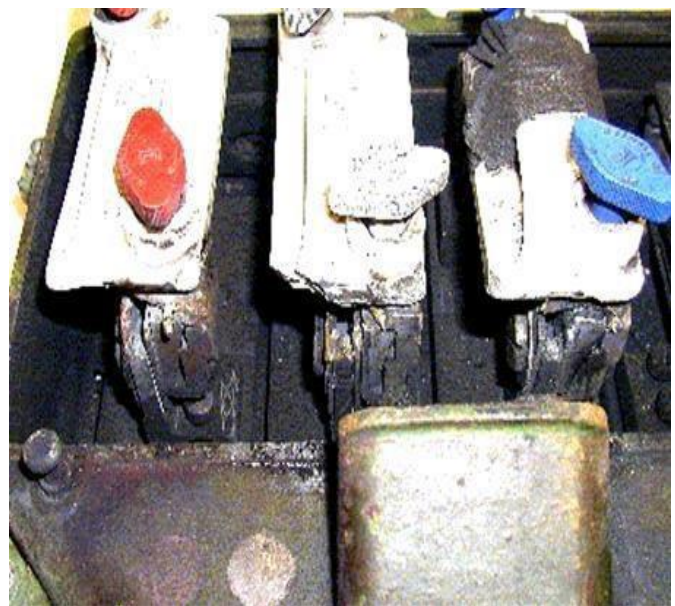
A typical example of a metal-encased cut-out which has known design deficiencies is the ISCO Type cut-out and extreme caution must be exercised when removing or replacing lids on this type of equipment. This particular example also had the phase barriers removed. All cut-outs must be assessed individually prior to attempting any live work on them ensuring that the phase barriers are in place.

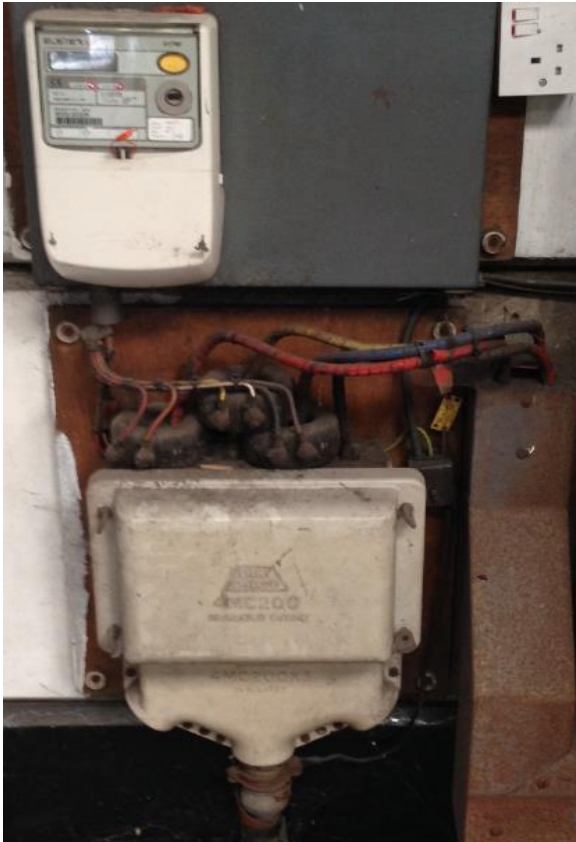
CT installation with missing test terminal block

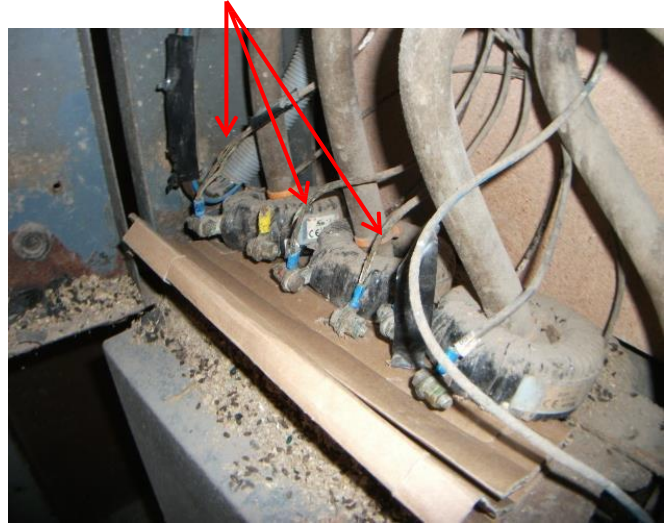
CT wiring insulation damaged by rodent infestation exposing inner conductor

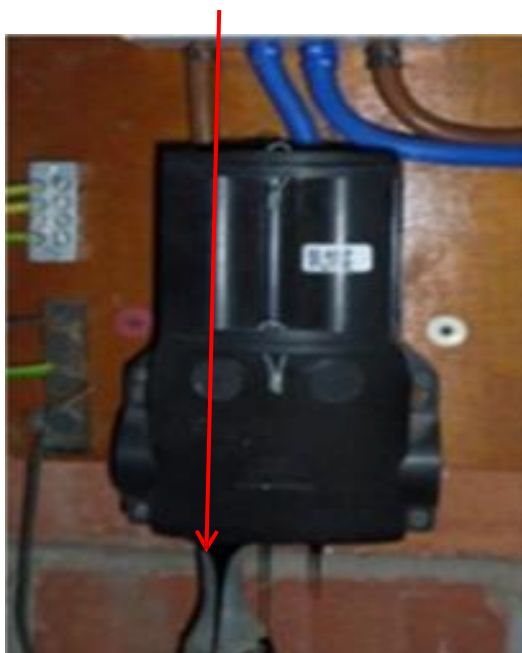
- There is no evidence of the DNO equipment currently operating hot;
- The DNO equipment appears in all other respects to be in good condition; and
- Compound has obviously leaked from the cut-out previously but is not currently leaking.

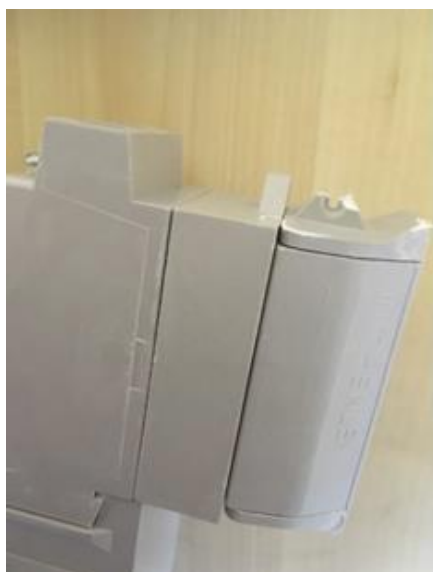
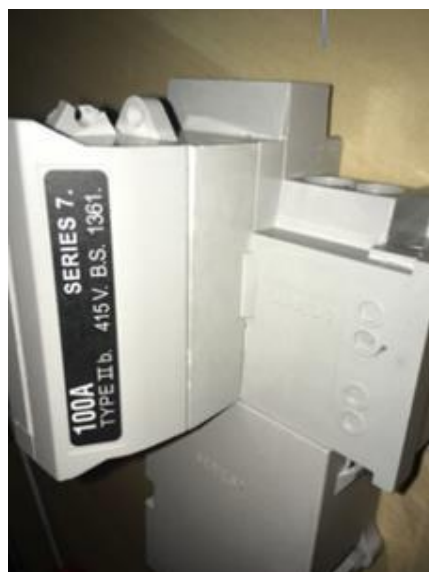
**Examples:** Photos showing where the tags are broken and it is not possible to seal the cut-out properly.

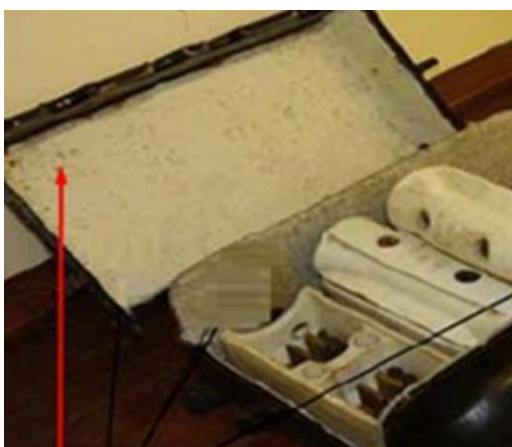
Coating and labels

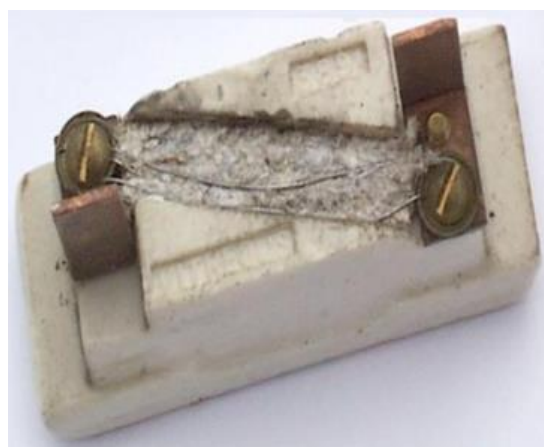
Asbestos wool
