BIRDS-3 Project

EM Vibration Test Report

Kyushu Institute of Technology
 Laboratory of Spacecraft Environment Interaction Engineering

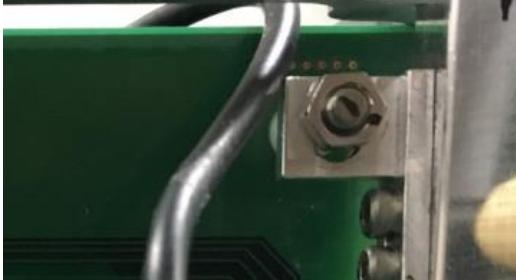
Table 9-2 Nut torque mark displaced

A few torque mark shift was observed. The nut that holds the spacers between the PCBs was observed to be have shifted. Table 9-2 shows the difference before and after.

Test Axis	Satellite Axis	Result	Discussion	<100Hz
X-axis	X-axis	No shift in frequency in Random and Sine Burst	-	Yes
	Y-axis	Amplitude of natural frequency of higher than X-axis	This can happen at times. Dr. Masui states that this is a non-issue.	Yes
	Z-axis	No shift in frequency in Random and Sine Burst	-	Yes
Y-axis	X-axis	Slight shift in frequency in both Random and Sine Burst. Right shift corresponds to natural frequency increasing.	The test article is more compact. Visual inspection showed nuts were loose.	Yes
	Y-axis	Slight shift in frequency in Random test however, the graph shifted back to original frequency after Sine Burst	The test article's natural frequency returned back to original frequency.	Yes
	Z-axis	No shift in frequency in Random and Sine Burst	-	Yes
Z-axis	X-axis	Slight shift in frequency in both Random and Sine Burst. Right shift corresponds to natural frequency increasing. This shows the test article was more compact than before	The test article is more compact. Visual inspection showed nuts were loose.	Yes

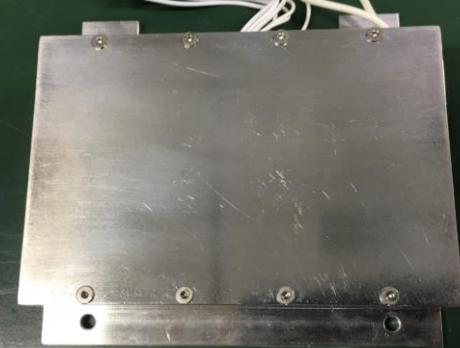
Table 9-3 Damage seen on Battery Box

Visual observation shows no breakage. The appearance before and after the test is shown in Table 9-4 for comparison. However, the DIP header of the Front Access Board (FAB) was in contact with the battery box during vibration board. This created small holes on the box. This is shown in Table 9-3.
