***Kysor of Cadillac, Inc. Site  
Wexford County, Michigan  
First Five Year Review***

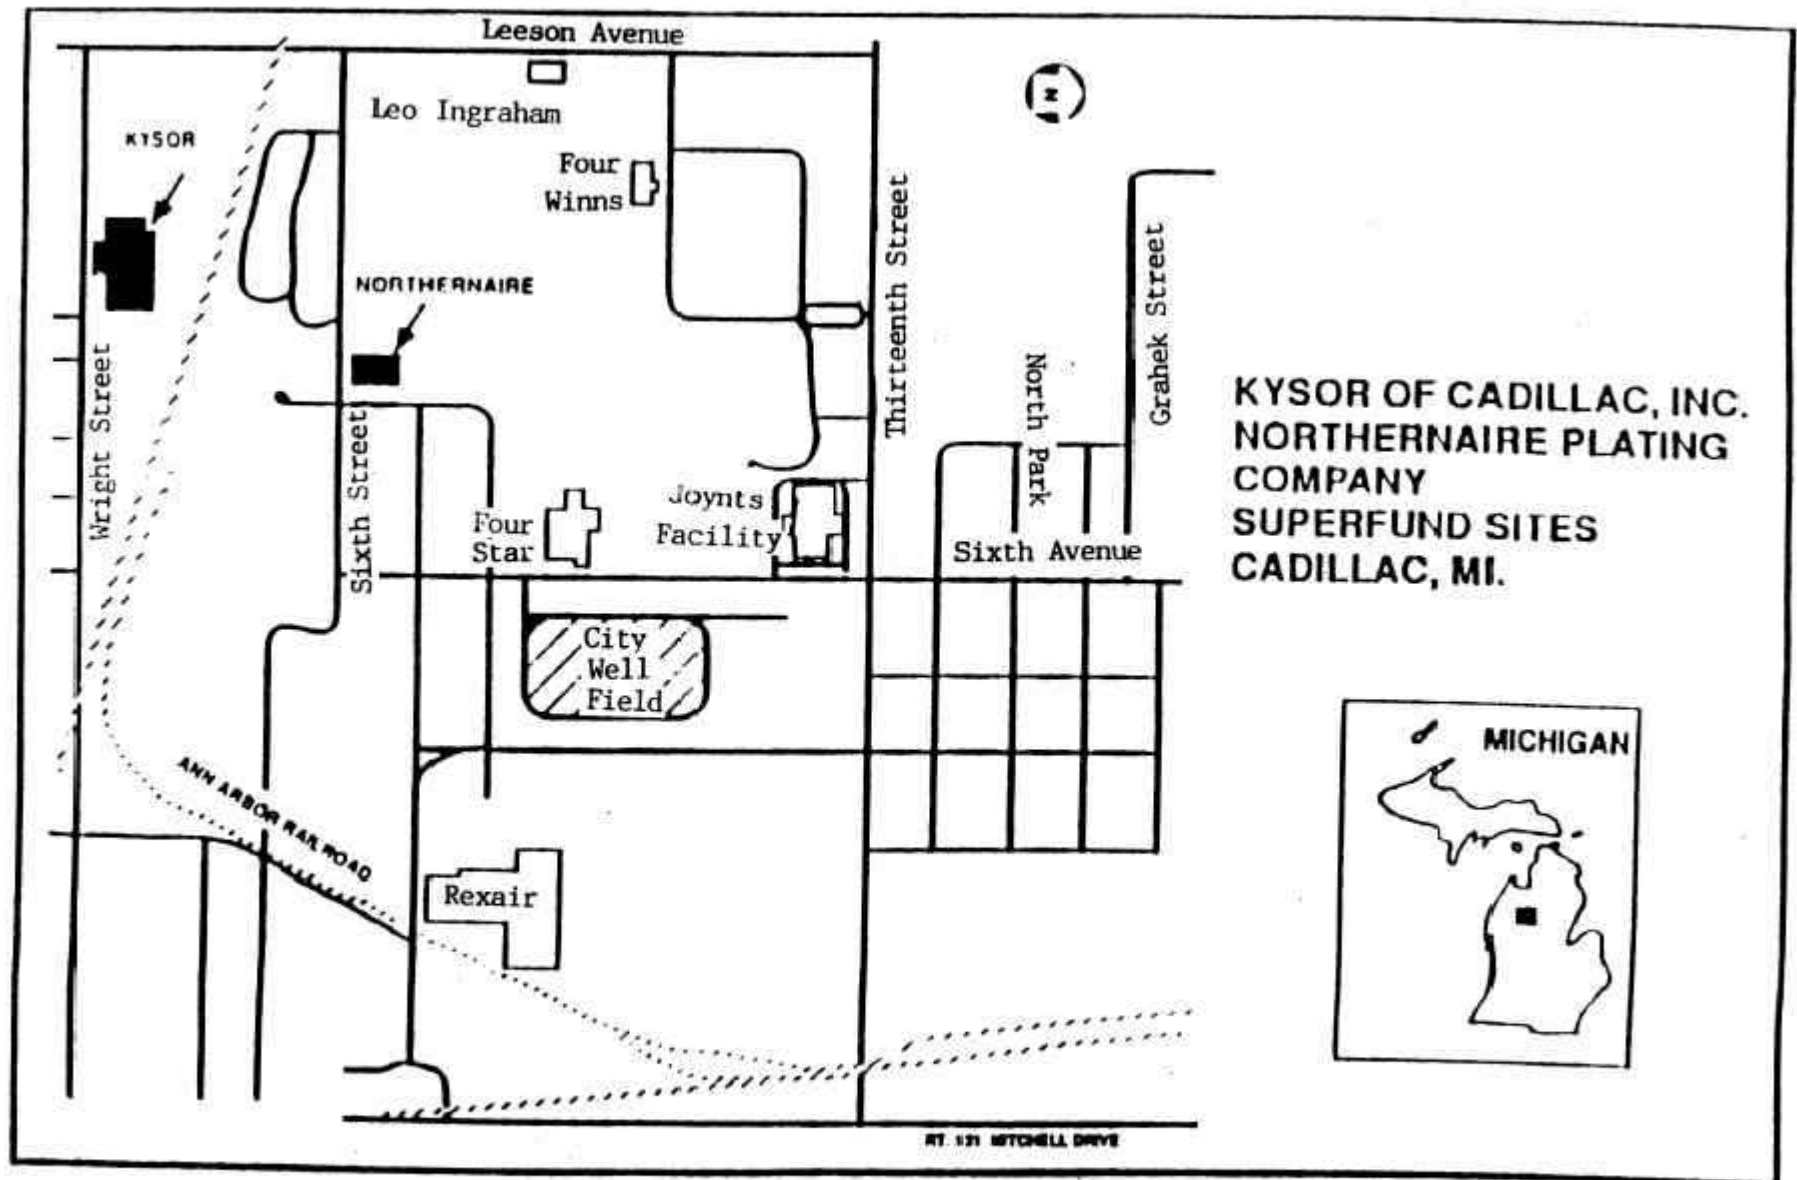
Figure 1

The Kysor Industrial Corporation Site (Kysor) covers approximately one square mile of the Cadillac Industrial Park within the city of Cadillac, Michigan and an adjacent area north of 13<sup>th</sup> Street in Haring Township. Kysor has an active facility at 1100 Wright Street at the southern edge of the industrial park, which manufactures truck parts and uses a variety of solvents, degreasers, and paints. It began operations in approximately 1959. Past disposal practices included dumping barrels of spent solvents directly on the soils behind the plant. Partial remediation of the contaminated soils at the Wright Street facility was conducted by Kysor in 1981, including the removal of the top six feet of an area of soil, for a total removal of 700 cubic yards of soil. However, MDNR observers noted strong odors and more than 100 parts per million of several volatile organic compounds (VOCs) remaining in soils. The excavation was backfilled with clean material (See Figure 1).
