# Five-Year Review Report

Fourth Five-Year Review Report

Northern Plating Superfund Site  
Cadillac, Wexford County, Michigan

September 2010

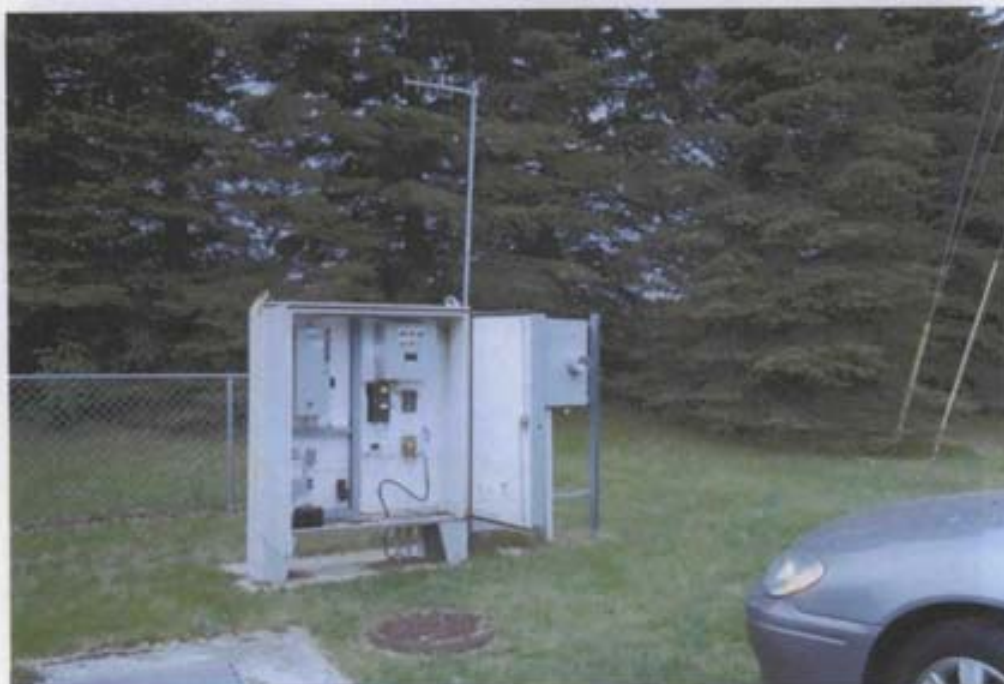
**Figure 1 – Electrical panel for Local Development Finance Authority (LDFA) extraction well I-7, located about 1,200 feet northwest of the edge of the Cadillac city well field. The antenna on top right side of panel is radio telemetry control system.**

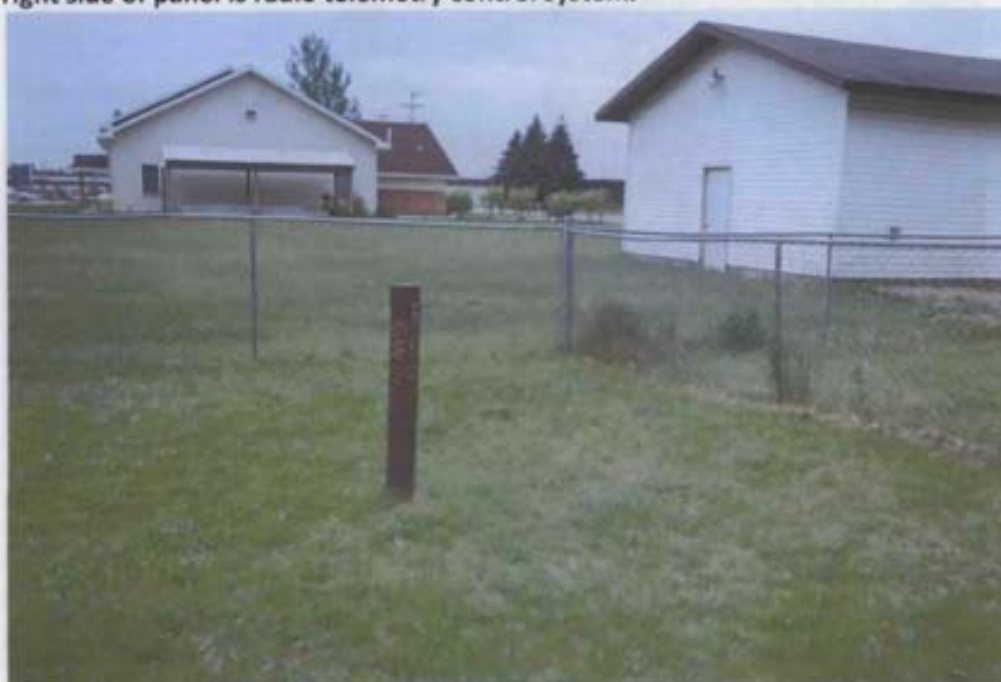
**Figure 2 – View of shallow aquifer well GW-11 located about 500 feet northwest of the Four Winns/A.H. Joynt facility. The well is used for water level and VOC monitoring.**

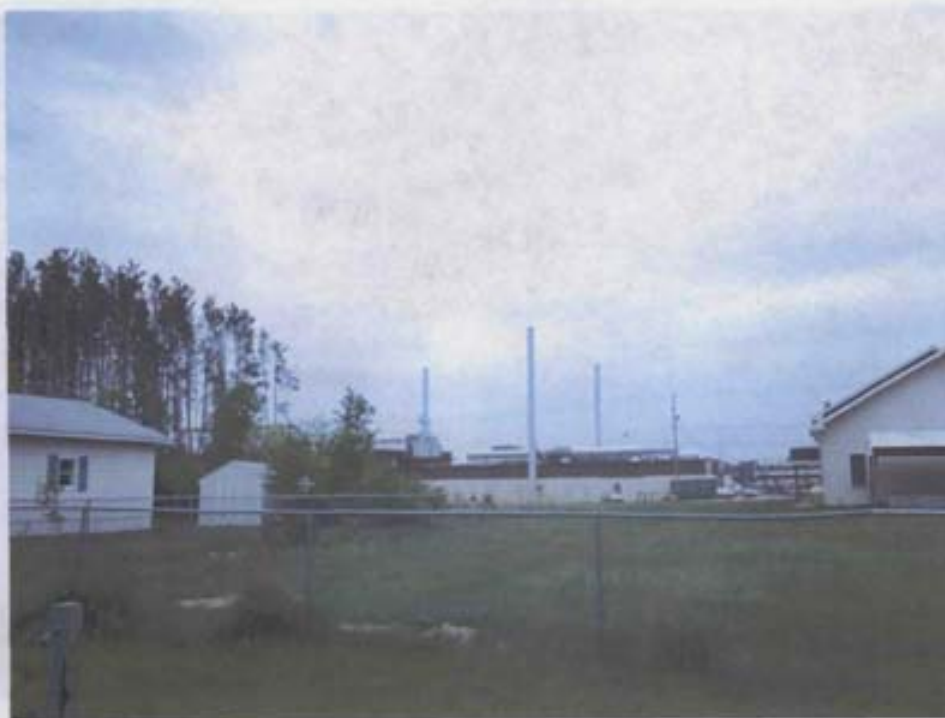
Figure 3 – View of the Four Winns facility as seen from the intersection of Seventh Avenue and Fourteenth Street, where well I-7 is located.

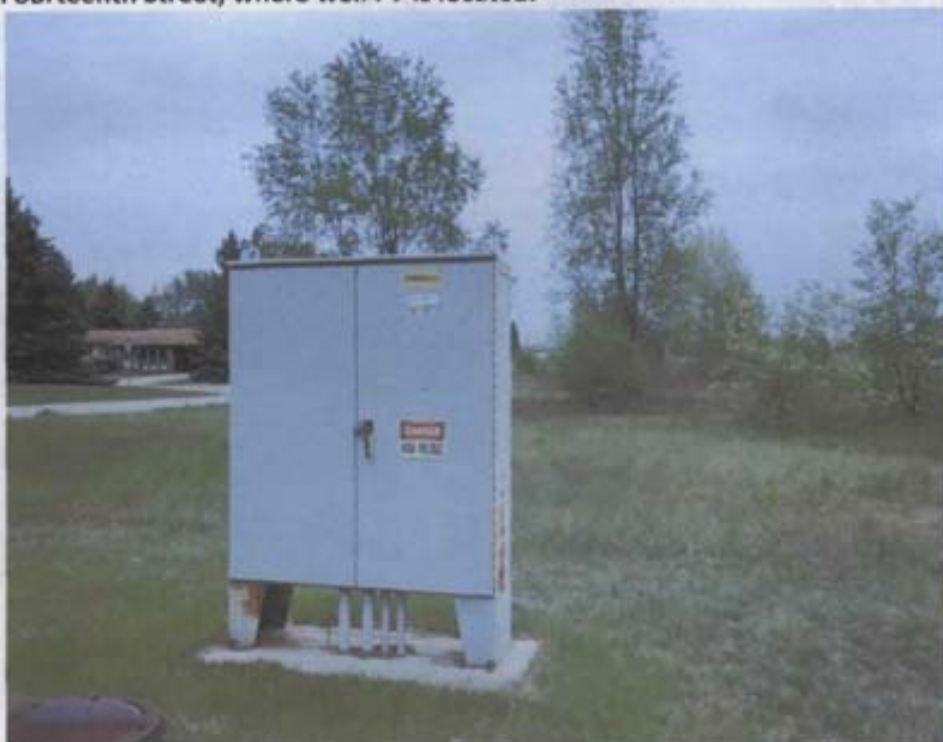
Figure 4 – View of electrical panel for LDFA intermediate depth extraction well I-8, located at the intersection of Seventh Avenue and Grahek Street in the North Park subdivision area. The well is about 2,250 feet northwest of, and the farthest distance from, the Cadillac well field.

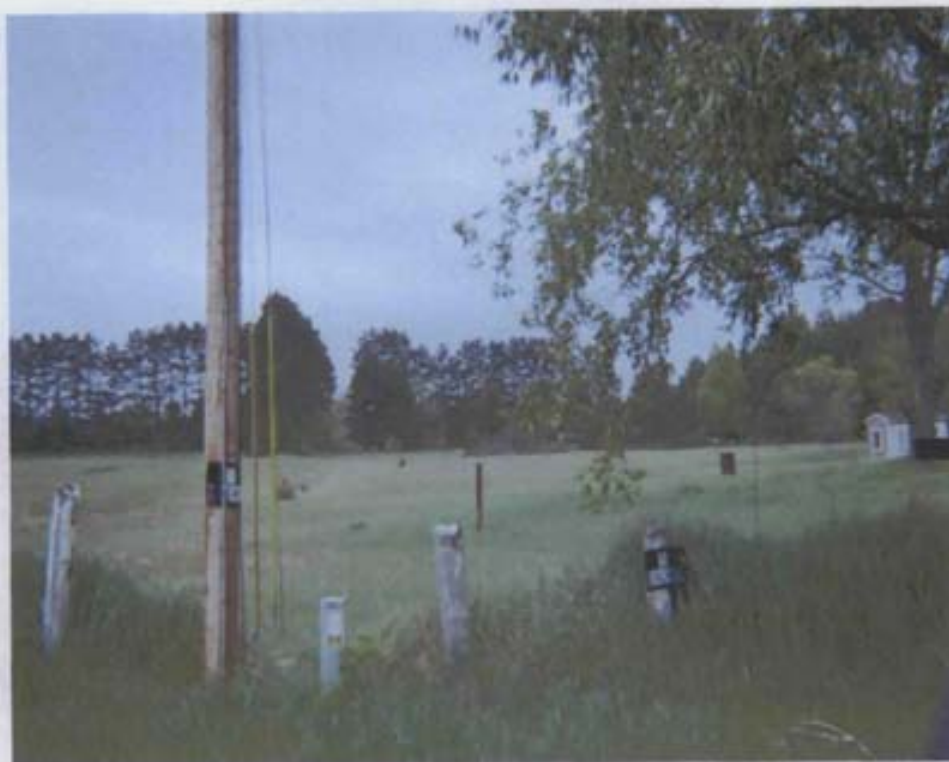
Figure 5 – View of well SLW-35. This shallow-aquifer well is located about 1,025 feet north of Thirteenth Street and northwest of the North Park subdivision area.

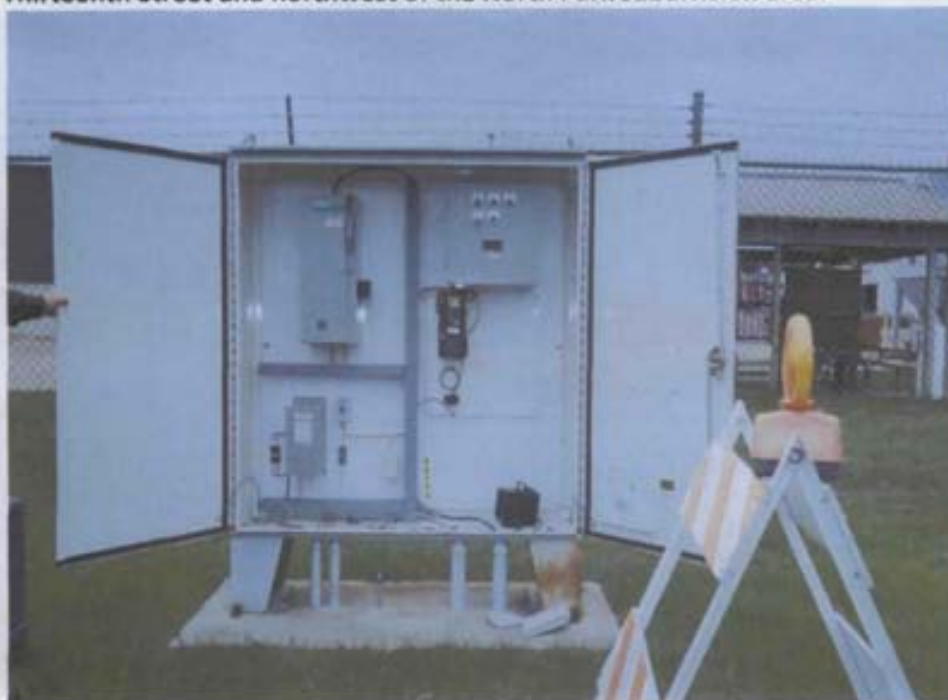
Figure 6 – View of electrical panel for LDFA intermediate extraction well I-5, located north of the Michigan Rubber facility and 1,000 feet northwest of the Four Star facility. Well I-5 is the dedicated chromium extraction well.

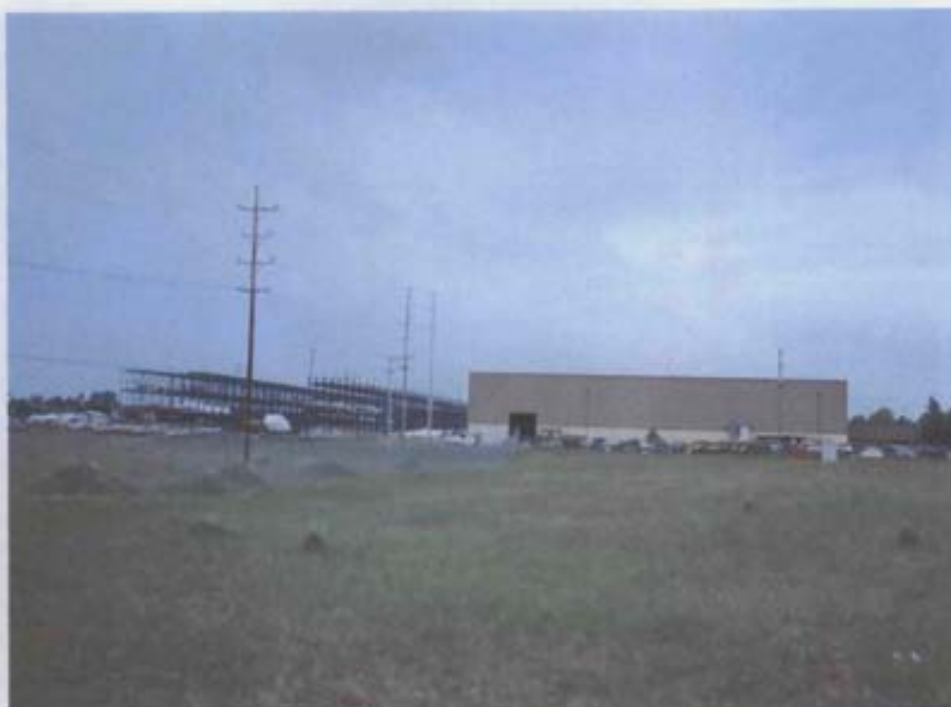
Figure 7 – A view of the back of the Four Winns Frisbie facility, which manufactures recreational boats. The electrical panel for the LDFA shallow-aquifer extraction well S-6 is visible at the far right background of the photo.

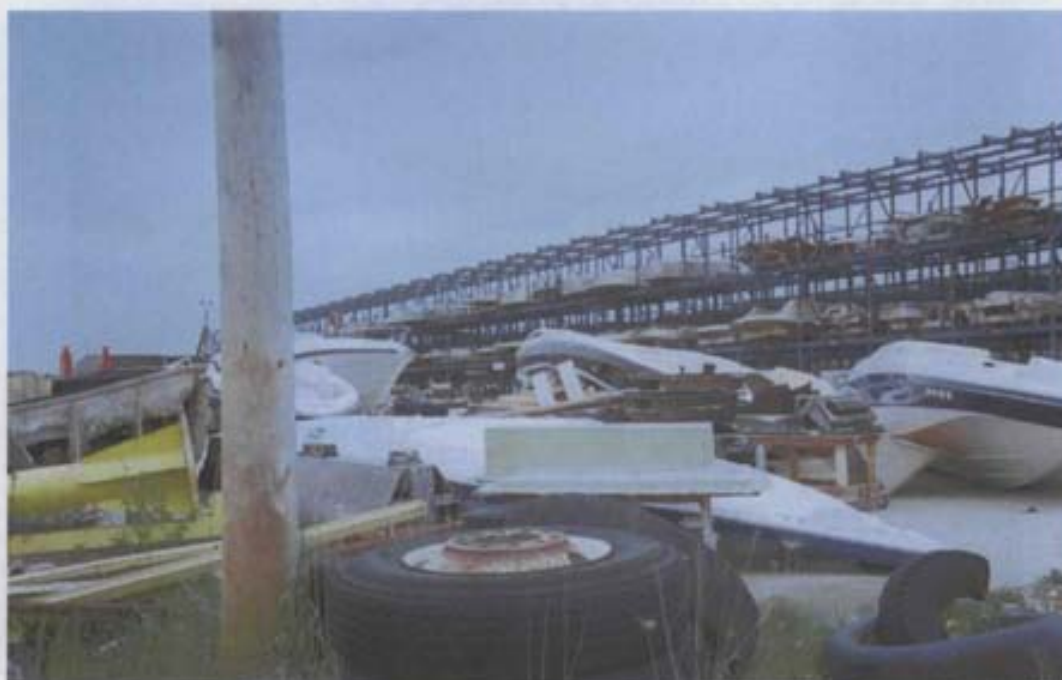
Figure 8 - A closer view of the back side of the Four Winns Frisbie facility.

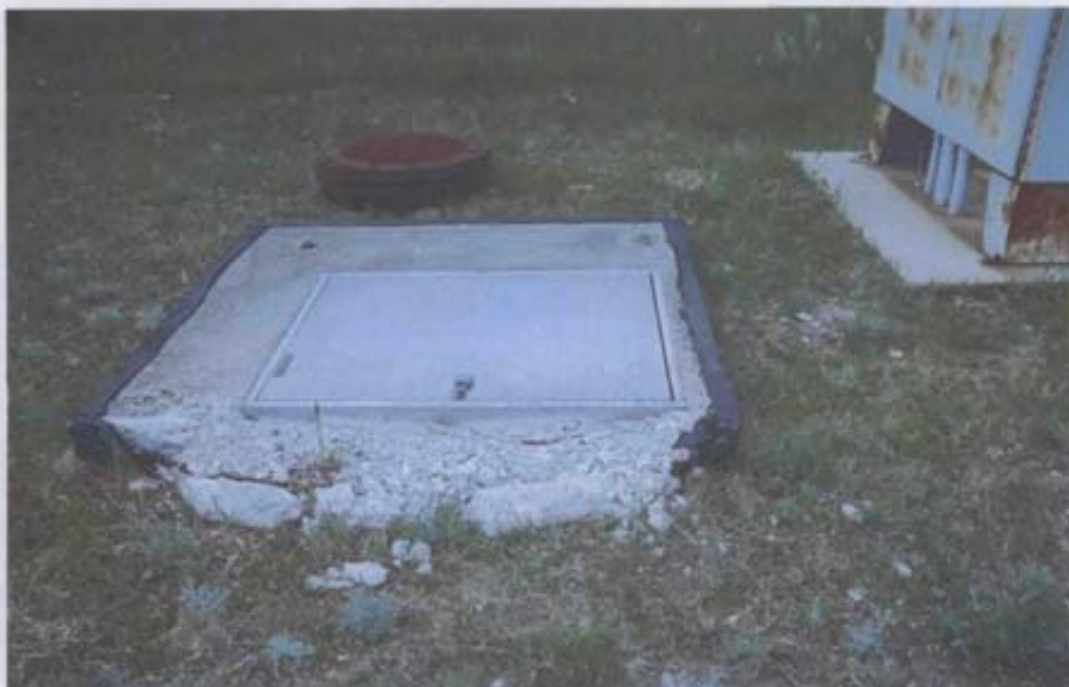
Figure 9 – A view of LDFA shallow-aquifer extraction well S-3, located about 1,250 feet west of the south west corner of the Cadillac city well field. The well cover in the middle of the photograph is cracked around the metal cover. The electrical panel is at the top right corner of the photo.

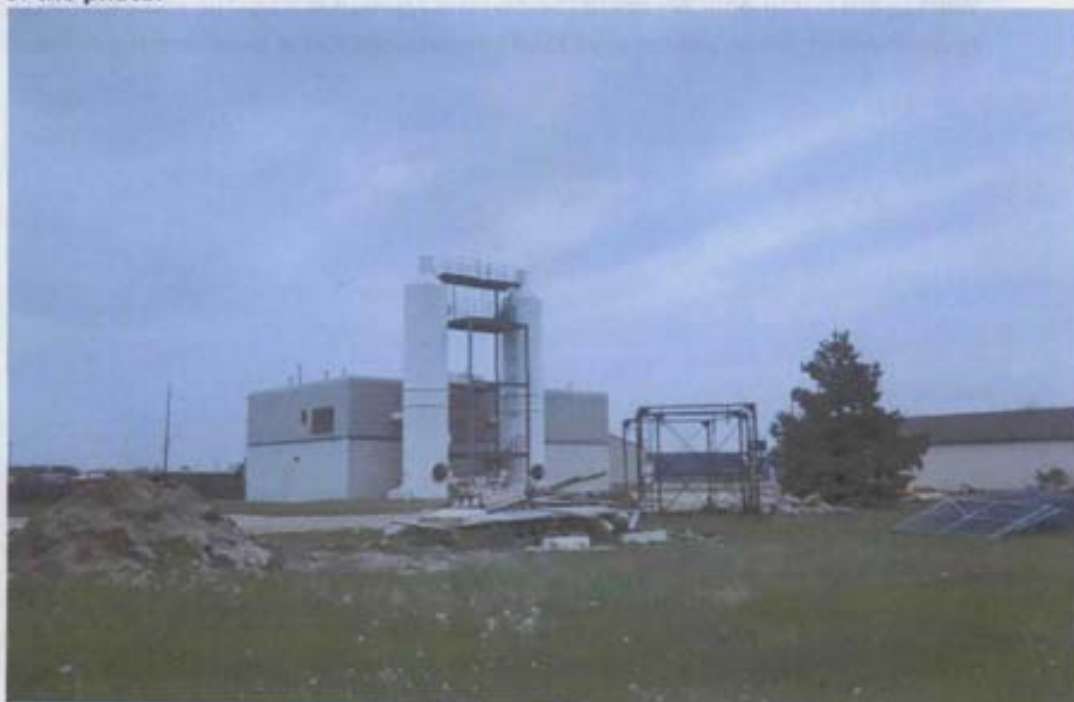
Figure 10 – A view of the south side of the LDFA groundwater treatment plant. The two air stripping towers are visible in the center mid-ground of the photo. The plant is in front of the towers.

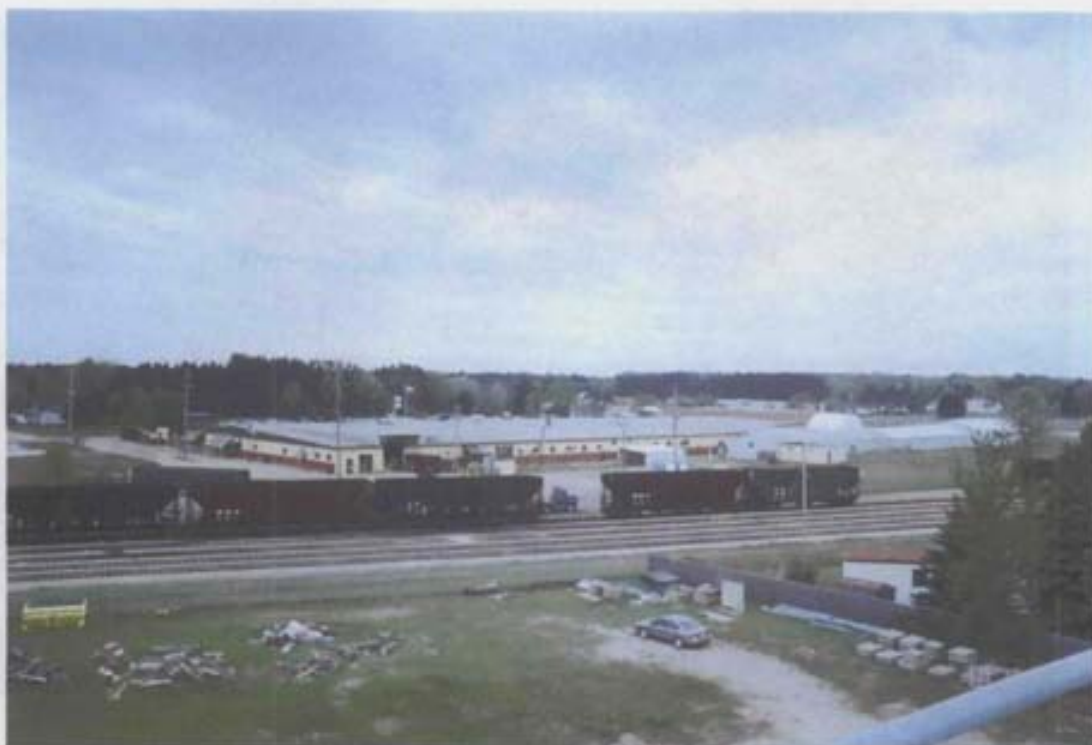
**Figure 11 –View from atop the air-stripping towers looking south toward the Kysor plant (now owned by Borg-Warner) just south of the railroad tracks. The Cadillac city Department of Public Works yard is immediately north (below) the railroad tracks. The soil vapor extraction (SVE) system (not visible in photo) is located between the Kysor plant and the railroad tracks.**

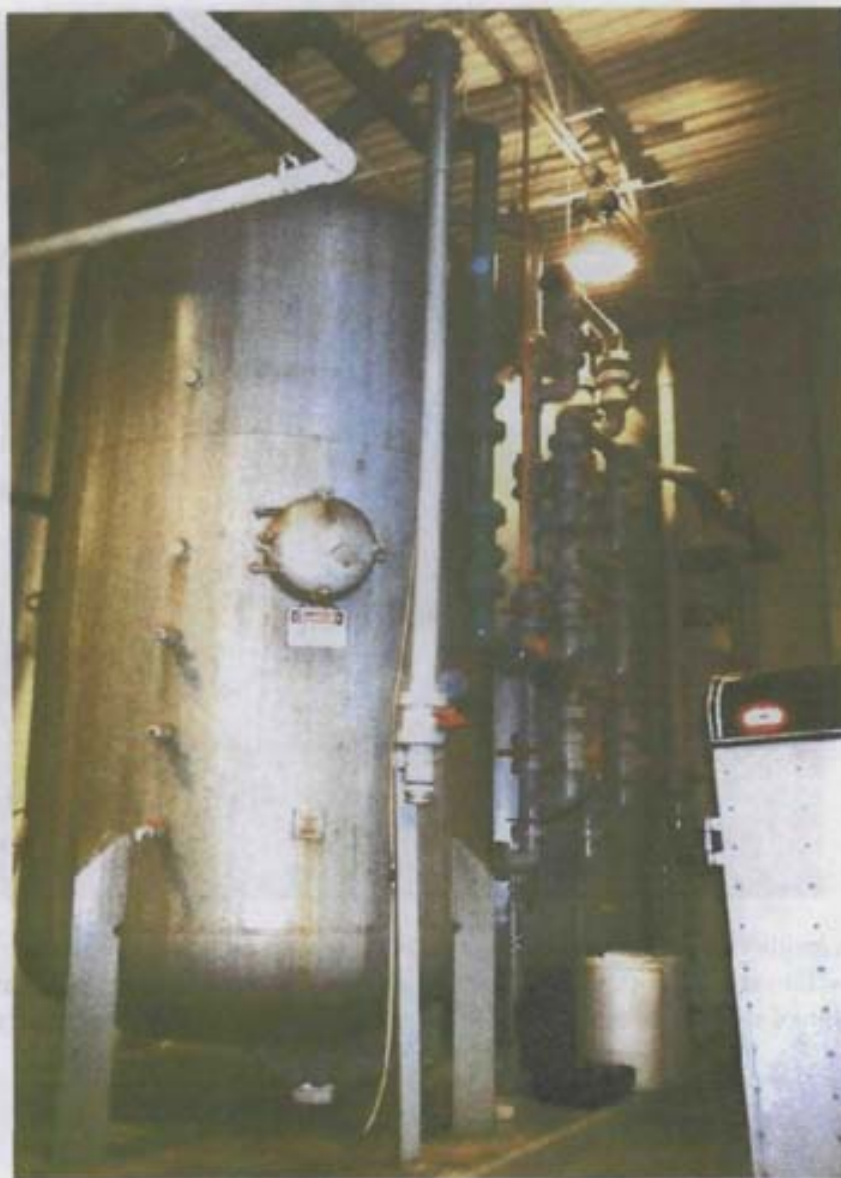
Figure 12 – View of one of the two GAC treatment tanks inside the LDFA treatment plant. The chromium stream from dedicated extraction well I-5 and the VOCs that may also be present in the extracted groundwater from I-5 are processed in these tanks. Most of VOC stream does not enter these vessels.

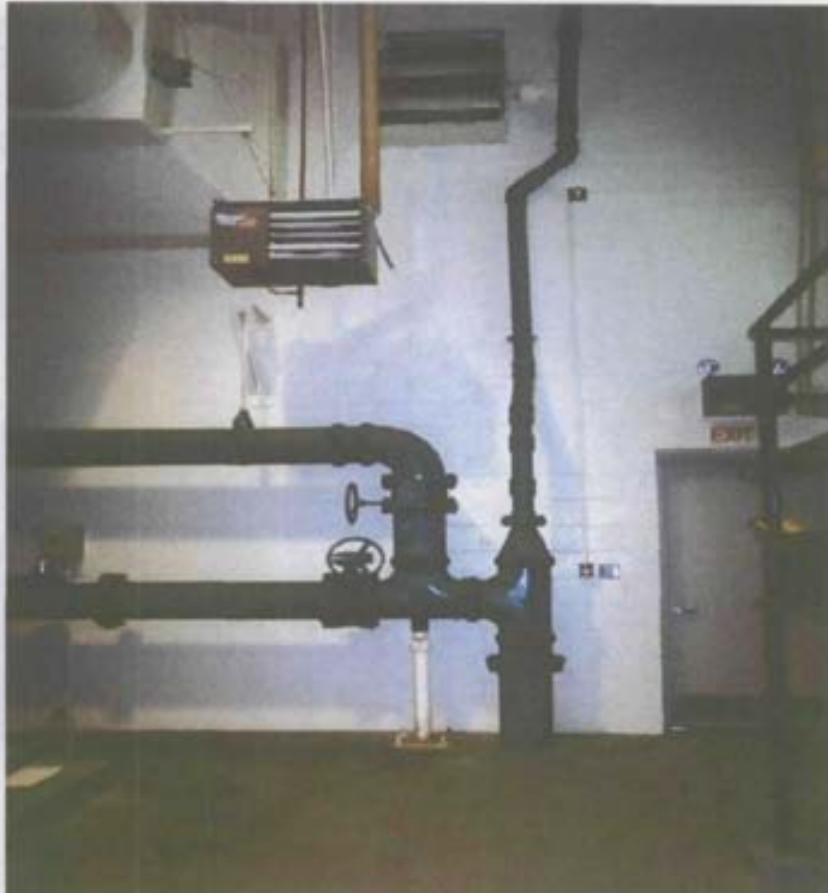
**Figure 13 – View inside the treatment plant of the joining of the dedicated chromium well (I-5) extraction stream with the VOC extraction wells. The thin vertical pipe carries the combined streams to the GAC filter tanks before entering the air strippers.**

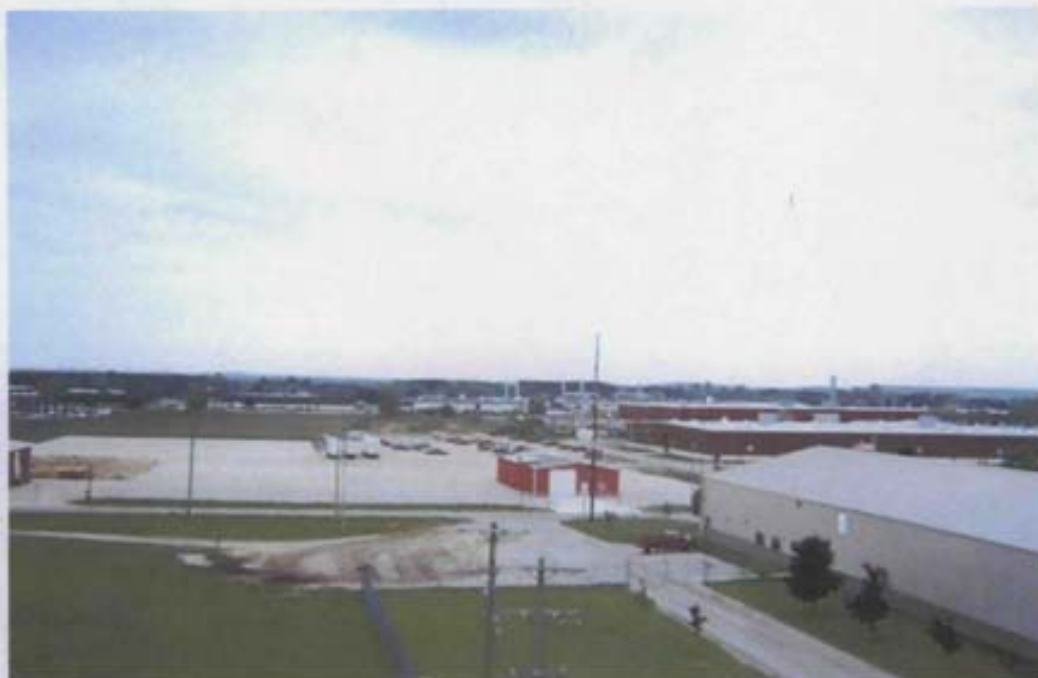
Figure 14 – View from atop the air stripping towers looking north. The Northernnaire facility is in the mid-ground. The Paulstra/CRC facility (long low red building) is to the right and immediately northeast of Northernnaire.

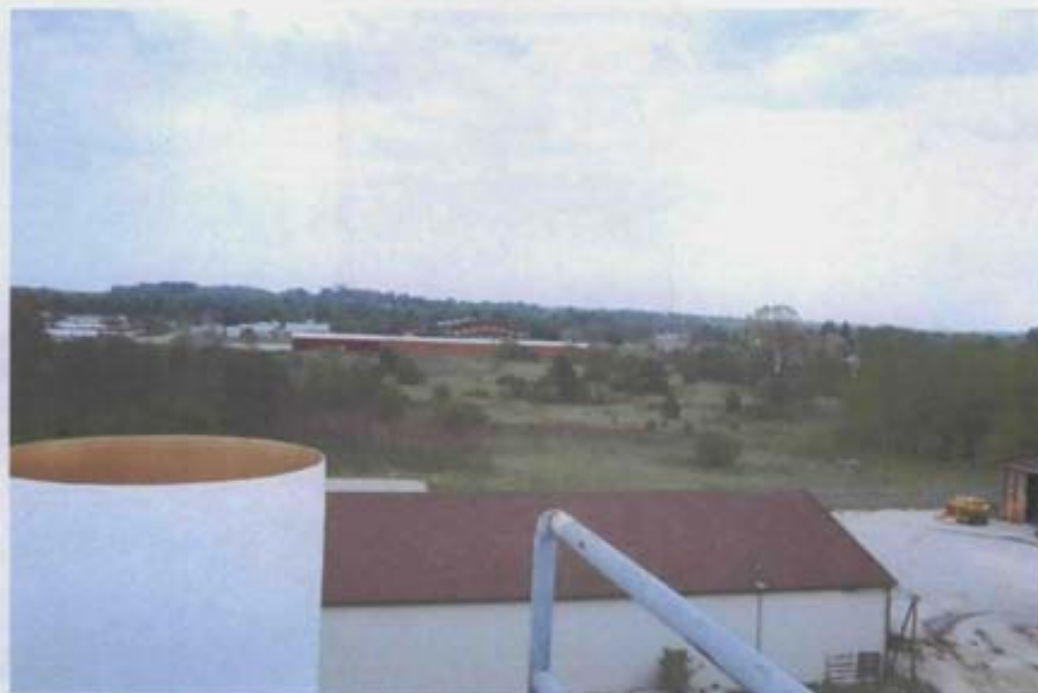
Figure 15 – View from atop the air stripping facility looking east. The Mitchell Corporation is in the background.

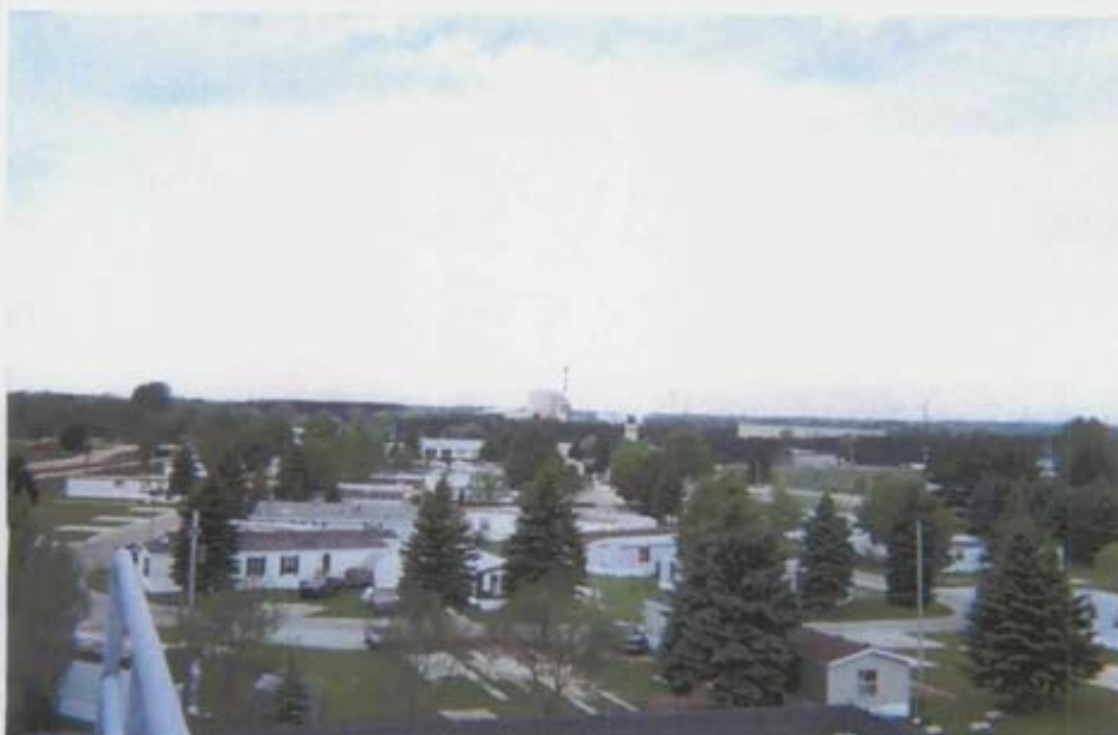
Figure 16 – View from atop the air stripping tower looking west. The Co-Gen power plant is barely visible in the far back center of the photo.

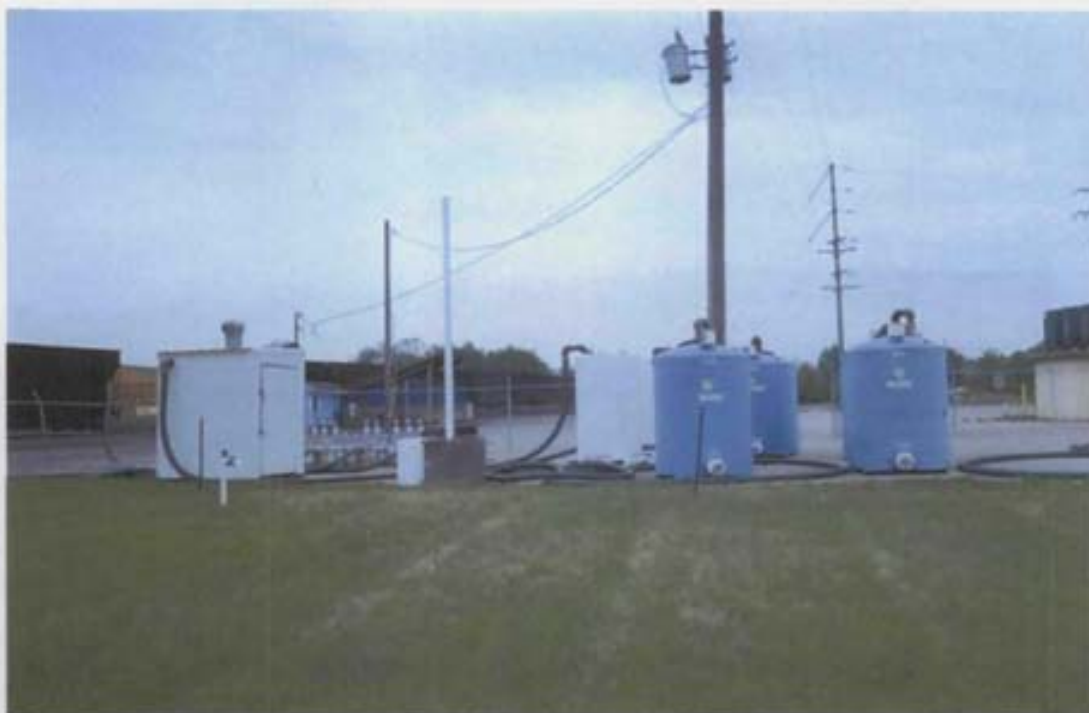
Figure 17 – View of the SVE system, now decommissioned after meeting soil cleanup goals. The system is located directly north of the Kysor plant and south of the railroad tracks. The foreground area is capped with a PVC liner. The concrete-asphalt pad is visible behind the blue GAC tanks.
