STATE OF MICHIGAN  
DEPARTMENT OF  
ENVIRONMENT, GREAT LAKES, AND ENERGY

September 3, 2025

SUBJECT: N3862, Wexford County Landfill, Wexford County

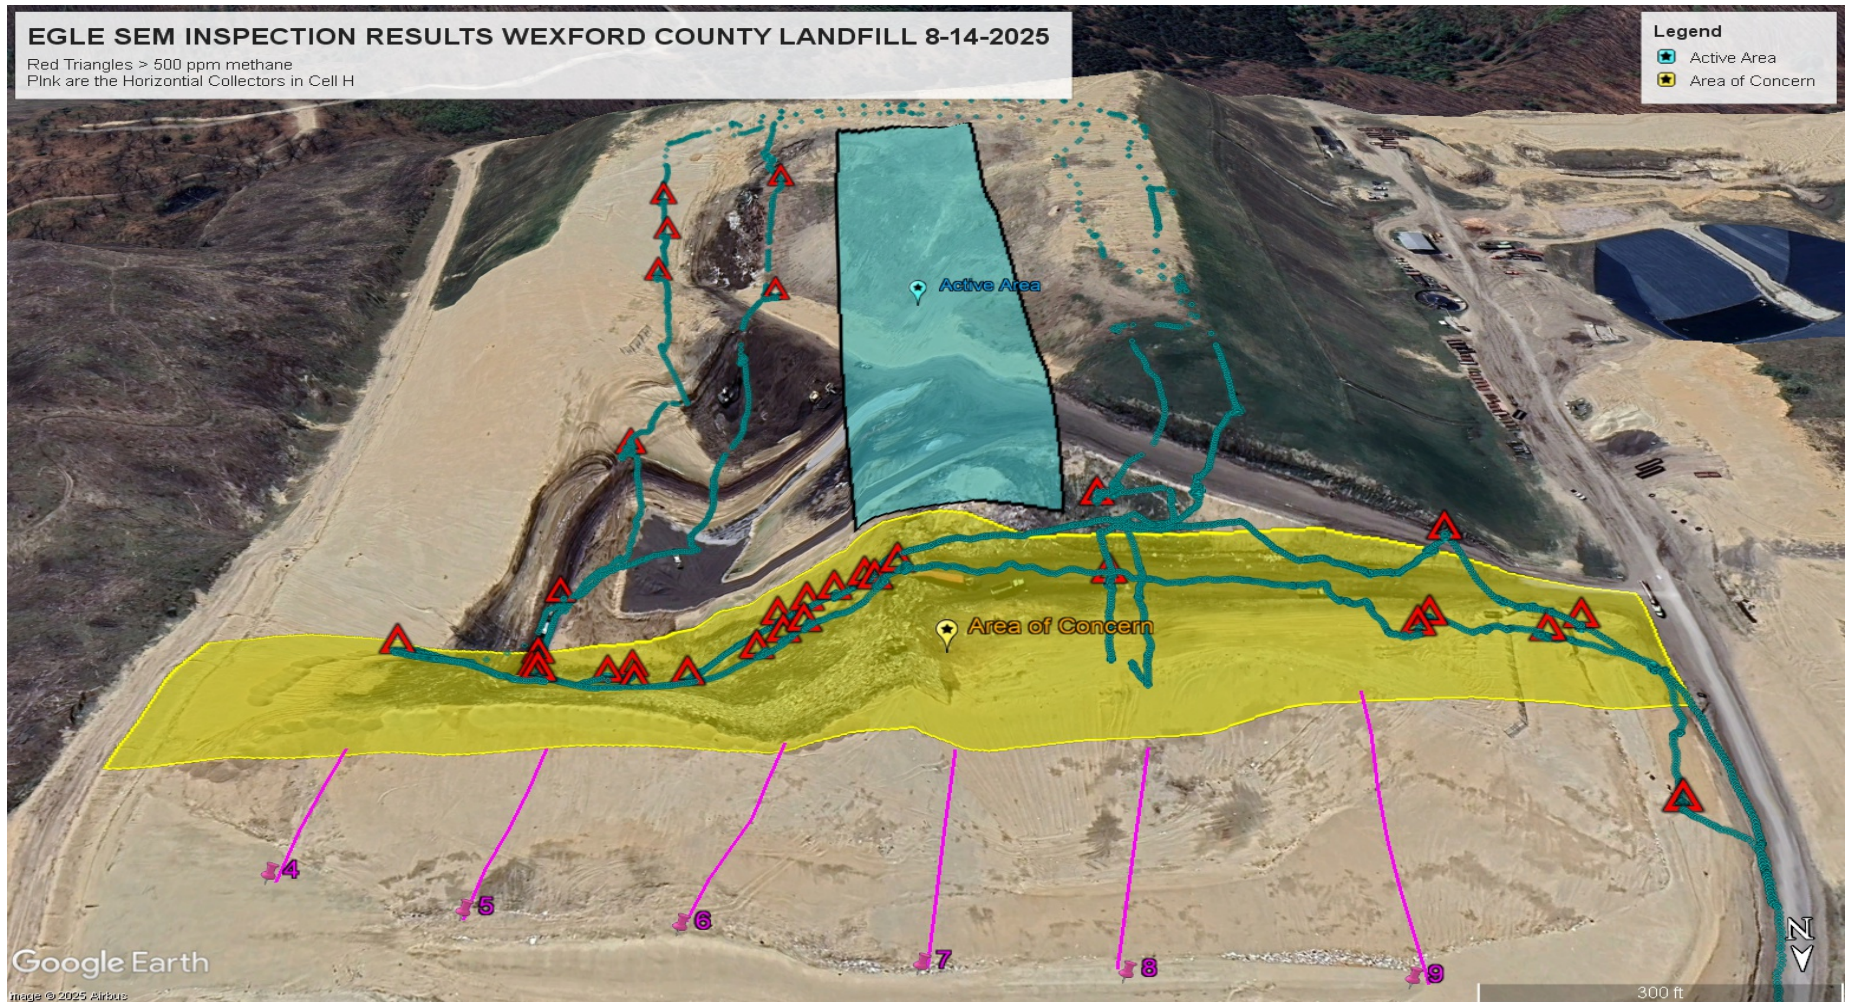
**ATTACHMENT (2):**

2. Sand is being used as cover material in the interim cover areas. Due to the high permeability of sand, landfill gas will tend to migrate unimpeded up through it unless it is topped with other cover materials. In the upper elevations of the southern portion of Cell H (possibly extending into the northern parts of Cells D & E and G-3), the combination of sand cover, newer waste, lateral gas migration from the current active cells to the south, and lack of gas well collection is resulting in excessive landfill gas emissions. This is most notable in the southeastern part of Cell H (and possibly Cell G-3) which is the part of the cell with the newest waste. It should be noted that the six (6) horizontal collectors that run north to south in Cell H do not extend far enough south to reach the upper elevations of Cell H where the excessive landfill gas emissions were detected. (Refer to Area of Concern on Results Map in Attachment (2)).

An aerial image of the Wexford County landfill and the path followed during the inspection and locations of methane concentrations above 500 ppm. The yellow box shows an Area of Concern.
