# Five-Year Review Report

Fourth Five-Year Review Report

Northernair Plating Superfund Site  
Cadillac, Wexford County, Michigan

September 2010

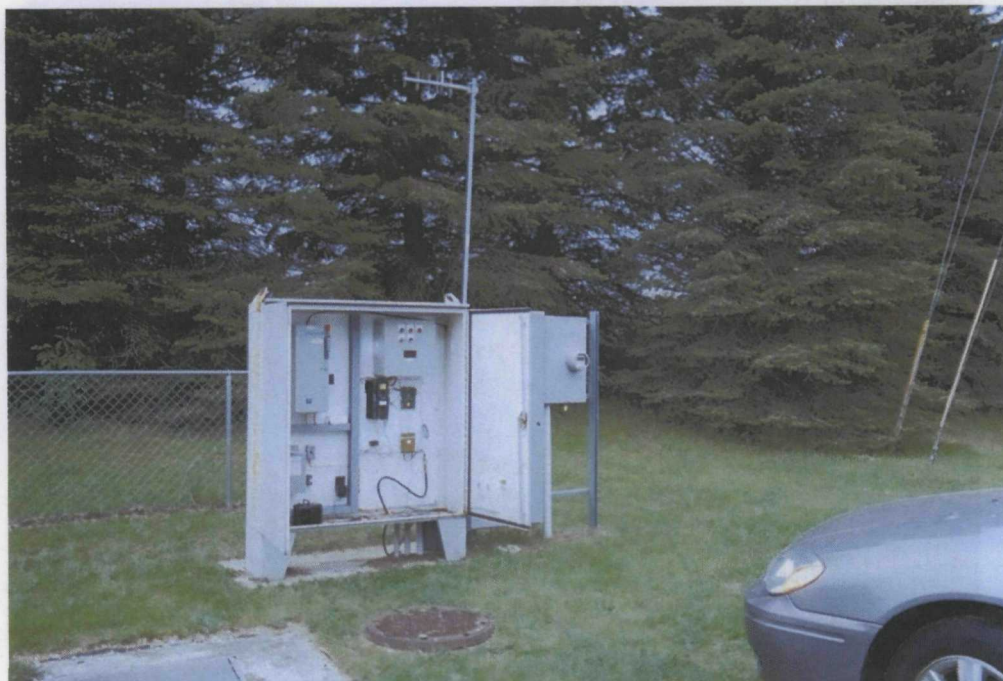
Figure 1 – Electrical panel for Local Development Finance Authority (LDFA) extraction well I-7, located about 1,200 feet northwest of the edge of the Cadillac city well field. The antenna on top right side of panel is radio telemetry control system.

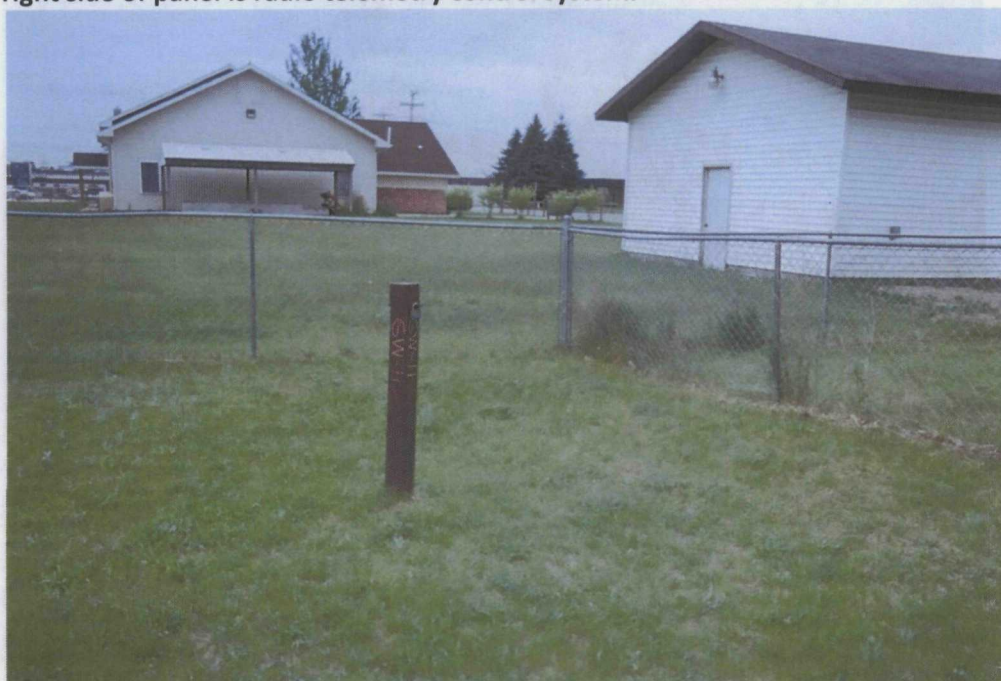
Figure 2 – View of shallow aquifer well GW-11 located about 500 feet northwest of the Four Winns/A.H. Joynt facility. The well is used for water level and VOC monitoring.

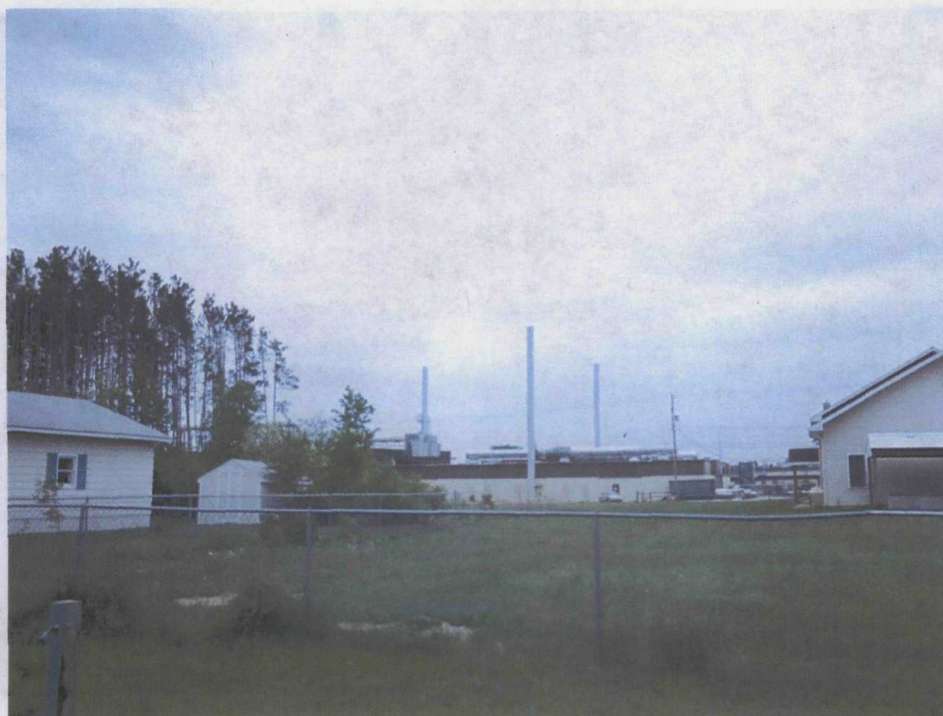
Figure 3 – View of the Four Winns facility as seen from the intersection of Seventh Avenue and Fourteenth Street, where well I-7 is located.

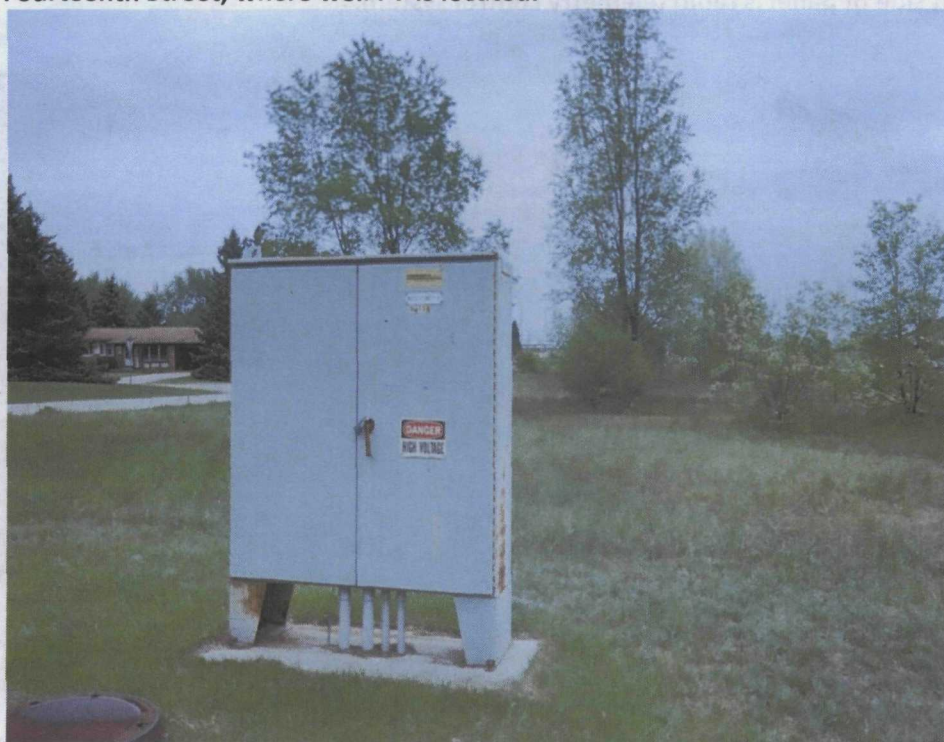
Figure 4 – View of electrical panel for LDFA intermediate depth extraction well I-8, located at the intersection of Seventh Avenue and Grahek Street in the North Park subdivision area. The well is about 2,250 feet northwest of, and the farthest distance from, the Cadillac well field.

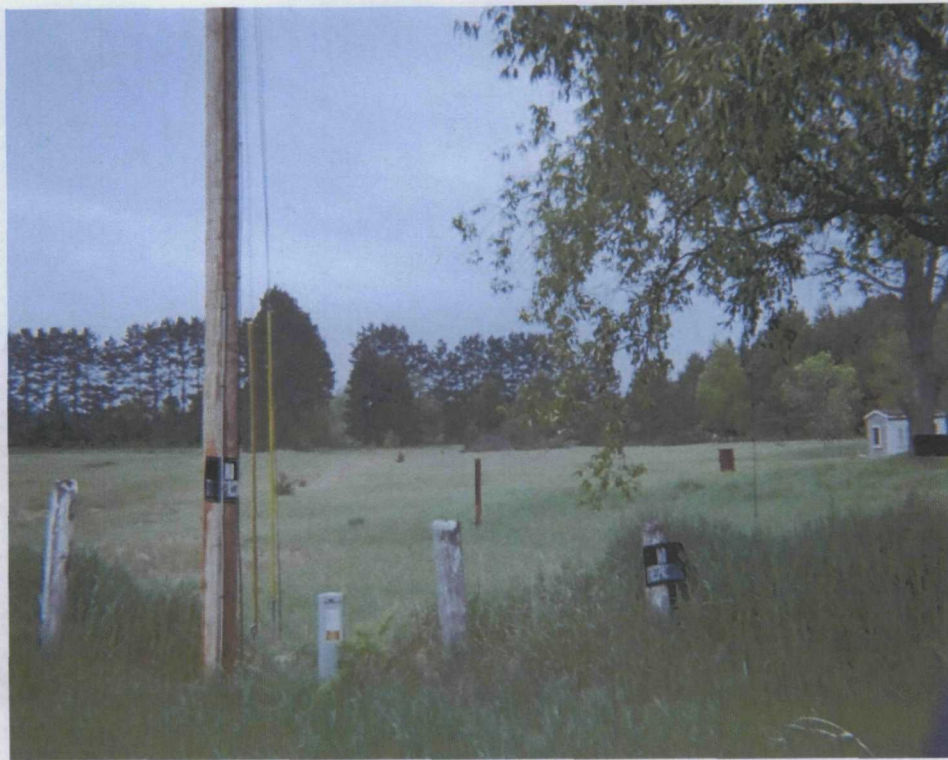
Figure 5 – View of well SLW-35. This shallow-aquifer well is located about 1,025 feet north of Thirteenth Street and northwest of the North Park subdivision area.

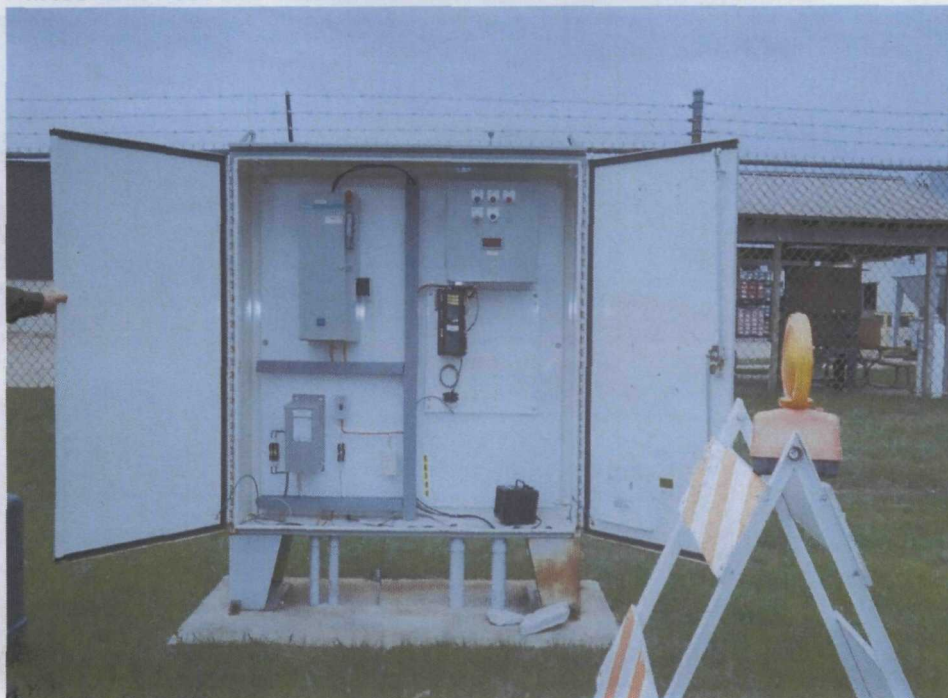
Figure 6 – View of electrical panel for LDFA intermediate extraction well I-5, located north of the Michigan Rubber facility and 1,000 feet northwest of the Four Star facility. Well I-5 is the dedicated chromium extraction well.

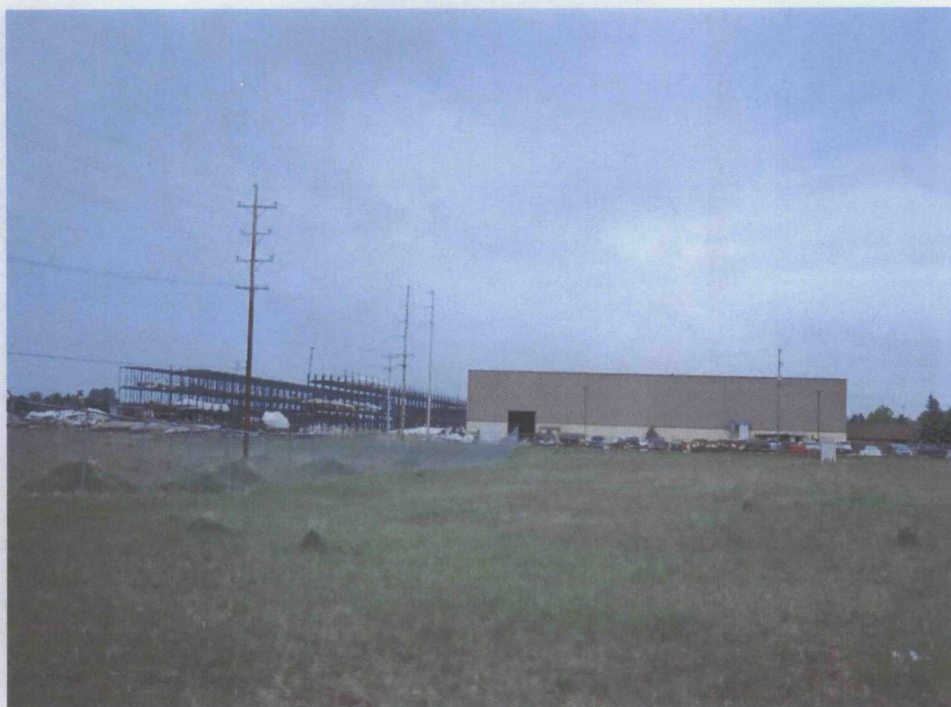
Figure 7 – A view of the back of the Four Winns Frisbie facility, which manufactures recreational boats. The electrical panel for the LDFA shallow-aquifer extraction well S-6 is visible at the far right background of the photo.

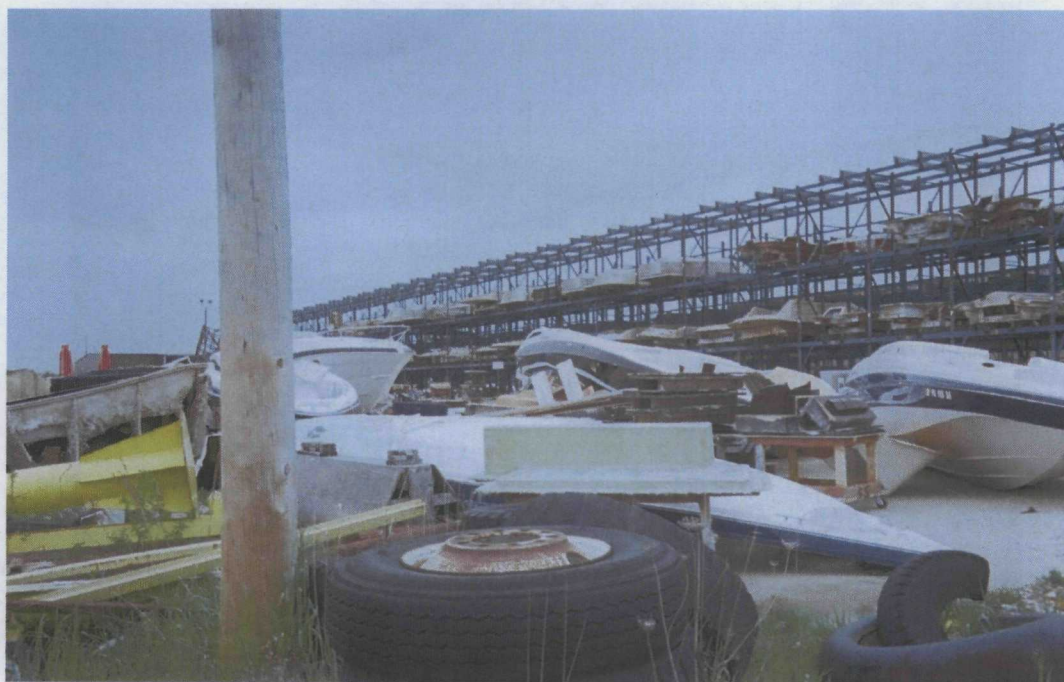
Figure 8 - A closer view of the back side of the Four Winns Frisbie facility.

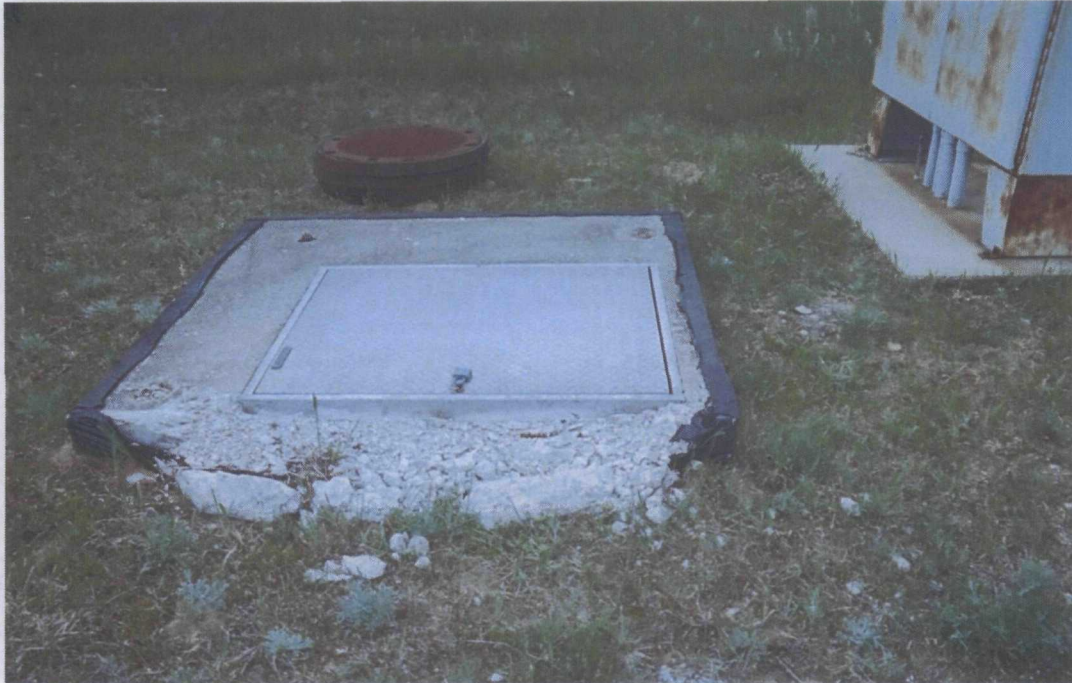
Figure 9 – A view of LDFA shallow-aquifer extraction well S-3, located about 1,250 feet west of the south west corner of the Cadillac city well field. The well cover in the middle of the photograph is cracked around the metal cover. The electrical panel is at the top right corner of the photo.

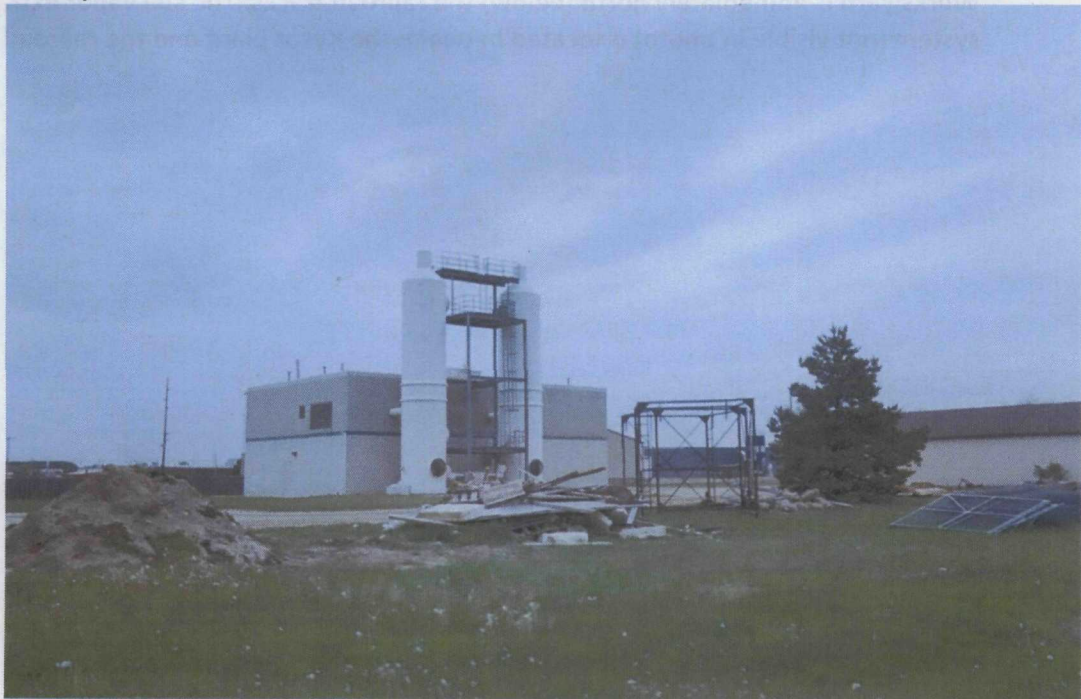
Figure 10 – A view of the south side of the LDFA groundwater treatment plant. The two air stripping towers are visible in the center mid-ground of the photo. The plant is in front of the towers.

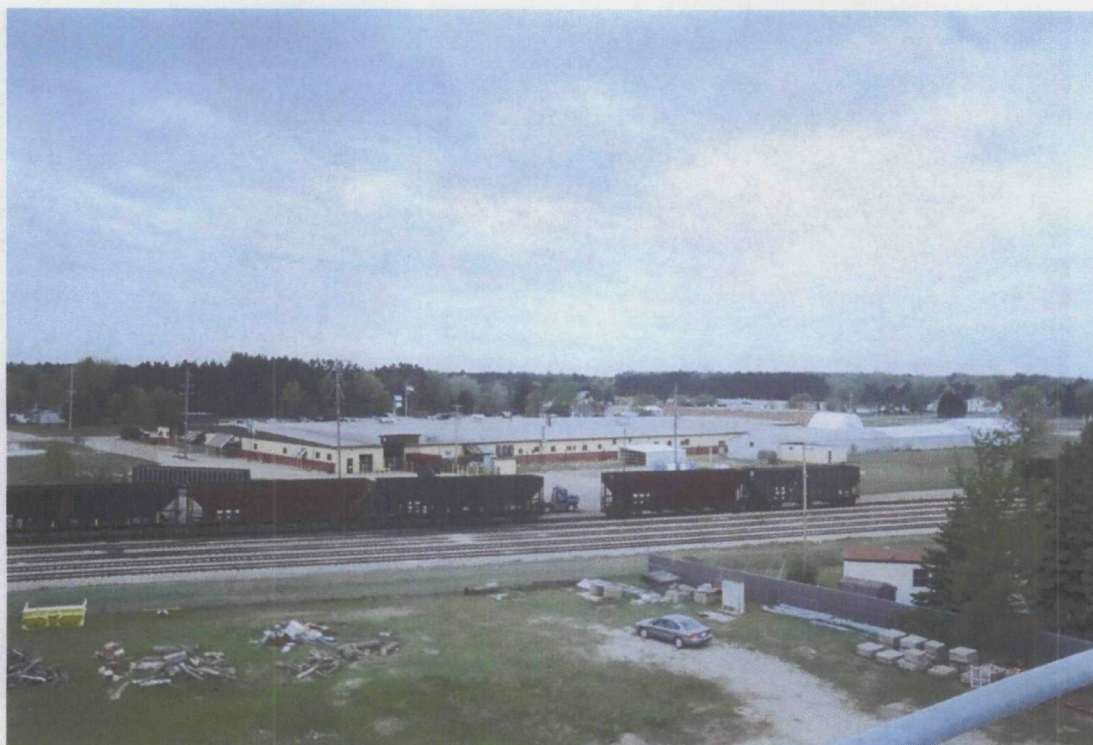
**Figure 11 –View from atop the air-stripping towers looking south toward the Kysor plant (now owned by Borg-Warner) just south of the railroad tracks. The Cadillac city Department of Public Works yard is immediately north (below) the railroad tracks. The soil vapor extraction (SVE) system (not visible in photo) is located between the Kysor plant and the railroad tracks.**

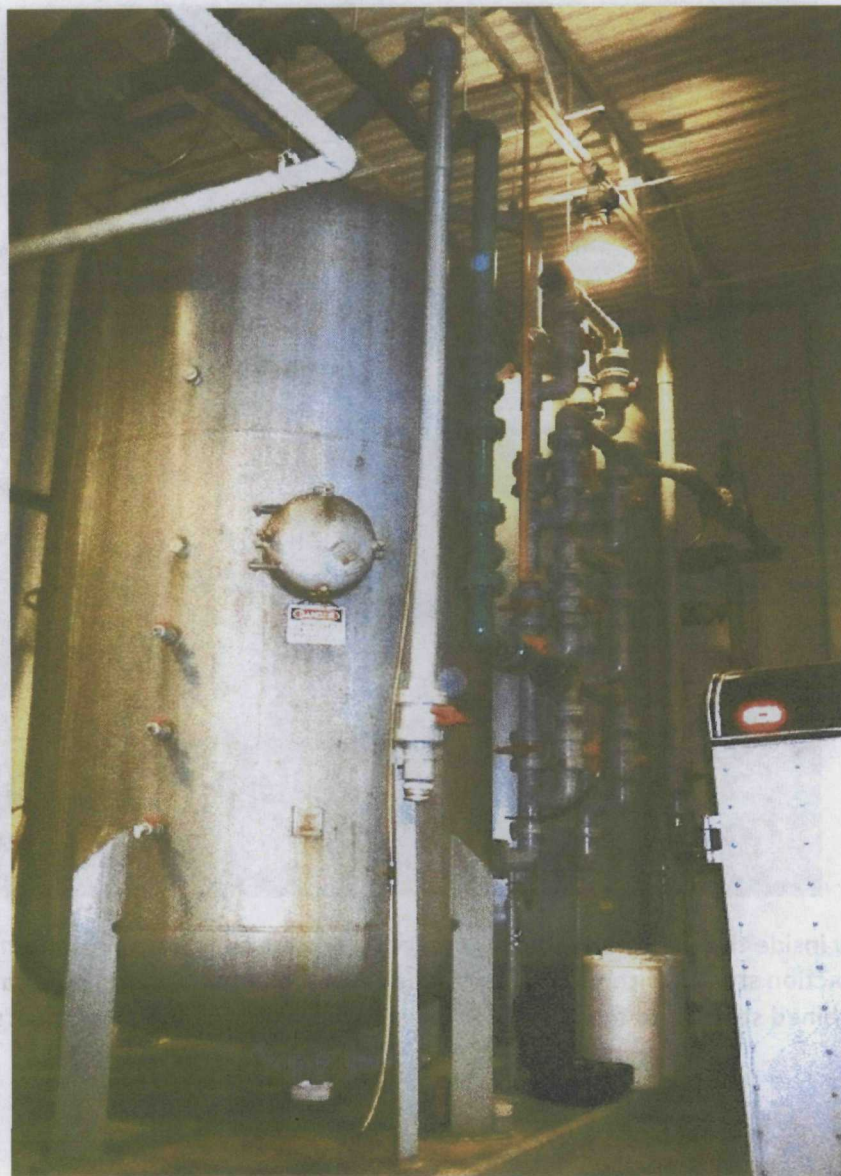
Figure 12 – View of one of the two GAC treatment tanks inside the LDFA treatment plant. The chromium stream from dedicated extraction well I-5 and the VOCs that may also be present in the extracted groundwater from I-5 are processed in these tanks. Most of VOC stream does not enter these vessels.

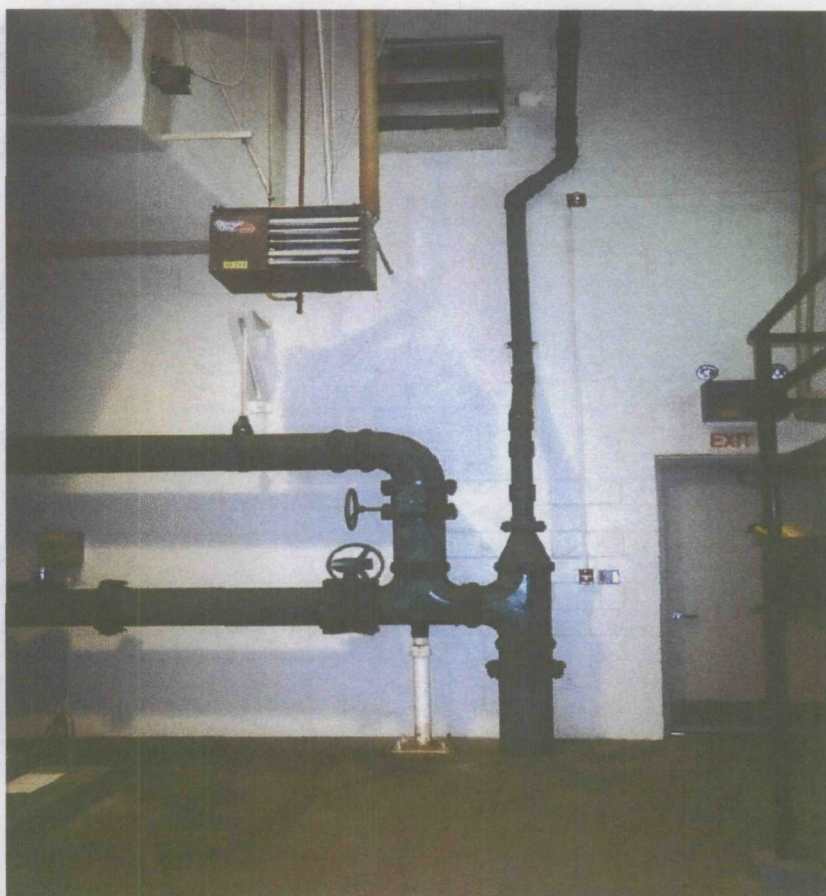
**Figure 13 – View inside the treatment plant of the joining of the dedicated chromium well (I-5) extraction stream with the VOC extraction wells. The thin vertical pipe carries the combined streams to the GAC filter tanks before entering the air strippers.**

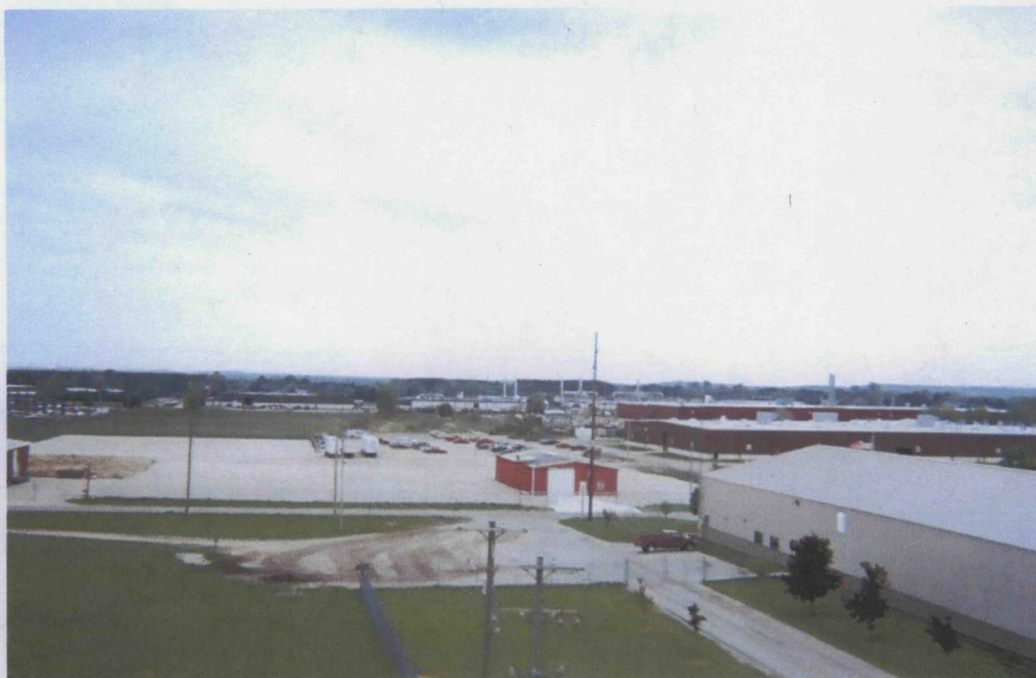
Figure 14 – View from atop the air stripping towers looking north. The Northernnaire facility is in the mid-ground. The Paulstra/CRC facility (long low red building) is to the right and immediately northeast of Northernnaire.

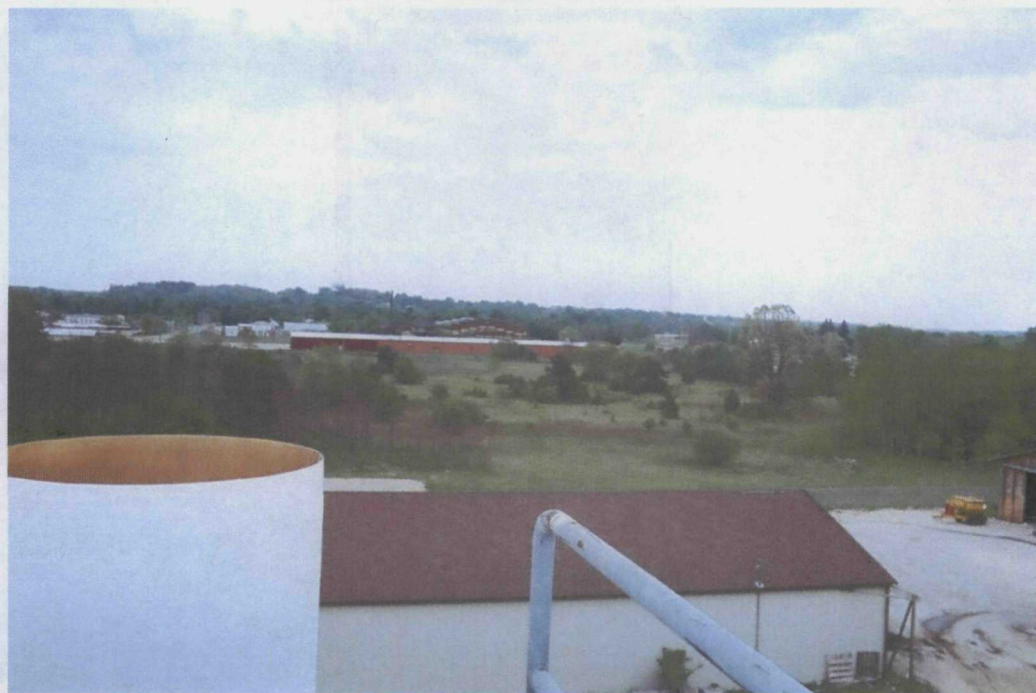
Figure 15 – View from atop the air stripping facility looking east. The Mitchell Corporation is in the background.

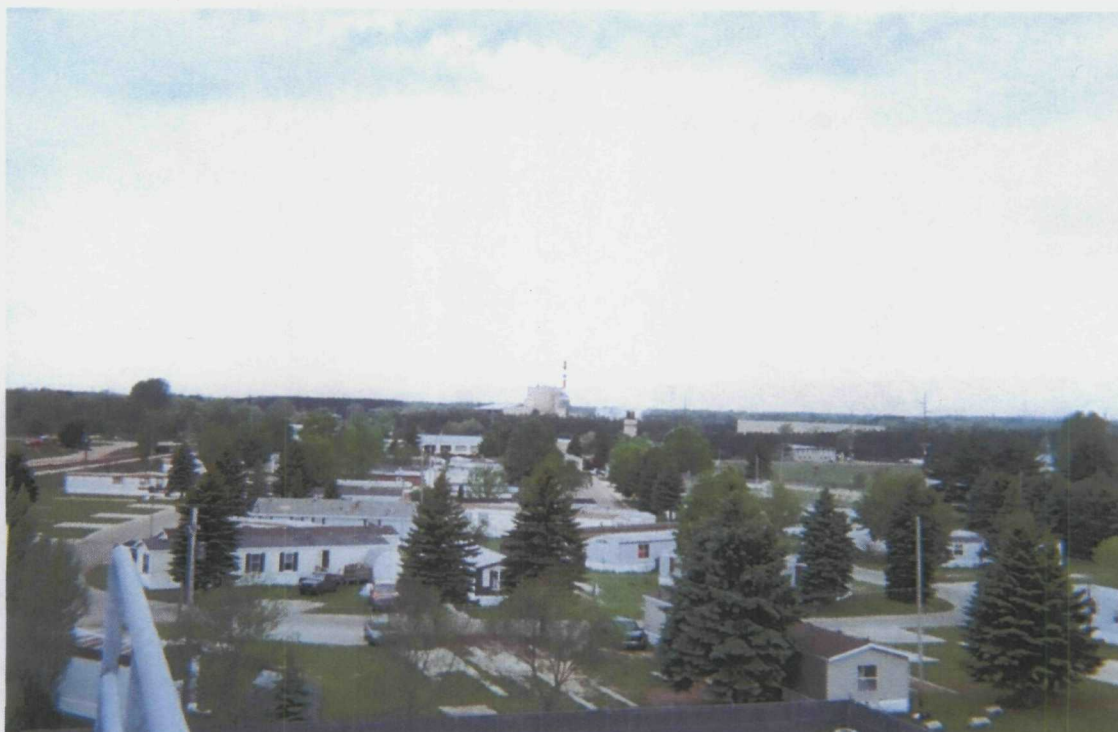
Figure 16 – View from atop the air stripping tower looking west. The Co-Gen power plant is barely visible in the far back center of the photo.

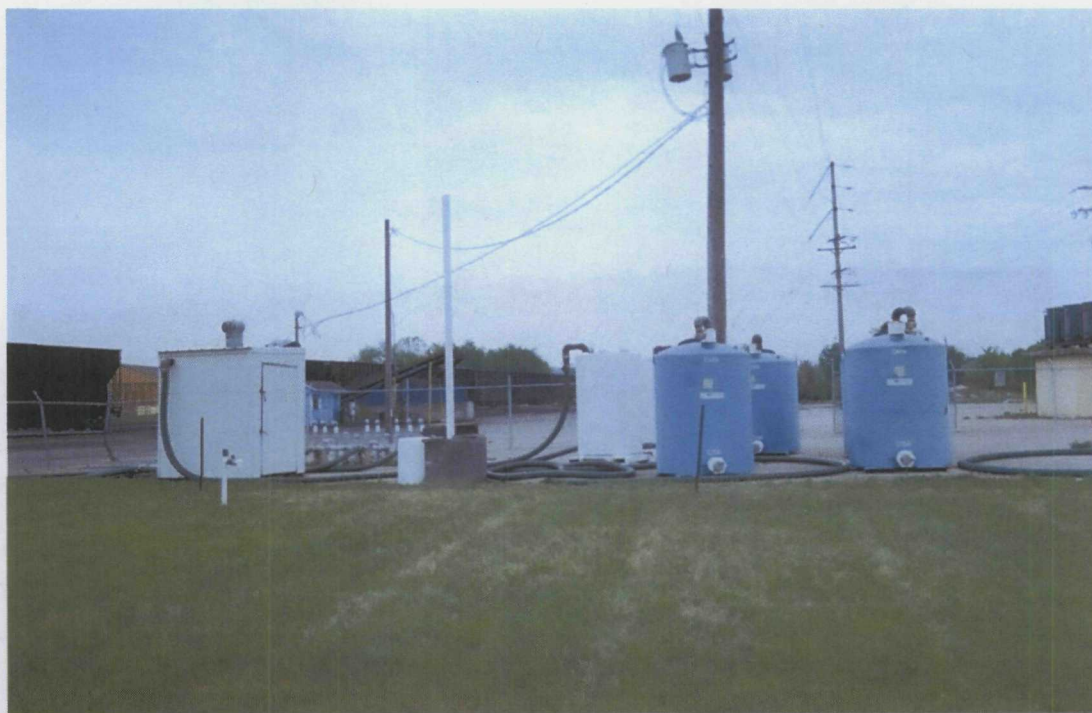
Figure 17 – View of the SVE system, now decommissioned after meeting soil cleanup goals. The system is located directly north of the Kysor plant and south of the railroad tracks. The foreground area is capped with a PVC liner. The concrete-asphalt pad is visible behind the blue GAC tanks.
