Night Mode Issues

About Night Mode Option

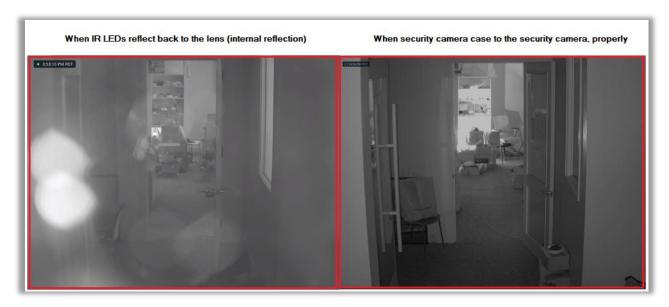
IR LEDs reflect back to the lens (internal reflection)

Cause: The security camera case is not attached to the camera, properly.

When the security camera case is not attached to the camera, properly, the IR LEDs beam angle changes. In such cases, the IR LEDs beam hits the dome and reflects back to the lens causing internal reflection.

Solution: Attach the security camera case to the security camera, properly. Refer to the "Installation of your Verkada cameras" page for more details.

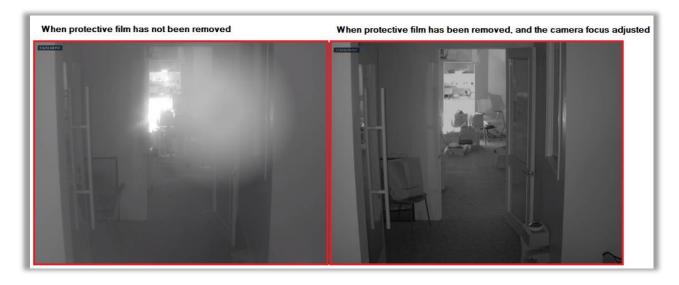
Image hides a part of another image (occlusion in an image)

Occlusion in an image occurs when an image hides a part of another image, based on the position of the security camera relative to the scene.

Cause: The lens protector (protective film on the glass dome) was not removed after installing the security camera, causing glare.

Solution: Remove the protective film on the glass dome.

IMPORTANT! After remove the protective film, clean the surface with a microfiber cloth and rubbing alcohol, and finally ensure that you adjust the security camera focus. Refer to the "<u>Changing a Camera's Orientation</u>" page for more details.

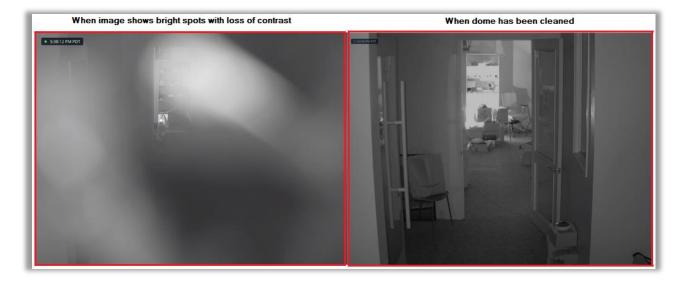
Bright spots on images

Cause: Dust or debris have accumulated on, or inside of, the glass dome.

Dust or debris reflect the IR LEDs causing bright spots and loss of contrast in the image.

Solution: Use canned air to blow away the dust and debris and always use a microfiber cloth and rubbing alcohol to wipe the glass dome (outside or inside). Allow time for the cleaned surfaces to dry, before putting your security camera back into service. After cleaning, ensure that the glass dome is attached to the case, properly.

IMPORTANT! If you are cleaning the inside of the glass dome, then ensure that you replace the desiccant pack (drying agent). Refer to "How to replace the desiccant pack" page for more details about replacing the desiccant pack (drying agent.

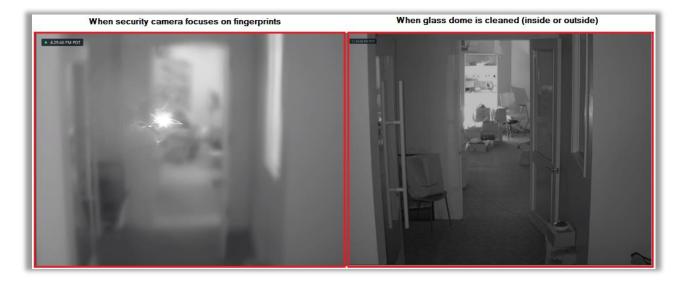
Out of focus security camera

Cause: Fingerprints on, or inside of, the glass dome.

The fingerprints reflect the IR LEDs beam hit the fingerprints and reflect back to the lens.

Solution: Use a microfiber cloth and rubbing alcohol to wipe the glass dome (outside or inside).

IMPORTANT! If you are cleaning the inside of the glass dome, then ensure that you replace the desiccant pack (drying agent). Refer to "How to replace the desiccant pack" page for more details about replacing the desiccant pack (drying agent.

Allow time for the cleaned surfaces to dry, before putting your security camera back into service. After cleaning, ensure that the glass dome is attached to the case, properly.

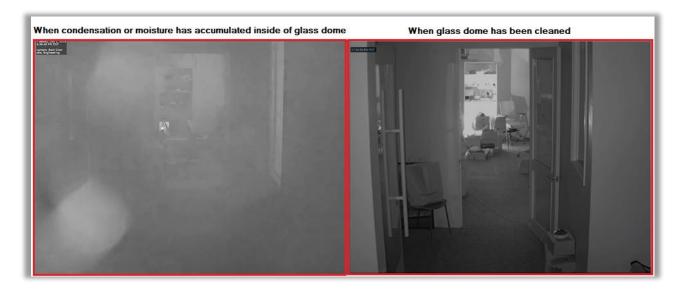
Loss of contrast

Cause: Condensation or moisture have accumulated inside of the glass dome.

Condensation can evaporate during the day light, leaving mineral residues on the lens and glass dome.

WARNING! Condensation or moisture inside of the glass dome can evaporate during the day light, leaving mineral residues on the lens and glass dome. This occurrence will have catastrophic effects on your security camera and may void your equipment warranty.

Solution: Use a microfiber cloth and rubbing alcohol to wipe the glass dome from inside.

IMPORTANT! If you are cleaning the inside of the glass dome, then ensure that you replace the desiccant pack (drying agent). Refer to "How to replace the desiccant pack" page for more details about replacing the desiccant pack (drying agent.

Allow time for the cleaned surfaces to dry, before putting your security camera back into service. After cleaning, ensure that the glass dome is attached to the case, properly.
