Aviation Investigation Preliminary Report

Location:	College Park, GA	Accident Number:	DCA24FA299
Date & Time:	September 10, 2024, 10:07 Local	Registration:	N503DN (A1); N302PQ (A2)
Aircraft:	Airbus A350-941 (A1); Mitsubishi Heavy Industries (MHI)/Bombardier CL600 2D24-900 (A2)	Injuries:	236 None (A1); 1 Minor, 59 None (A2)
Flight Conducted Under:		Part 121: Air carrier - Scheduled (A1); Part 121: Air carrier - Scheduled (A2)

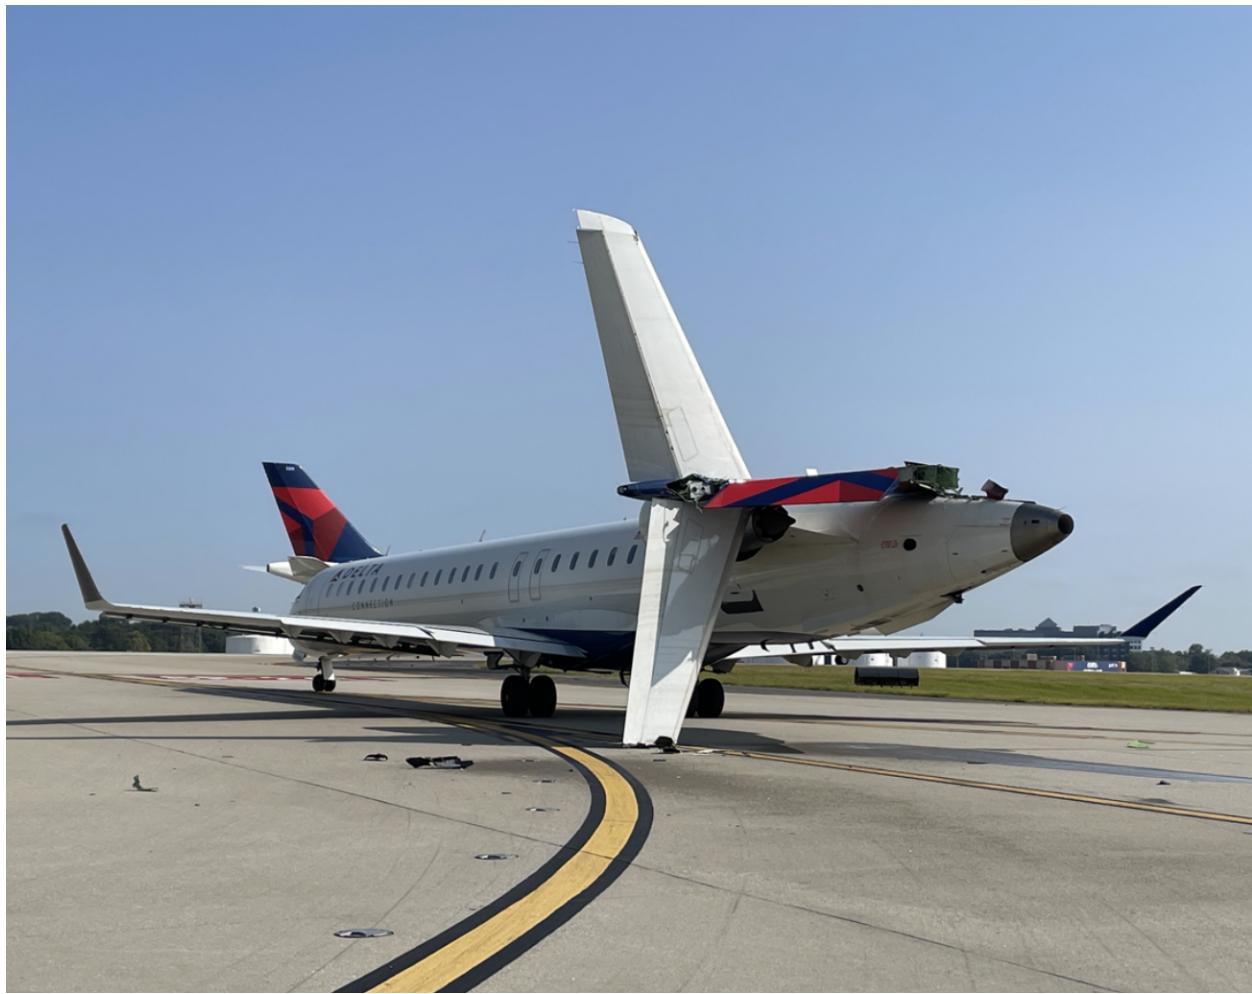
Figure 1. Photograph showing the CRJ after impact. (Source: Atlanta Airside Operations)

At that time, the right wingtip of the A350 impacted the vertical stabilizer of the CRJ, which was holding short of runway 8R at taxiway H. Following the collision, the captain stopped the A350 and set the parking brake. After airport rescue and firefighting (ARFF) examined the exterior of the A350, the crew was given clearance for the airplane to return to the gate.

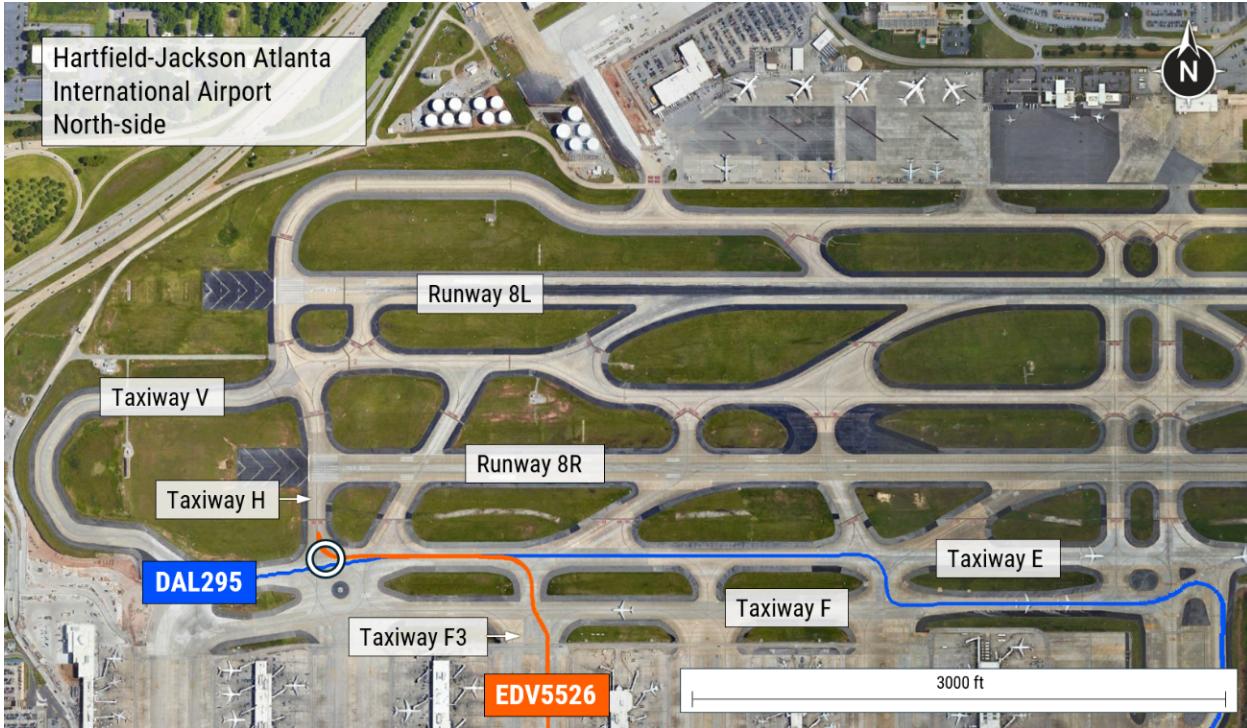
Figure 2 is a Google Earth screenshot that is overlaid with the ground tracks of the A350 (DAL295, the blue line) and the CRJ (EDV5526, the orange line). The white circle shows the location of the collision at the intersection of taxiways E and H.

Figure 2. Ground position tracks for DAL295 (A350) and EDV5526 (CRJ) in relation to taxiways E and H.

The FAA provided the NTSB with certified ADS-B latitude and longitude data. Analysis of the ADS-B and preliminary FDR data showed the airplanes collided at 10:07:46. The CRJ was stationary, and the A350 was taxiing at a groundspeed of about 12 knots. The CRJ sustained lateral accelerations of 0.5 G left followed by 0.55 G right, and the CRJ's heading was rotated about 9° clockwise.
