DEPARTMENT OF ENVIRONMENT AND NATURAL RESOURCES
ENVIRONMENTAL MANAGEMENT BUREAU REGION 8
DENR Compound, Brgy. 2, Tacloban City

SURVEY REPORT FOR HAZARDOUS WASTES

Evashore Beach Resort

May 14, 2021

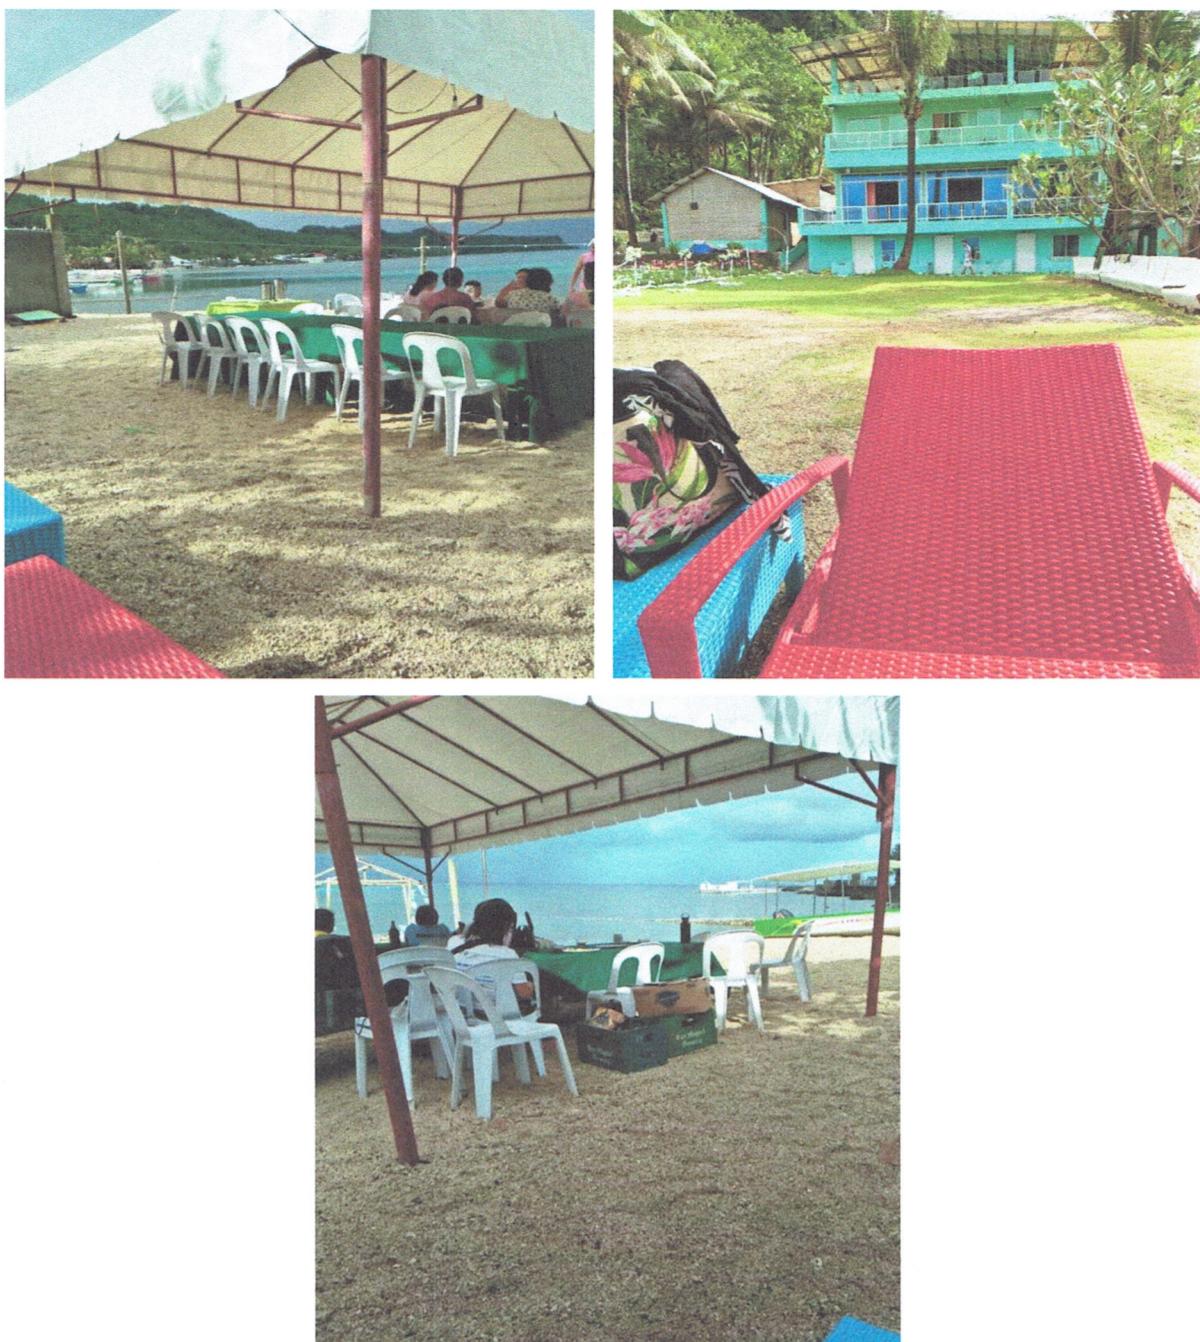
- The establishment is operational for business during the inspection;
- No Generator set;
- On the Process of securing Water Discharge Permit and Hazardous Waste Generator's Permit;
- The establishment provides nine (9) rooms accommodation for guests;
- Septic tanks are provided for domestic water wastes storage, and
- D407 BFL, BATTERIES classified wastes are stored in a separate area not accessible by other person.
- The resort was located at 9.927122°N, 125.072823°E

- The owner was advised to secure Discharge Permit Online (thru opms.emb.gov.ph/accounts/login) and DENR ID Registration Online (thru hwms.emb.gov.ph/login).
- To submit the January-June 2021 Compliance Monitoring Report online. (thru online.emb.gov.ph/cmr)
