## PCBMV-06: PCB MANAGEMENT MONITORING AND VALIDATION INSPECTION REPORT

CCO Registration Number:	CCO-PCB-R8-PEP-19		
Name of Establishment:	PEPSI-COLA PRODUCTS PHILIPPINES INC. (PCPPI)		
Location of Establishment:	National Highway, Brgy. Sto. Niño, Tanauan, Leyte		
Name of PCO:	Erwin D. Darole / Tennette P. Balote		
PCO Accreditation No.:	2019-RVIII-0043 / 2020-RVIII-0038		
Phone / Fax: (053)527-3770/0948-978-1511		Email: edwin.darole@pcppi.com.ph	
Date Monitored:		January 19, 2021

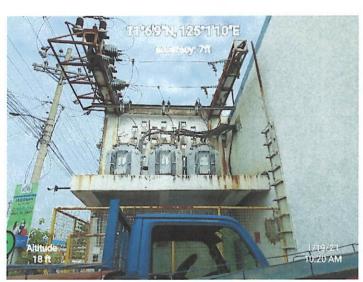
PCB FREE TRANSFORMERS OF PCPPI-TANAUAN PLANT

- 1. All PCB-free transformers must conform to the standard labeling, thus, it must be labelled appropriately indicating PCB-free and as required in sec 5.2.2 of EMB MC 2015-007.
- 2. To update PCB Management Plan.
- 3. To secure online registration of DENR ID.
- 4. To facilitate transport of stored hazardous wastes within the applied period.
- 5. Strict compliance to RA 6969 and other existing environmental laws.

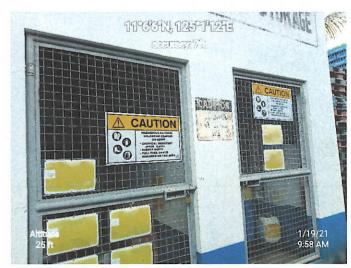
PCPPI-TANAUAN PLANT HAZARDOUS WASTE STORAGE AREA

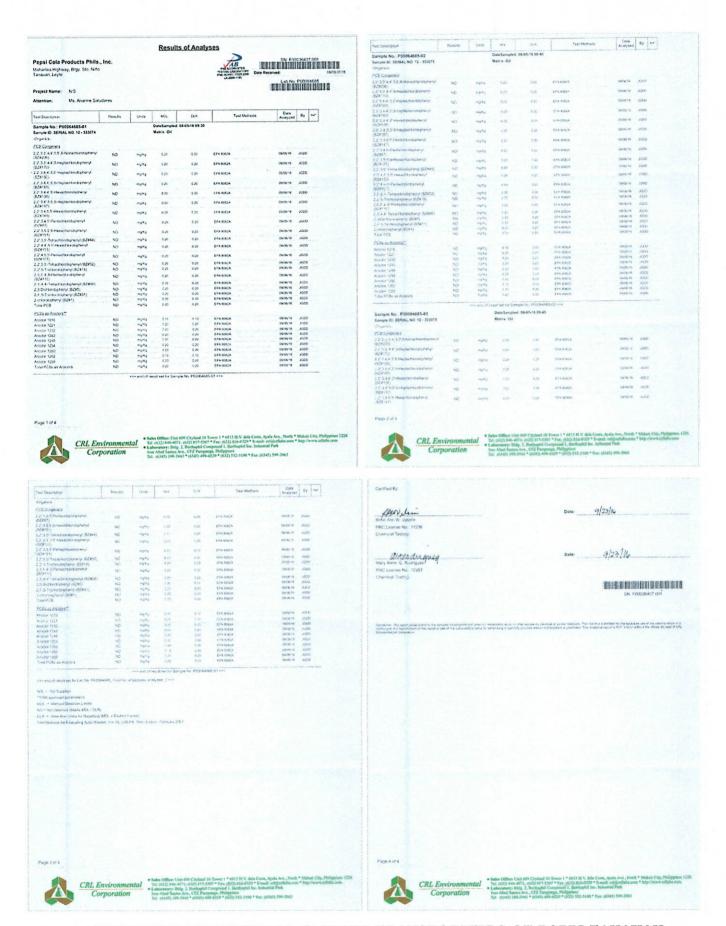
TEST RESULTS OF THREE (3) UNITS TRANSFORMERS OF PCPPI-TANAUAN
