## IH 45 in Dallas District

- Completed in 1975
- 8-in CRCP Slab
- 6-in soil cement base
- 6-in lime treated subgrade with 4 % lime

## **IH0045 [DAL] Test Section**

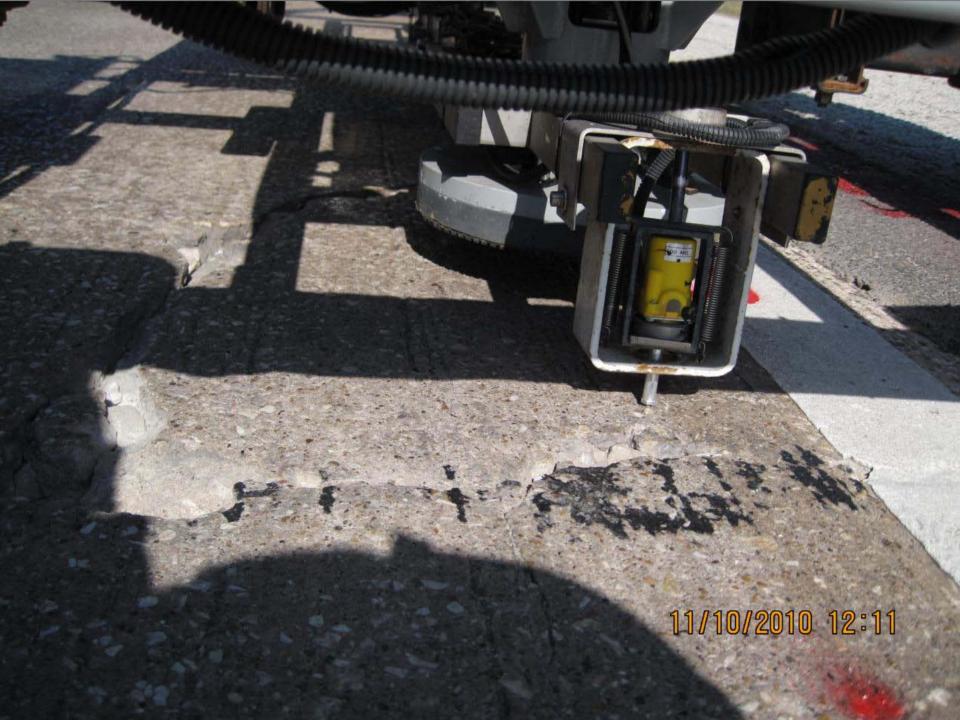
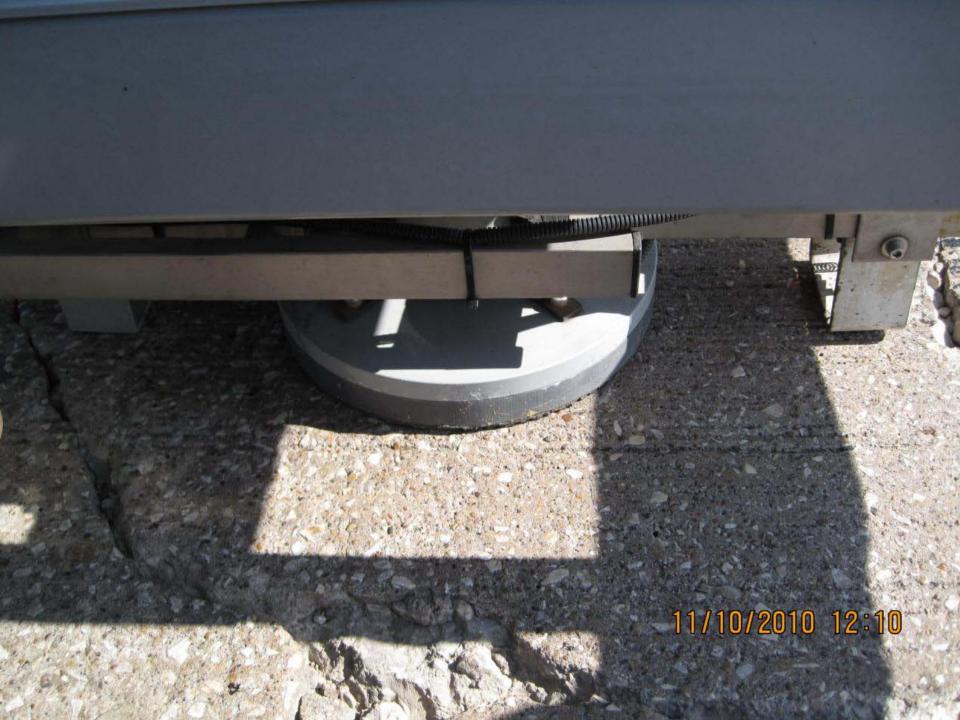
## **Deflection at Punchout**

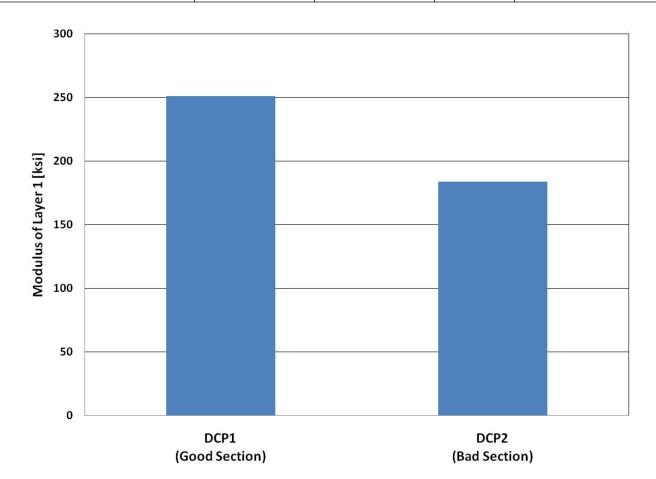
## **DCP**

Location	Layer	mm/blow	CBR	Modulus (ksi)
DCP1 (Good Section)	1	0.26	1302.15	251.14
	2	0.07	5890.06	659.81
DCP2 (Bad Section)	1	0.41	800.05	183.88
	2	2.25	117.80	53.96
