## Ignition Problems

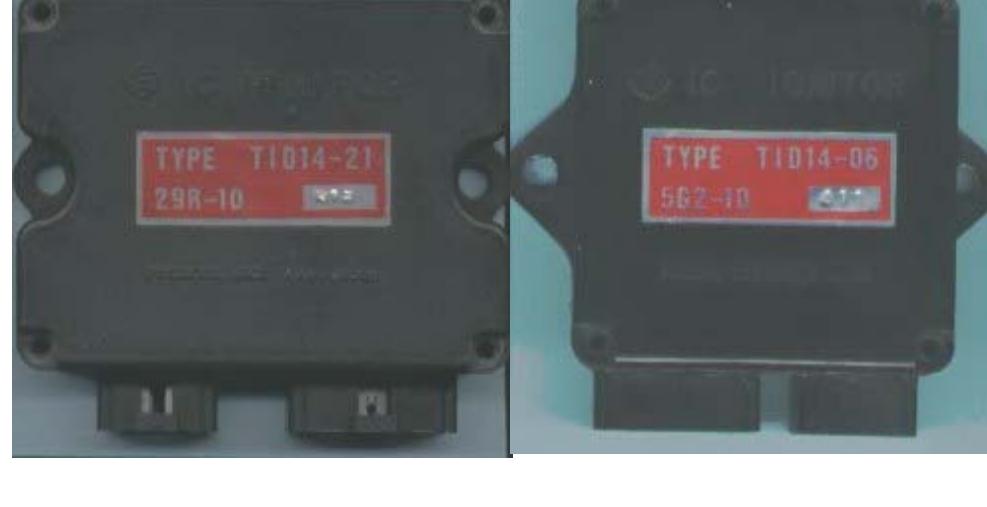
Later type from a 1983 XJ750EII Older type as used on my 1985 XJ750P  
(Remember the XJ750P is actually based on the 1981-82 Seca and was used as a way to get rid of new old stock parts)

There are a number of different TCI's used on XJ's. Here the later design on the left has been highlighted for part identification and the older design is on the right.

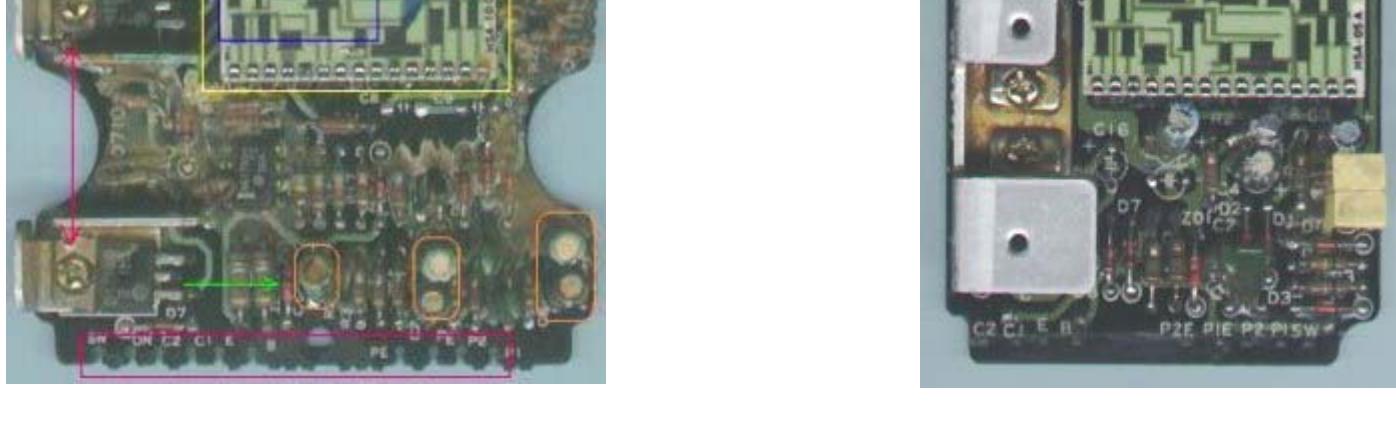
Inside the left hand unit there is a Printed Circuit Board (PCB'd) that is held in by 3 screws and a line of soldered connections down the edge (red box) that connect the board to the sockets where the wiring plugs into the case. The right hand one has the edge solder and two screws through the back of the case.

To remove the PCB'd from the case you must first de-solder the edge connections using a fine tip soldering iron (blunt pencil tip about 40 watts is ideal) and a solder sucker like this....

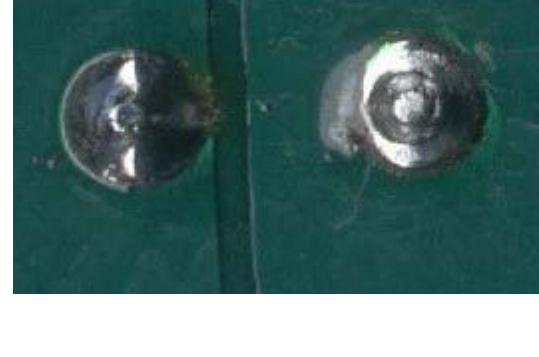
What is a dry joint? A dry joint is one thing, TROUBLE! It is a connection with a high electrical resistance and is often not actually connected firmly resulting in intermittent faults.

On the left is a good joint. It is bright and shiny and smooth. On the right is the curse of any circuit, a dry joint, note the obvious ring around the wire, this is in fact a crack in the solder caused by either vibration or electrical loading resulting in heat. You can also make out the satin finish on the solder as apposed to the bright smooth appearance on the good joint on the left.

They are easy to fix, simply reflow the solder with your iron and add a small amount of fresh resin cored solder. If it is a really bad joint it is wise to remove all the old solder with your sucker and renew it with fresh solder.
