# Broken in Half, Miles from Home

By Carlton Larsen

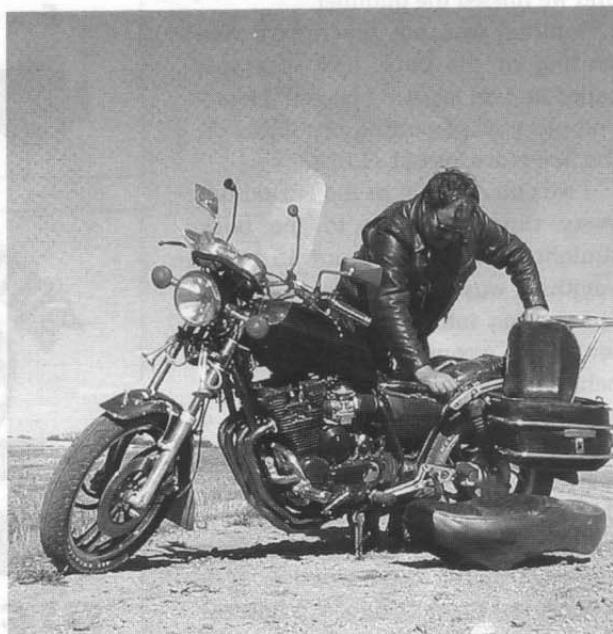
The nearest farm was a couple of kilometres away, and no vehicles were in sight for miles. I was a very long way from home, and about 20 kilometres away from my destination and there, staring me in the face, was a catastrophic failure. All four of the frame tubes forward of the rear suspension had broken off.

only things holding the back wheel on were the swingarm, the aluminum grab rail, and the wiring harness. It was too far to walk, and the bike was already broken in half so I had little to lose. I carefully climbed back on the loose seat and eased into first gear. At 10 kmh, rising to 40 when I finally reached the pavement, it took over an hour to cover that 20 kilometres. The story has a happy ending. I knew my friend lived next door to a skilled welder. Under Darren Domes' creative hands and humming Mig welder, the Maxim gained a couple of pounds and a good deal more strength than it brought from Japan.

If there is a moral to this story, then there are at least four. First, it is important to cultivate friendships with welders and neighbours of welders. You never know when your bike may break in half. Second, if you add a major component to your bike, make sure the frame is strong enough to take the increased loads. Third, potholes take their toll and contribute to metal fatigue.
