# Aviation Investigation Final Report

<b>Location:</b>	Gustine, California	<b>Accident Number:</b>	WPR22LA084
<b>Date &amp; Time:</b>	January 23, 2022, 10:30 Local	<b>Registration:</b>	N333XL
<b>Aircraft:</b>	Bell UH-1E	<b>Aircraft Damage:</b>	Substantial
<b>Defining Event:</b>	Sys/Comp malf/fail (non-power)	<b>Injuries:</b>	1 None
<b>Flight Conducted Under:</b>	Part 137: Agricultural

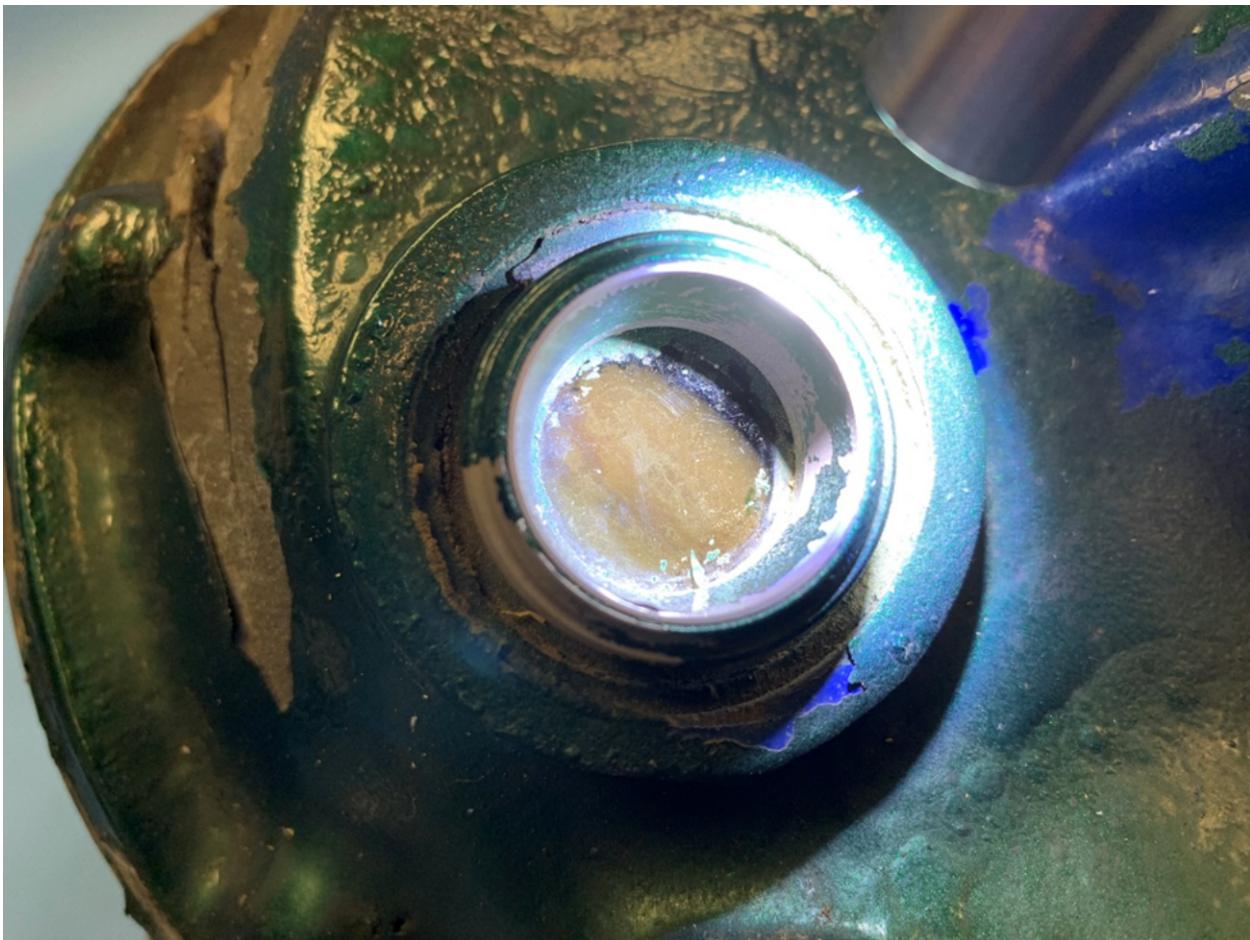
Examination of the oil level sight glass revealed that the inside was covered with a material that did not allow for sufficient viewing of the oil level. It is likely that, when the pilot looked at the oil level sight glass during his preflight check, he interpreted what he saw as an adequate amount of oil.

The interior of the housing was covered in soot. When a flashlight was aimed at the oil level sight glass, no light passed through it (figure 3).

Figure 3. Oil level sight glass for the 90° gearbox.
