#### IN THE HIGH COURT OF THE REPUBLIC OF SINGAPORE

# [2018] SGHC 193

Suit No 717 of 2012

# Between Millenia Pte Ltd (formerly known as Pontiac Marina Pte Ltd) ... Plaintiff And (1) Dragages Singapore Pte Ltd (formerly known as Dragages et Travaux Publics (Singapore) Pte Ltd) (2) Builders Shop Pte Ltd (3) Meinhardt (Singapore) Pte Ltd (4) Meinhardt Façade Technology (S) Pte Ltd (5) Arup Singapore Pte Ltd ... Defendants And Arup Singapore Pte Ltd ... Third Party

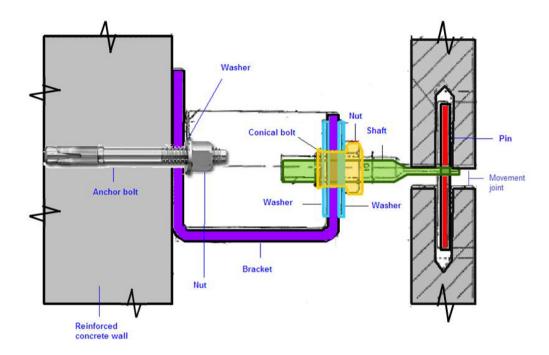
- 21 For this bracket system, panels were generally installed as follows.<sup>21</sup>
  - (a) One end, the longer end, of the bracket was attached to the reinforced concrete wall ("the RC wall") of the Building with an anchor bolt, nut and a spring washer. The longer end had a vertical slot cut into it to accommodate site adjustment in the vertical plane. The spring washer prevented the bracket from moving downwards.<sup>22</sup>
  - (b) A shaft was inserted through the other, shorter end of the bracket, and secured by a conical bolt and nut which were restrained by washers.<sup>23</sup> This end of the bracket had a horizontal slot to accommodate site adjustment along the horizontal plane.

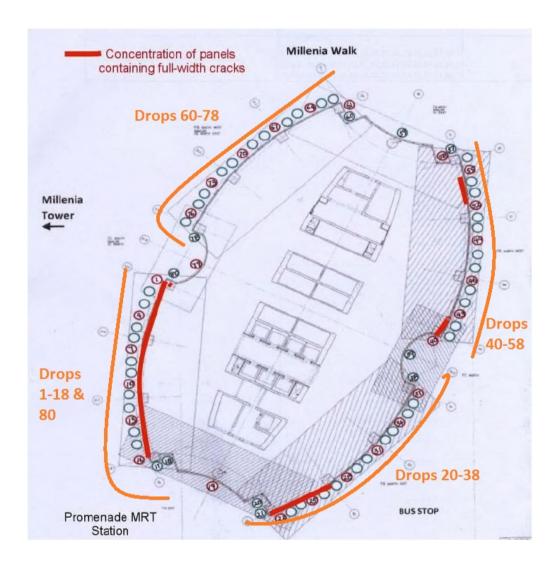
this point with the following diagram (to which I have added lines and text indicating the drop numbers in orange):684

This diagram indicates that the panels with full-width cracks were clustered on drops 1–16 and, to a lesser extent, on drops 22–26, which were located in closer proximity to Promenade Station than the other drops, while panels with full-width cracks were also found on drops 41–42 and 53–54. On first sight, this
