# ARE Labs Inc.

Title: Foaming Cleanser Spray Coverage Testing

Client: Bragg & Bevier LLC

1/29/2026

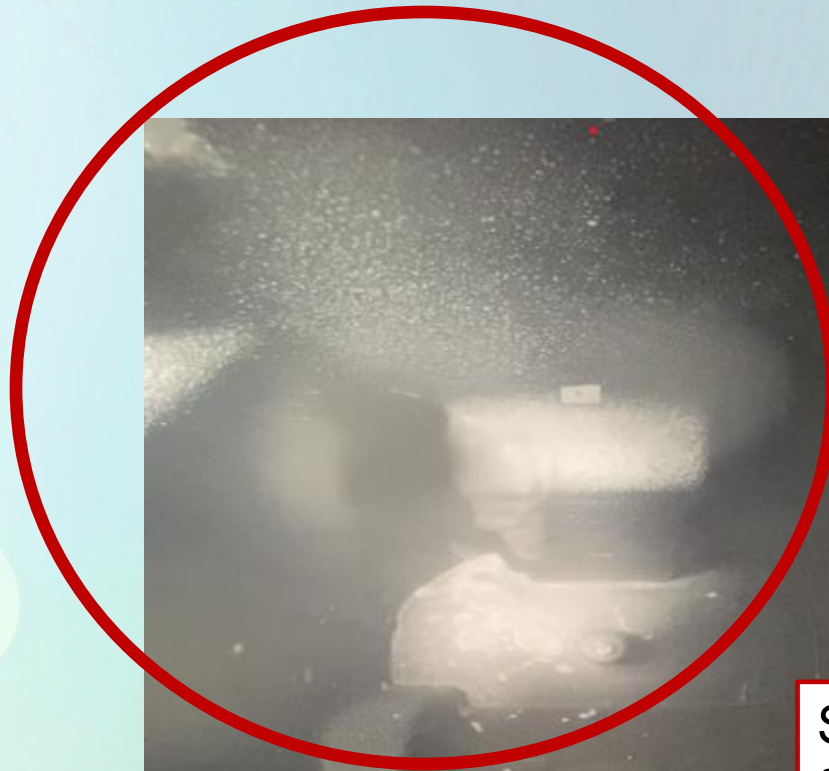
# Trial #2 Mid-Point

Since the spray was fan shaped it mainly only covered one side and hardly anything was got outside what is displayed in the circle.

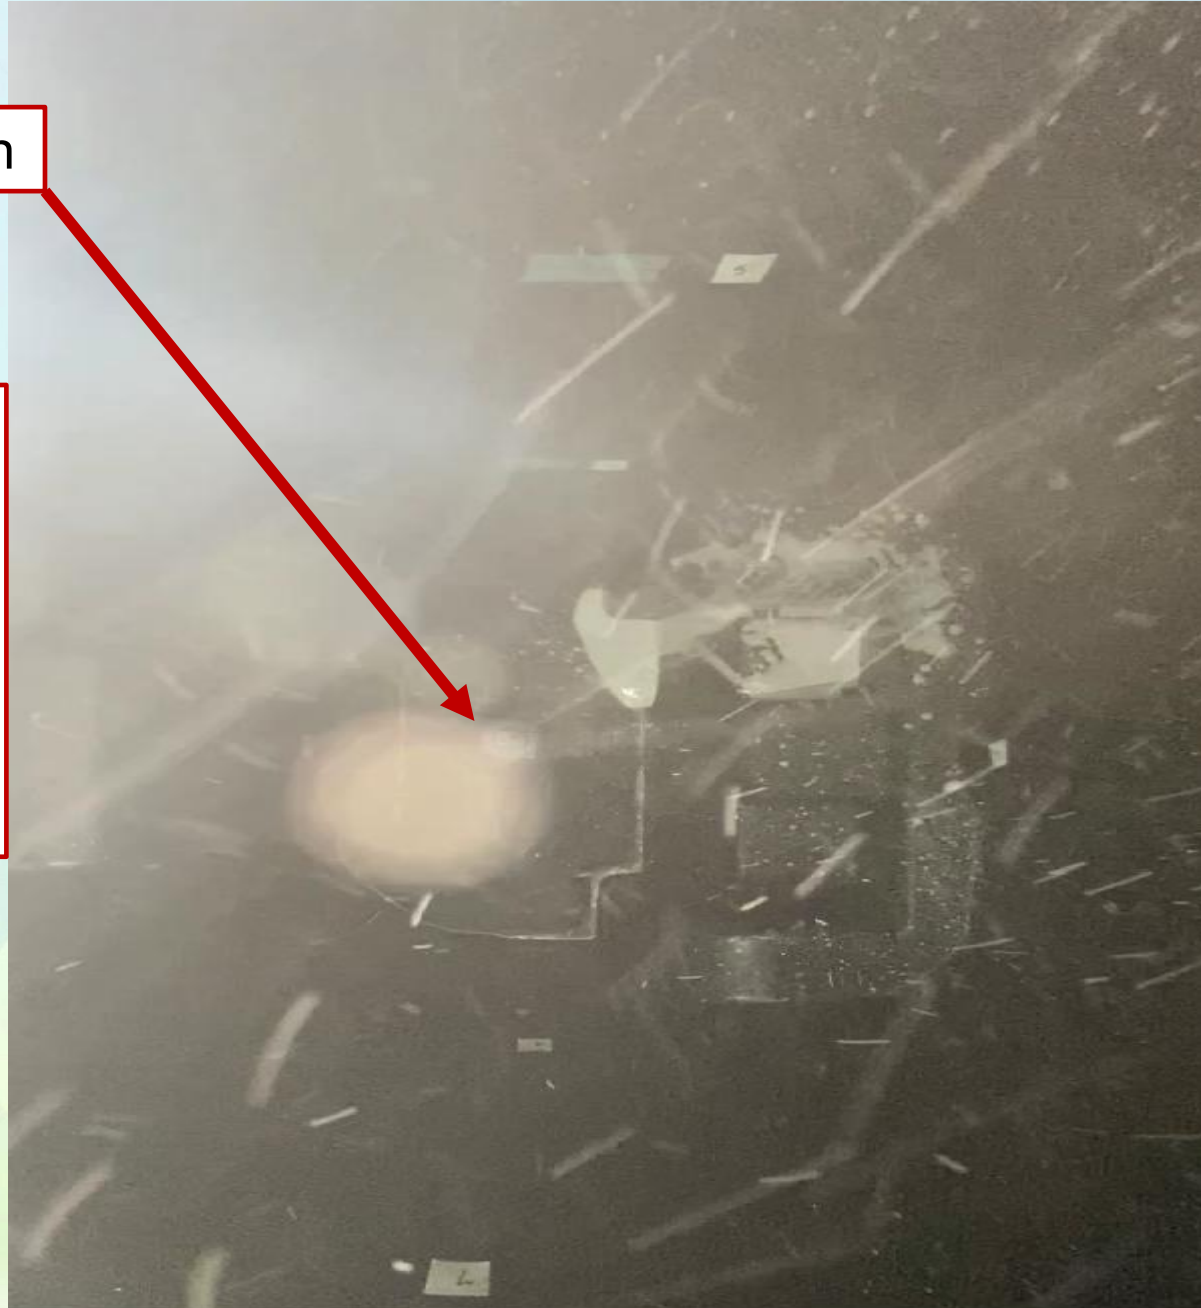
# Trial #3 Mid-Point

The spray for most of the time was spraying with a constant stream but went to a full cone shape when 10% of the contents inside remained.

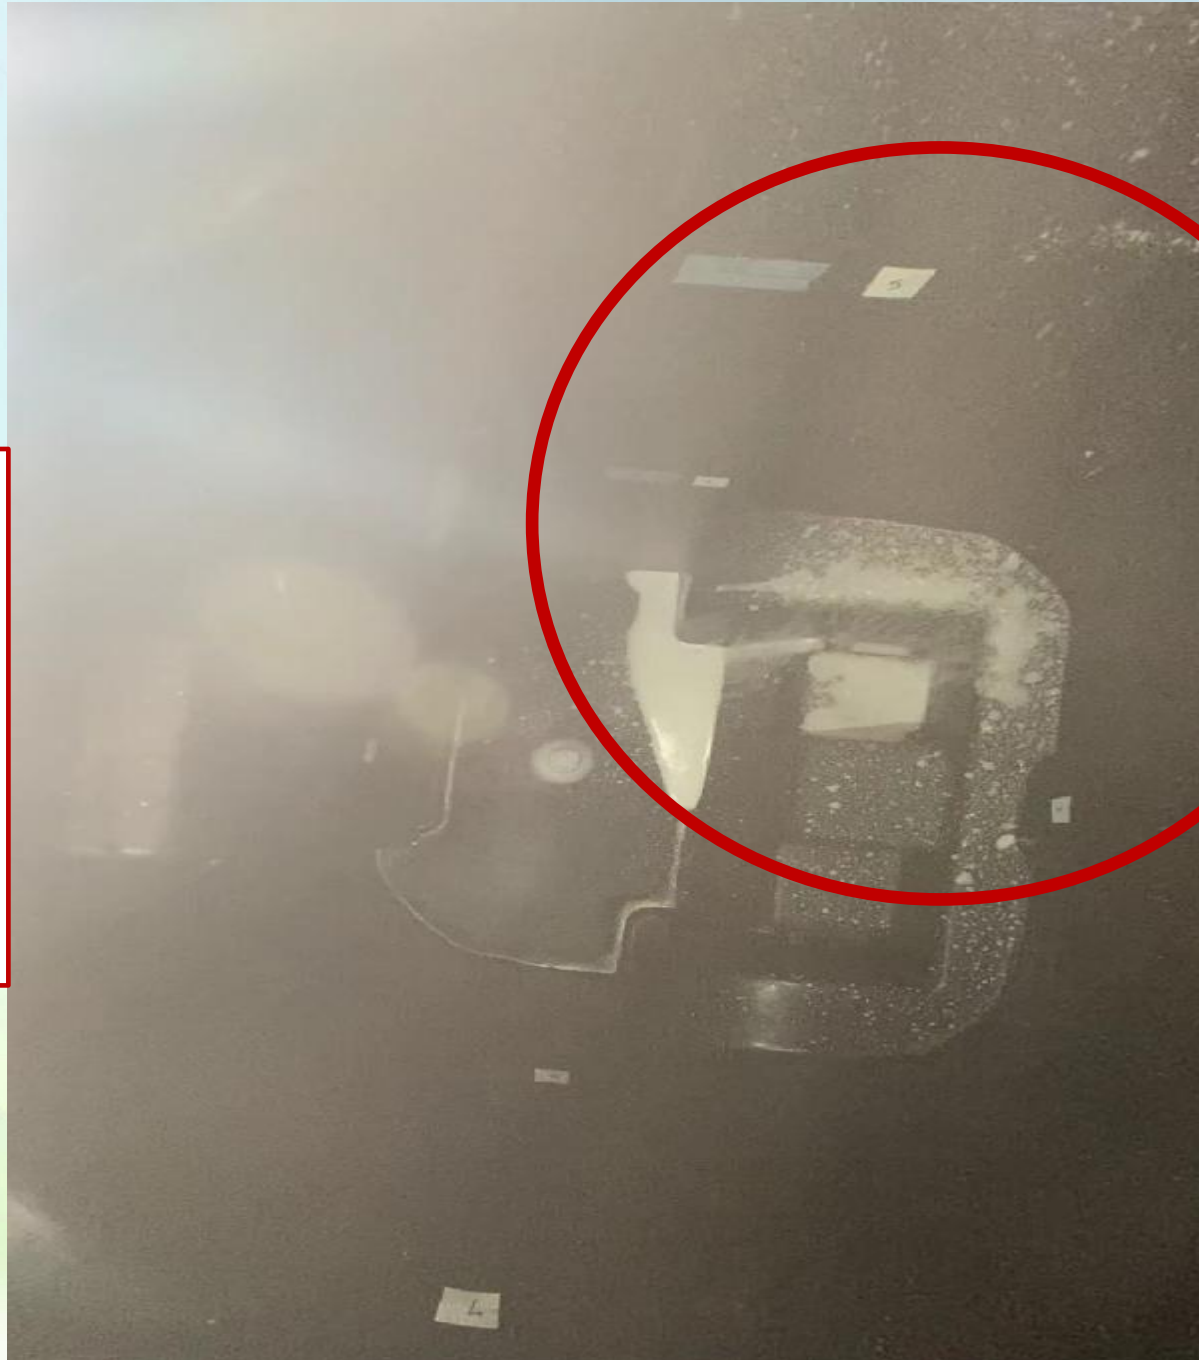
# Trial #3 End-Point

The latch on the nozzle when pushed down angles the spray toward it and as a result the spray can mostly went towards the corner that is indicated.

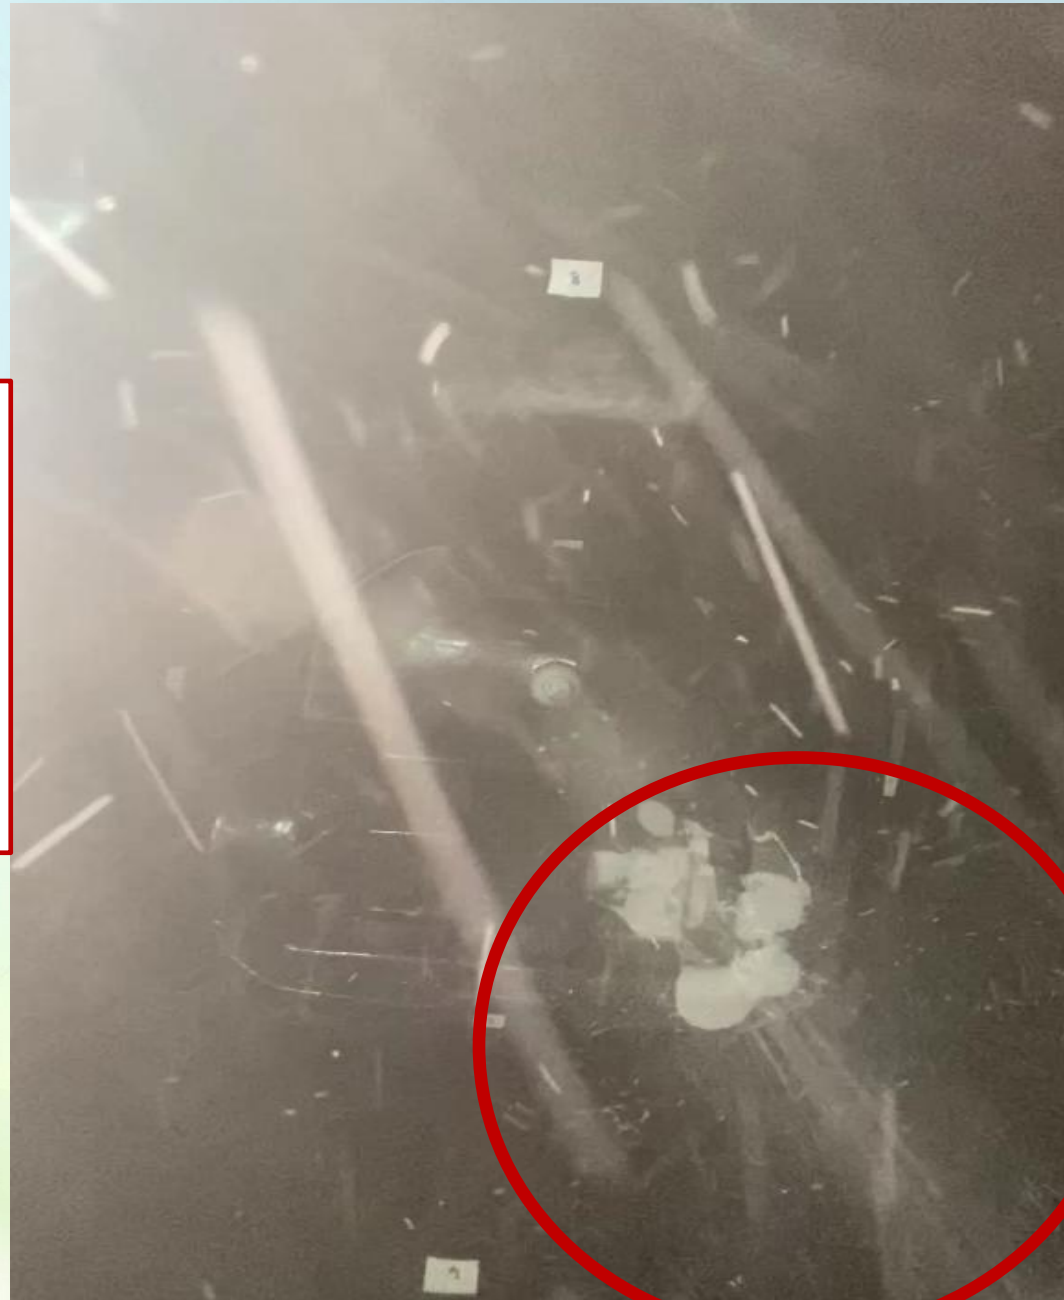
# Trial #4 Mid-Point

The spray for most of the time was spraying with a constant stream but went to a full cone shape when 10% of the contents inside remained.

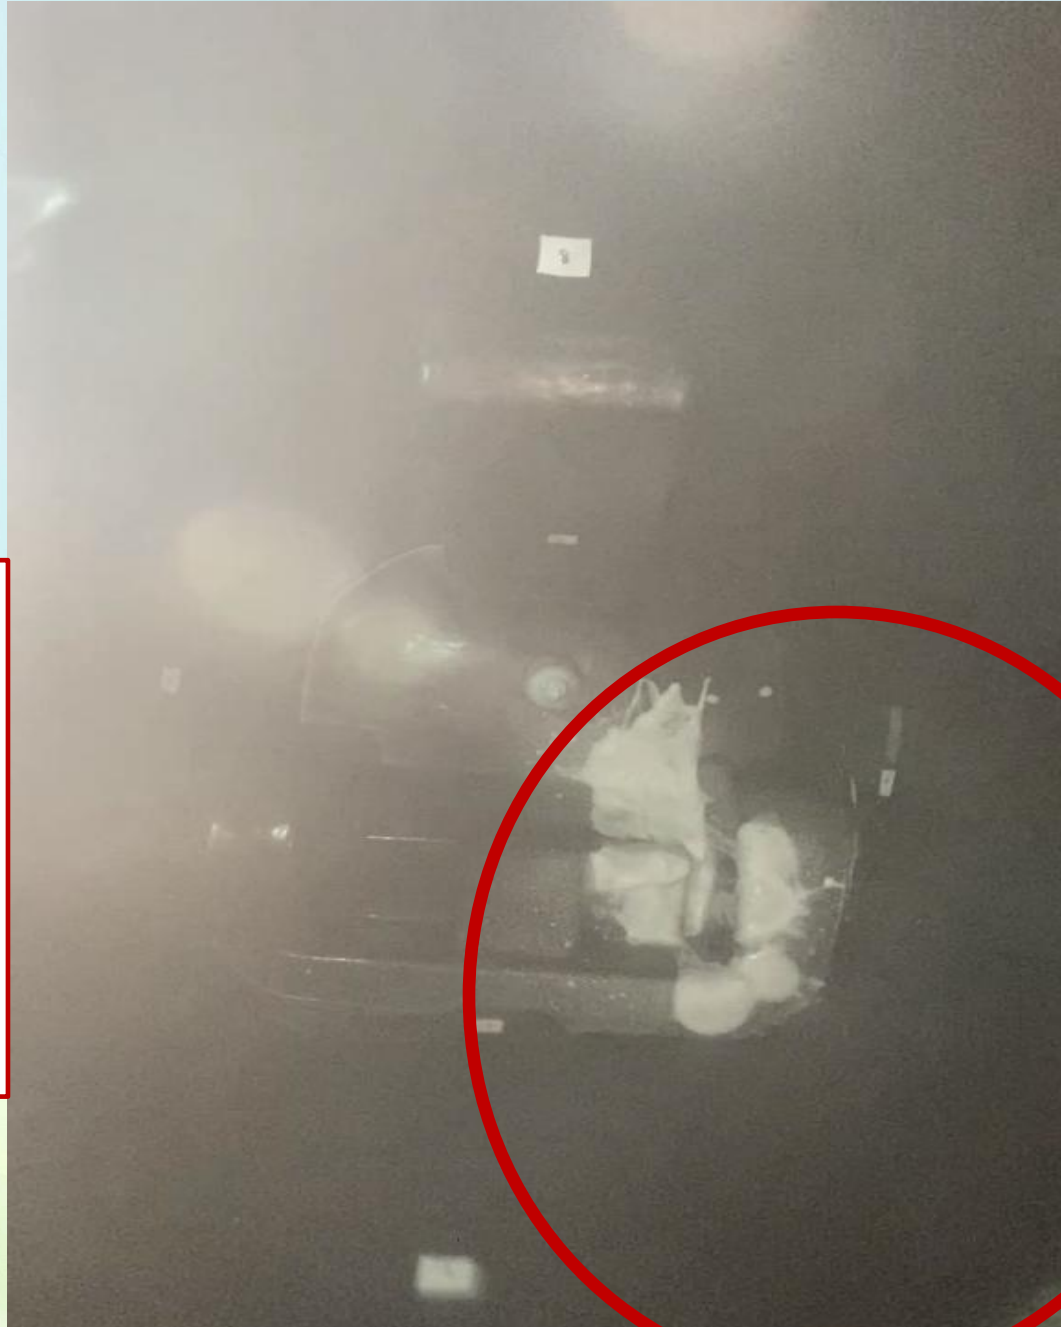
# Trial #4 End-Point

The latch on the nozzle when pushed down angles the spray toward it and as a result the spray can mostly went towards the corner that is indicated.

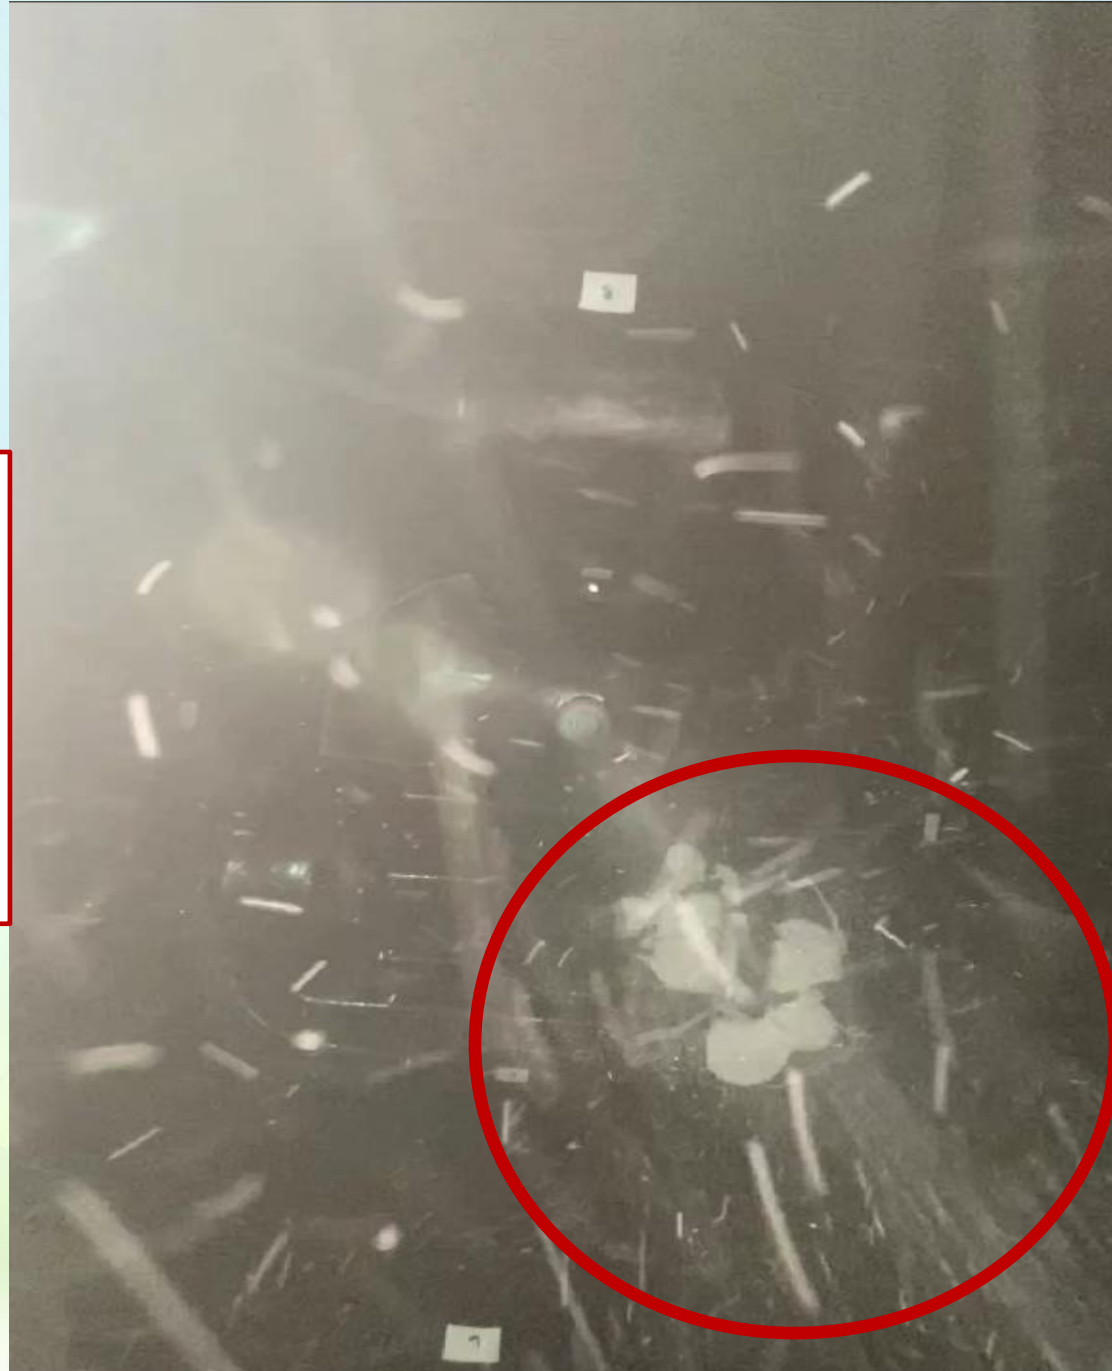
# Trial #5 Mid-Point

The spray for most of the time was spraying with a constant stream but went to a full cone shape when 10% of the contents inside remained.

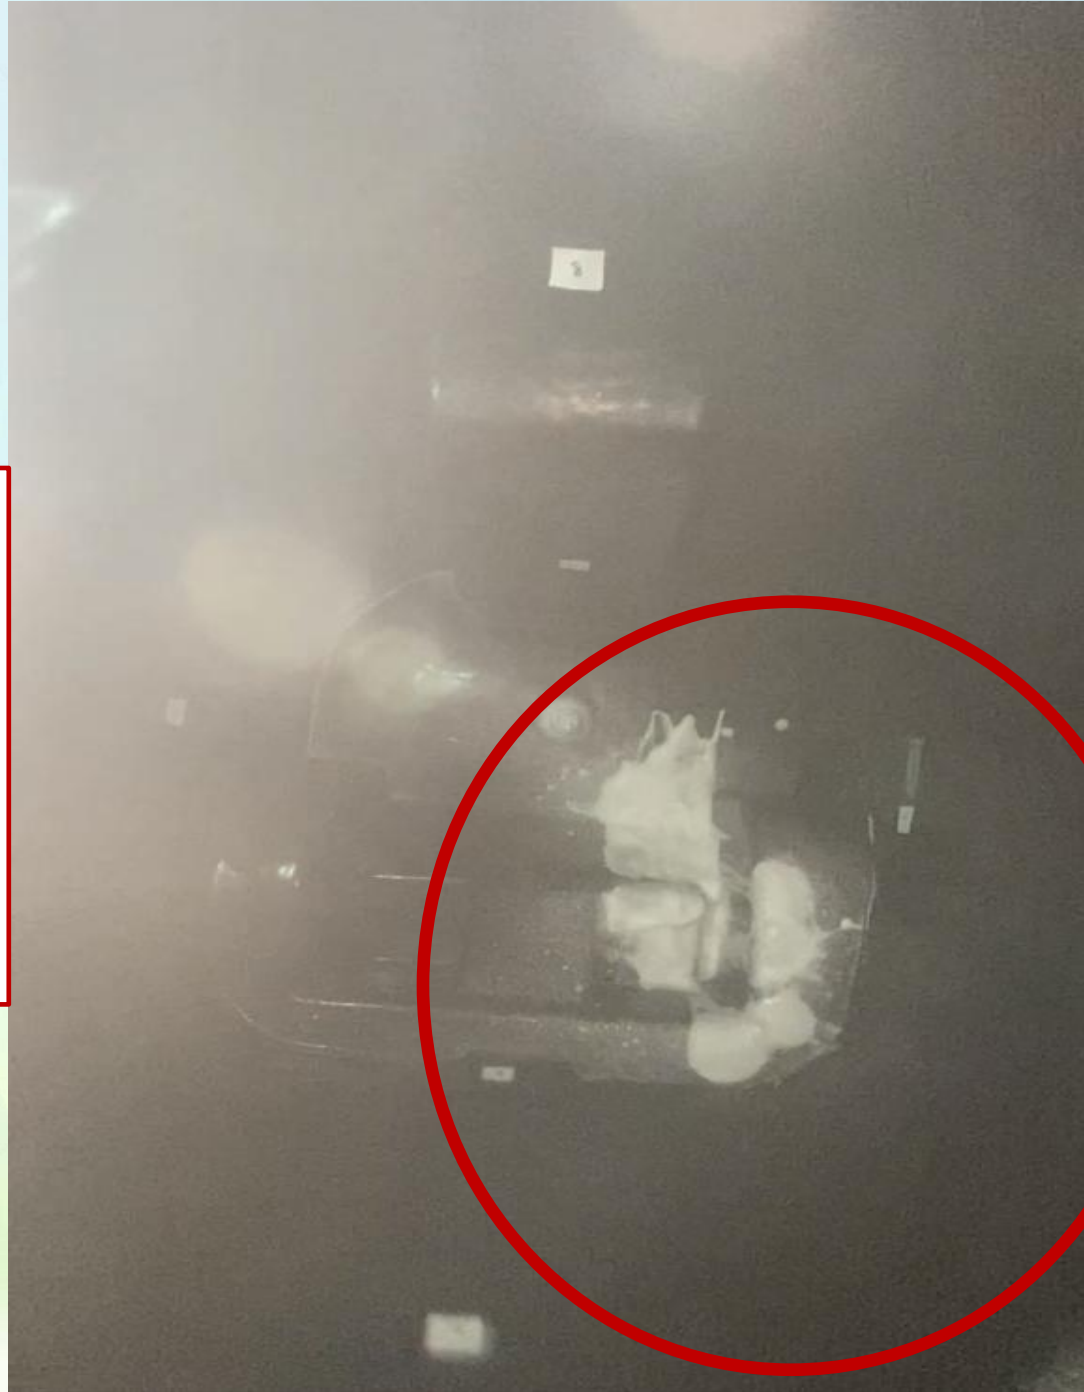
# Trial #5 End-Point

The latch on the nozzle when pushed down angles the spray toward it and as a result the spray can mostly went towards the corner that is indicated.
