# Comprehensive Car Inspection Report

## Hyundai Verna

SX1.5VTVT IVT | 2025 | AT | Petrol

Report generated on: 24 Apr, 2025

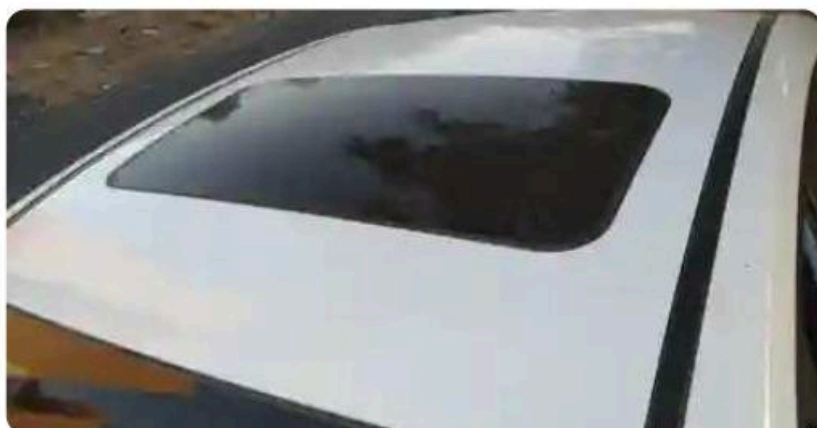
Roof: No Dents, Scratched

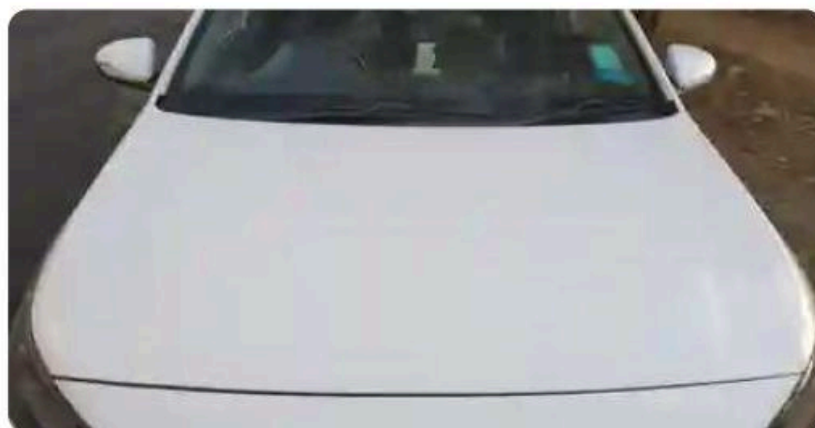
Bonnet/Hood: No Dents, Scratched

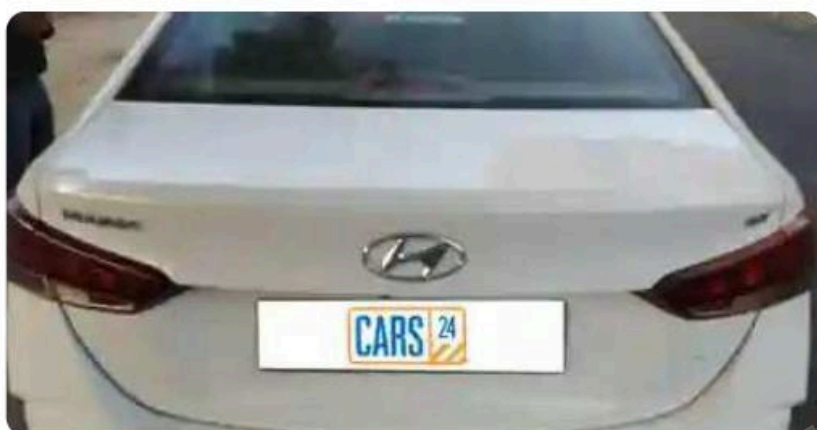
Dicky Door / Boot Door: No Dents, Scratched

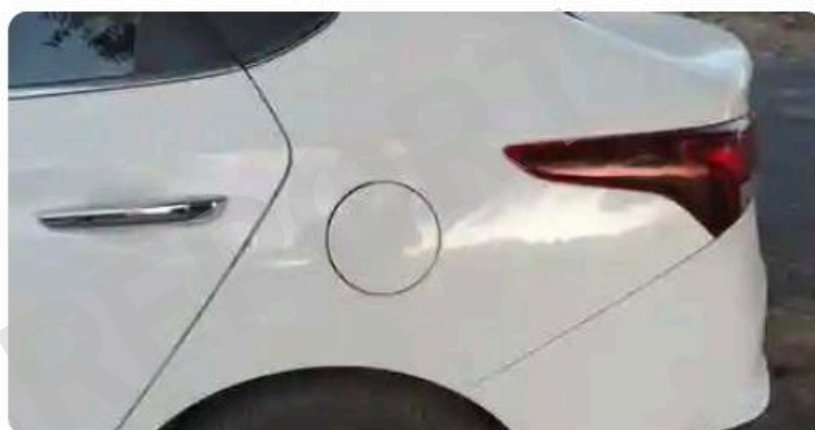
Quarter Panel LHS: No Dents, Repainted

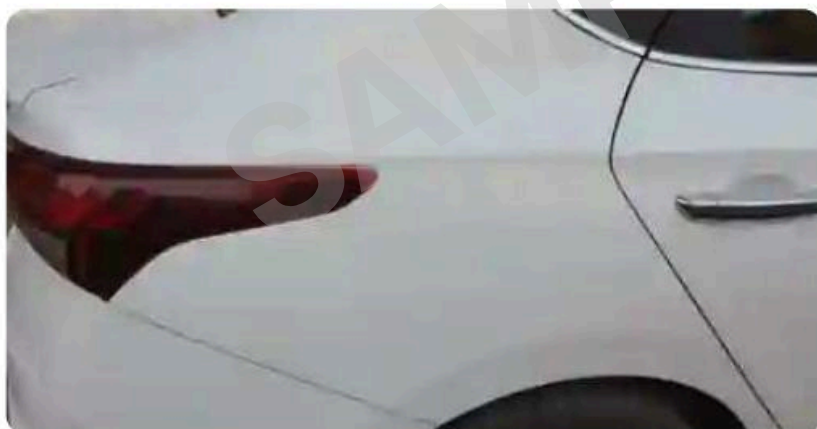
Quarter Panel RHS: No Dents, Repainted

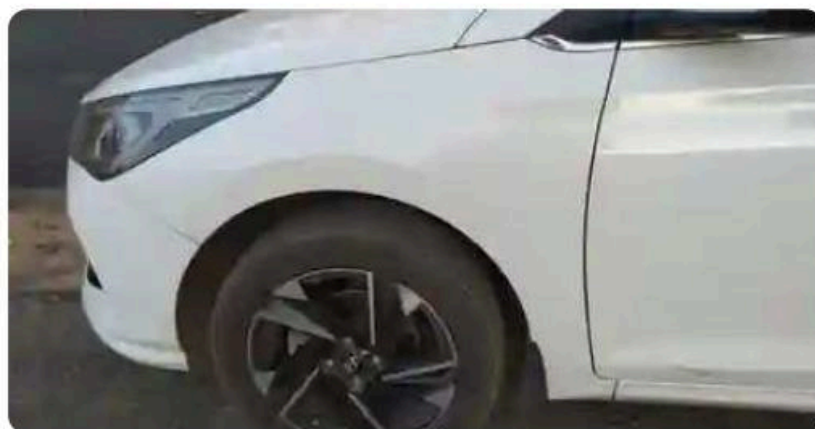
Fender LHS: No Dents, Scratched, Repainted

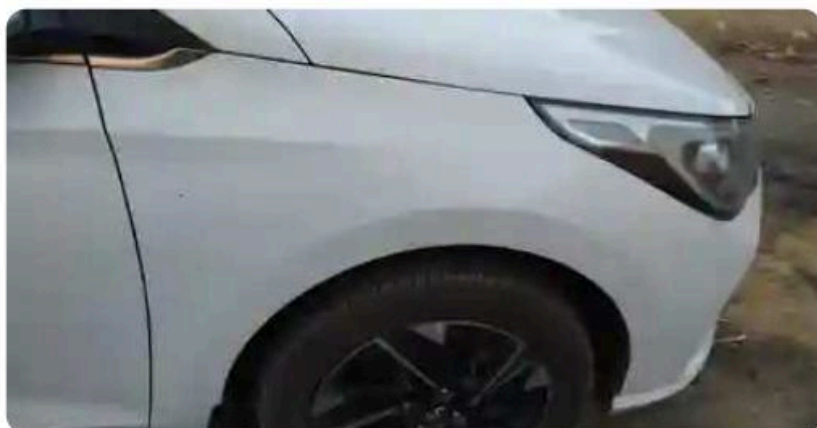
Fender RHS: No Dents, Repainted

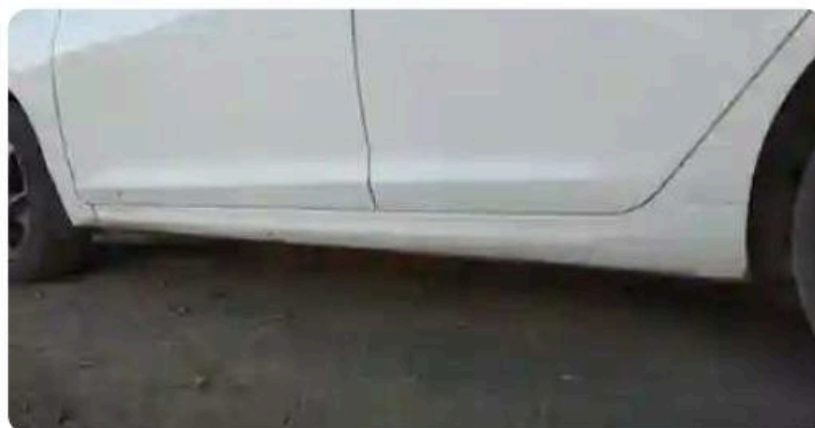
Running Border LHS: No Dents, Scratched, Repainted

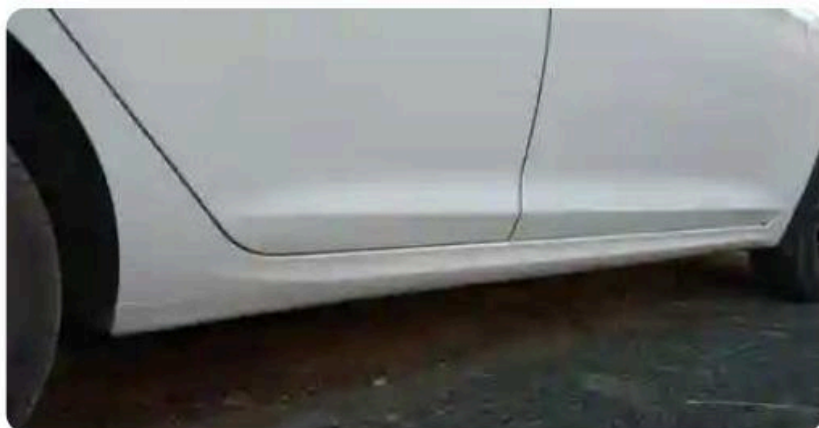
Running Border RHS: No Dents, Repainted

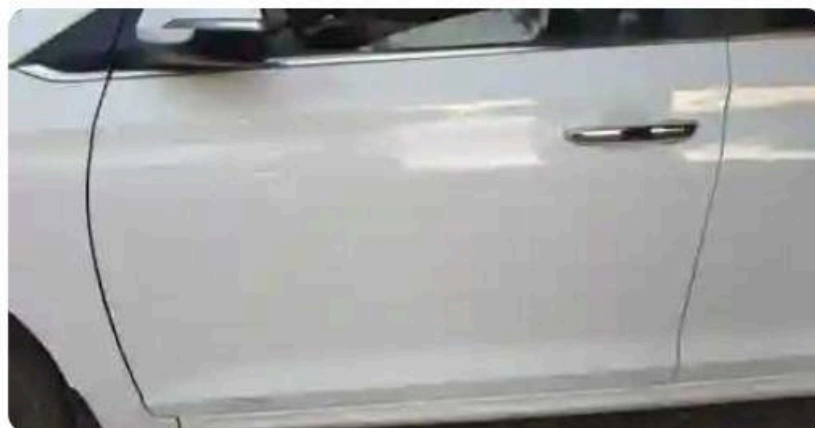
Door LHS Front: No Dents, Scratched, Repainted

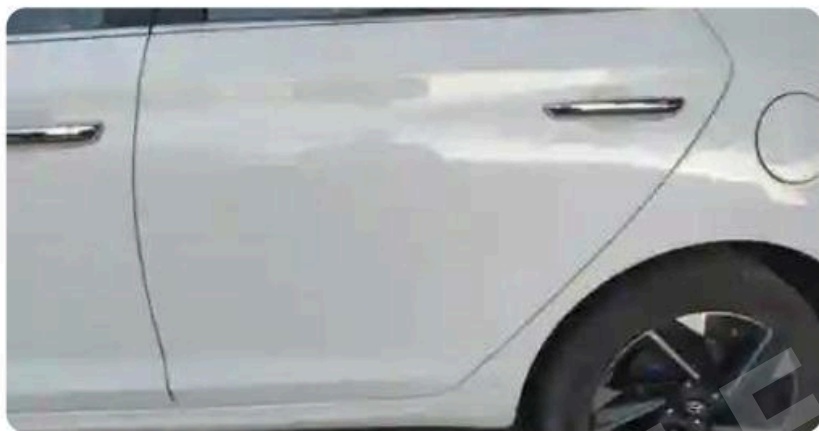
Door LHS Rear: No Dents, Repainted, Scratched

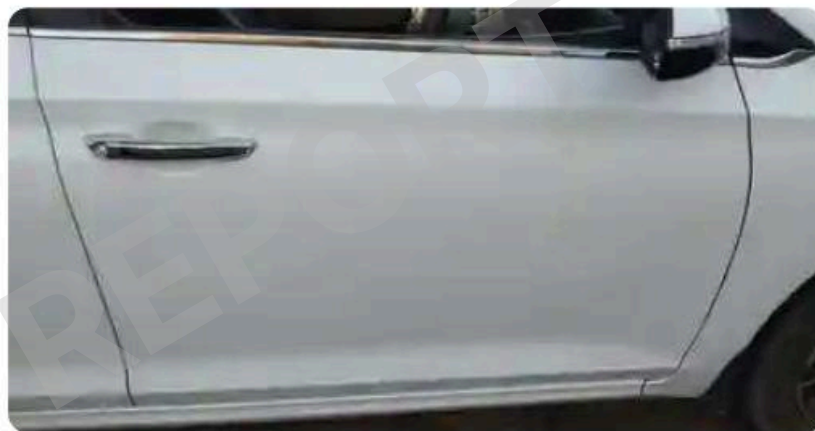
Door RHS Front: No Dents, Repainted

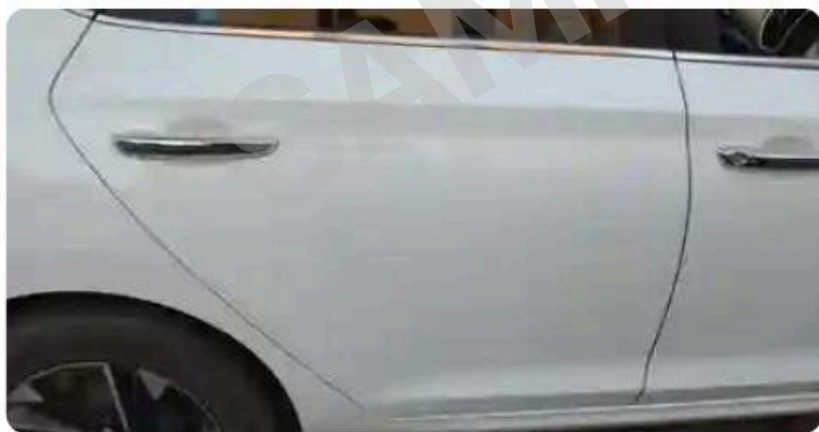
Door RHS Rear: No Dents, Repainted

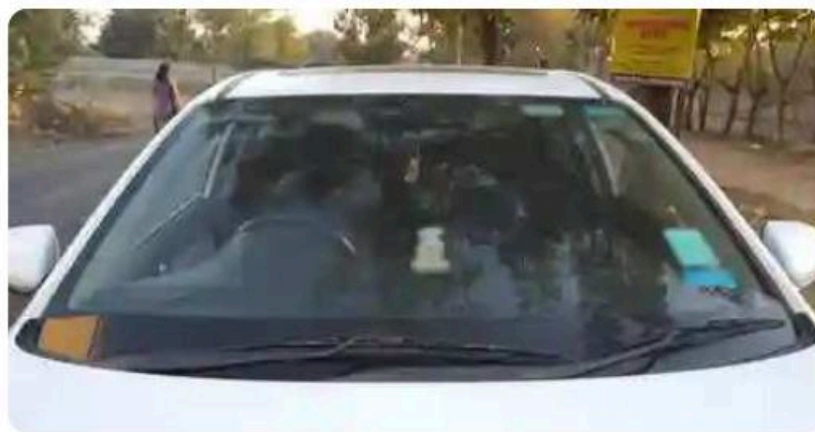
Windshield Front: Scratched

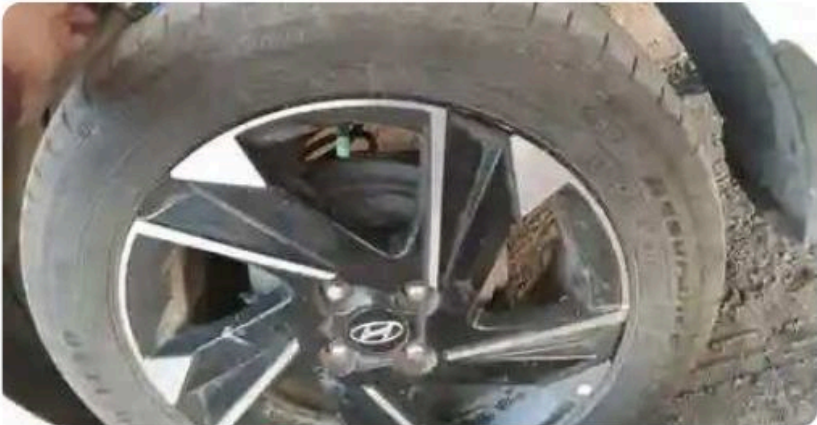
LHS Rear Tyre:

30% life remaining

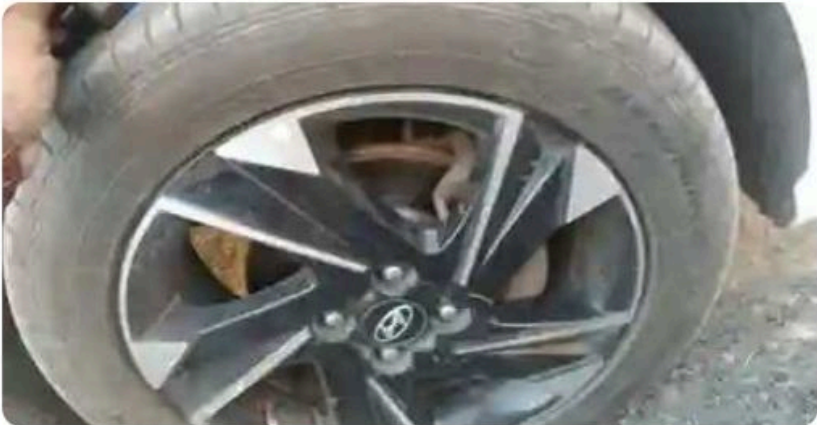
RHS Front Tyre:

70% life remaining

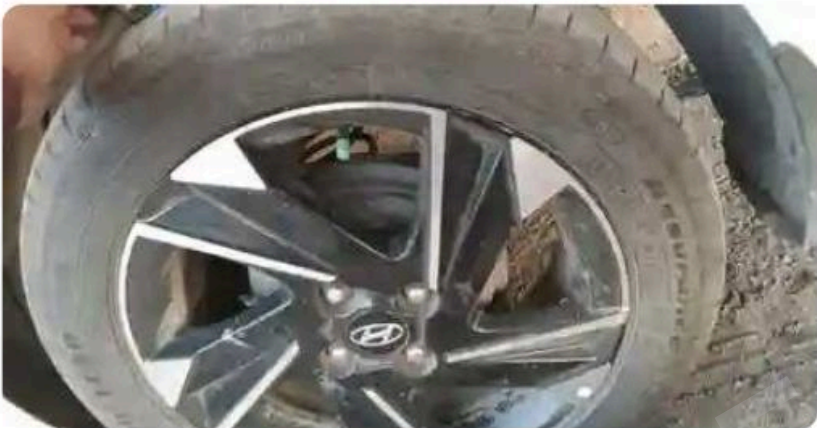
LHS Rear Tyre:

30% life remaining
