# CARROBAAR DRIVE

PREMIUM INSPECTION REPORT

## Maruti WagonR

VARIANT: VXi • REG: GJ23CH4369

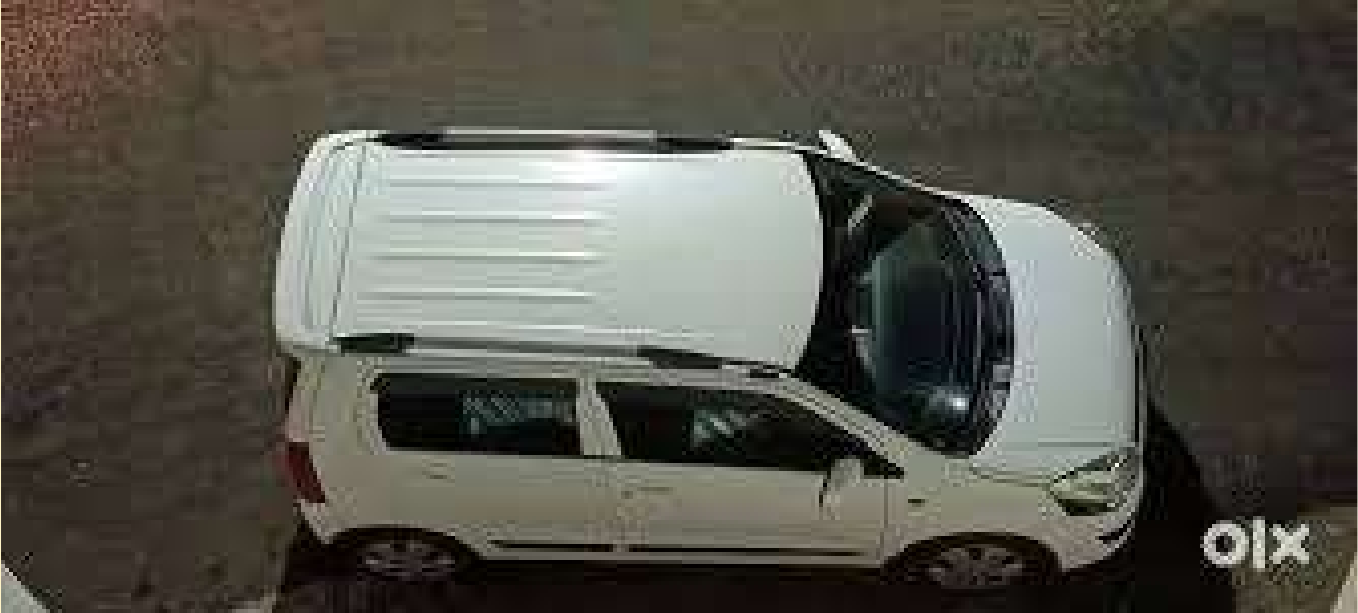
DEFECT CARD: ROOF

| NO. | CHECKPOINT COMPONENT | RESULT | OBSERVATION | RECOMMENDATION | EVIDENCE | STATUS |
|---|---|---|---|---|---|---|
| 12 | Roof | MINOR | Scratch observed on Roof. | Cosmetic rectification before delivery. | Yes | ⚠ |

Observation: Scratch observed on Roof.

Recommendation: Cosmetic rectification before delivery.

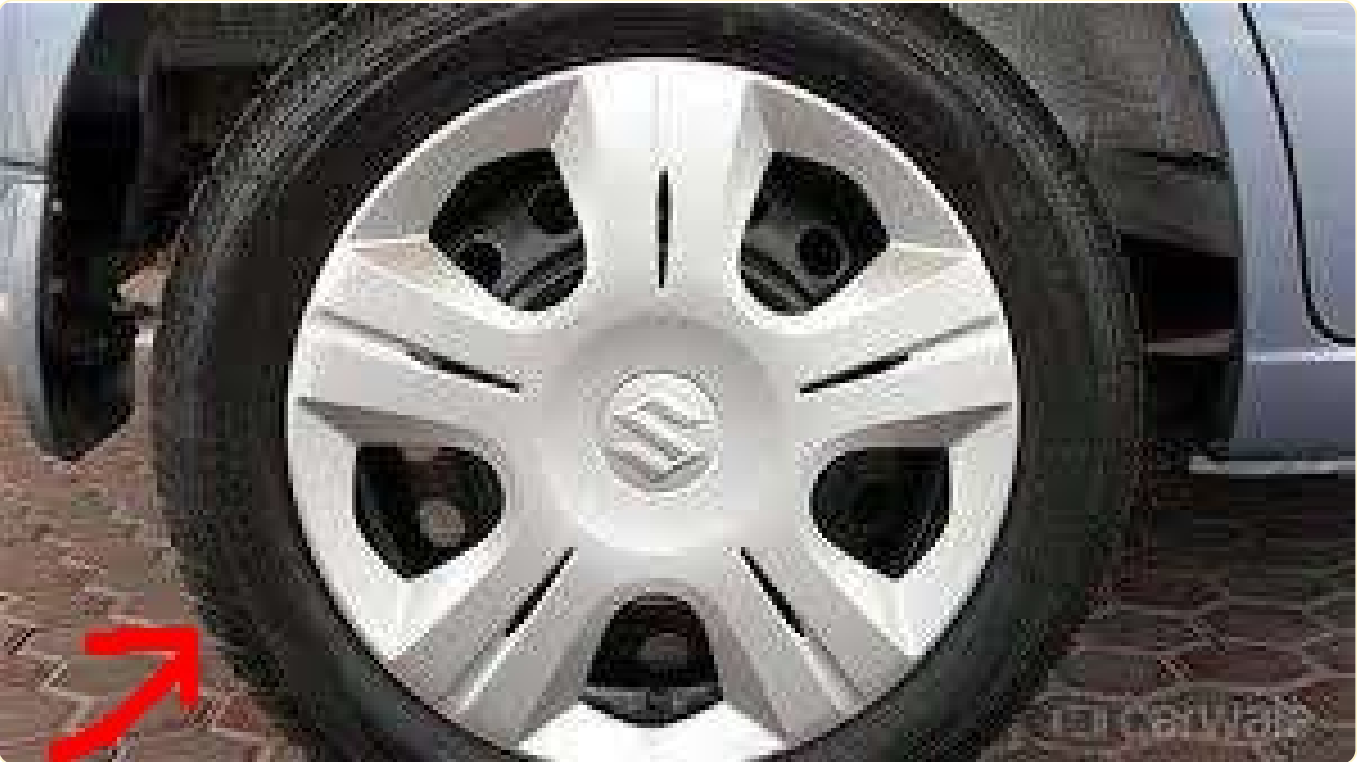
⚠ DEFECT CARD: WHEEL RL

| NO. | CHECKPOINT COMPONENT | RESULT | OBSERVATION | RECOMMENDATION | EVIDENCE | STATUS |
|---|---|---|---|---|---|---|
| 3 | Wheel RL | MINOR | Wheel design differs from specified vehicle variant on Wheel RL. | Dealer clarification required. | Yes | ⚠ |

Observation: Wheel design differs from specified vehicle variant on Wheel RL.

Recommendation: Dealer clarification required.

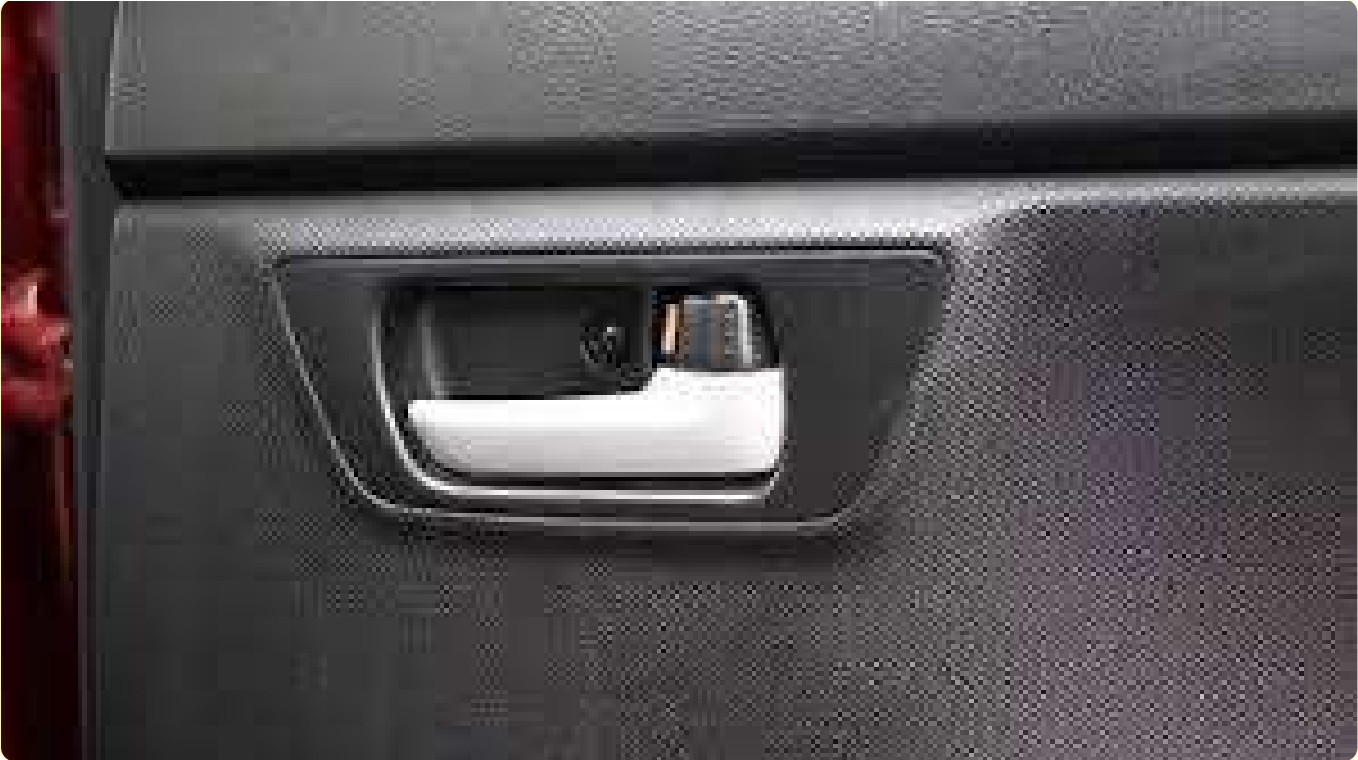
**DEFECT CARD: DOOR HANDLES**

| NO. | CHECKPOINT COMPONENT | RESULT | OBSERVATION | RECOMMENDATION | EVIDENCE | STATUS |
|---|---|---|---|---|---|---|
| 3 | Door Handles | MINOR | Improper fitment of trim on Door Handles. | Dealer rectification before delivery. | Yes | ⚠ |

**Observation:** Improper fitment of trim on Door Handles.

**Recommendation:** Dealer rectification before delivery.

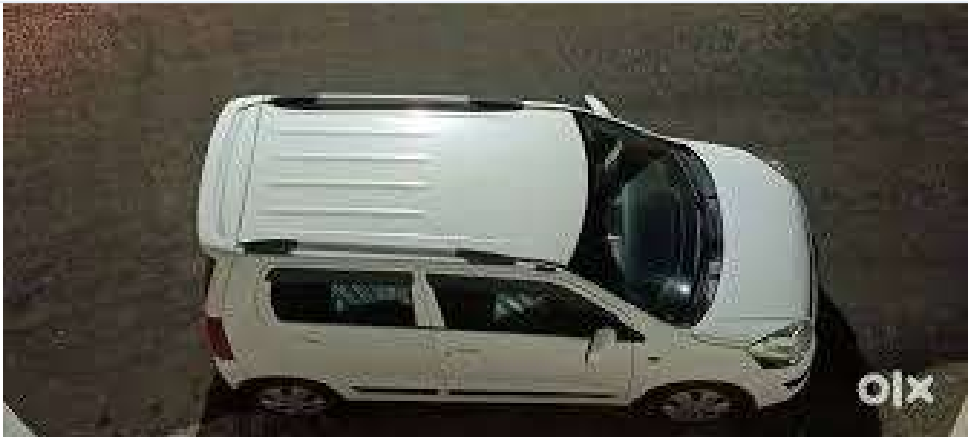
ROOF (PHOTO 1)

MINOR

**Observation:** Scratch observed on Roof.  
**Recommendation:** Cosmetic rectification before delivery.

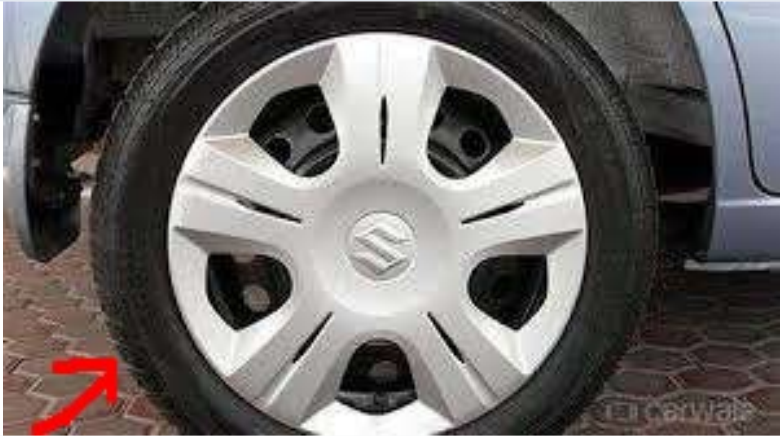
WHEEL RL (PHOTO 1)

MINOR

**Observation:** Wheel design differs from specified vehicle variant on Wheel RL.  
**Recommendation:** Dealer clarification required.

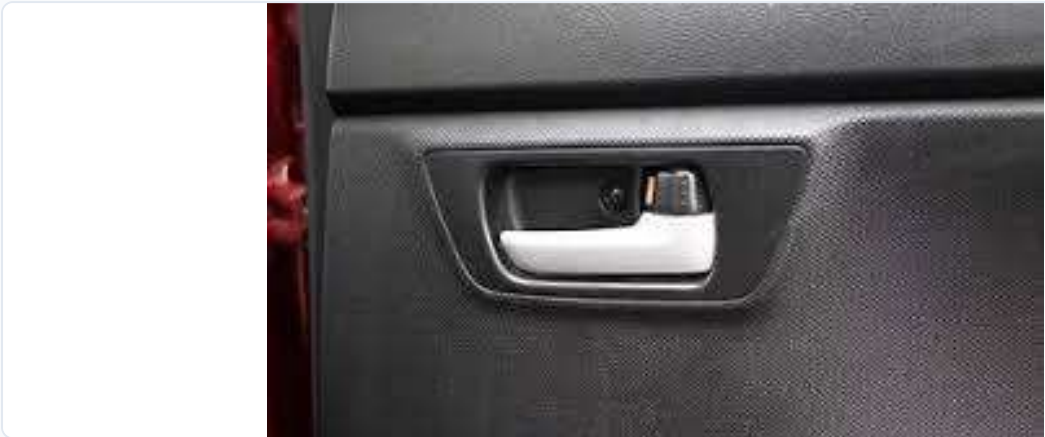
#### DOOR HANDLES (PHOTO 1)

MINOR

**Observation:** Improper fitment of trim on Door Handles.

**Recommendation:** Dealer rectification before delivery.
