# Recovery Electronics Full Test

| <b>Title:</b> | Electronics Full Test Report |
| <b>Project:</b> | HELVETIA |

| General Information | | | |
|---|---|---|---|
| <b>Test – ID:</b> | ReEI01 | | |

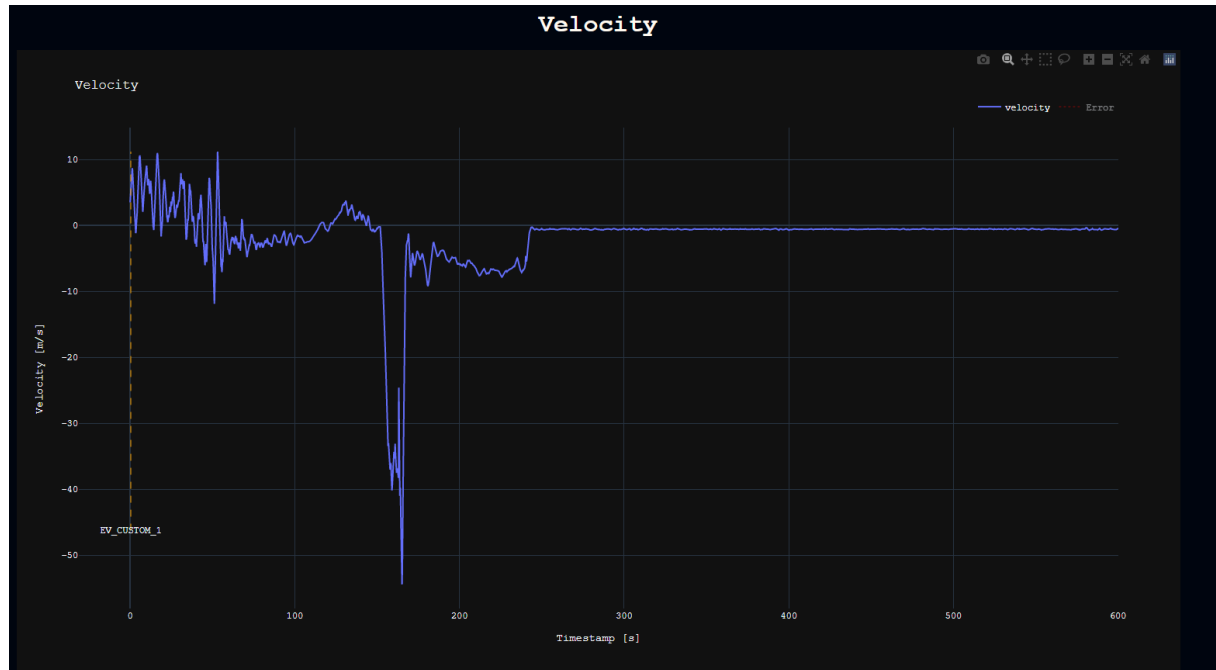
Figure 2.13 shows such velocity profile and indicates the main deployment as the sudden velocity spike up to 180ft/s (55m/s). This is the peak velocity the structure reaches during which the main chute falls out and the lines need to be taut. When main chute is fully opened at 165 seconds, the velocity drops to roughly 20ft/s (6m/s). From 170 seconds onwards it keeps this velocity until touchdown happens at 245 seconds. In figure 2.14, the shock load for the main chute deployment can be assessed as 12.9g which reflects the simulation data at 13g very well.

Figure 2.13 HDT 2: Velocity Data obtained from CATS (SRAD) FC

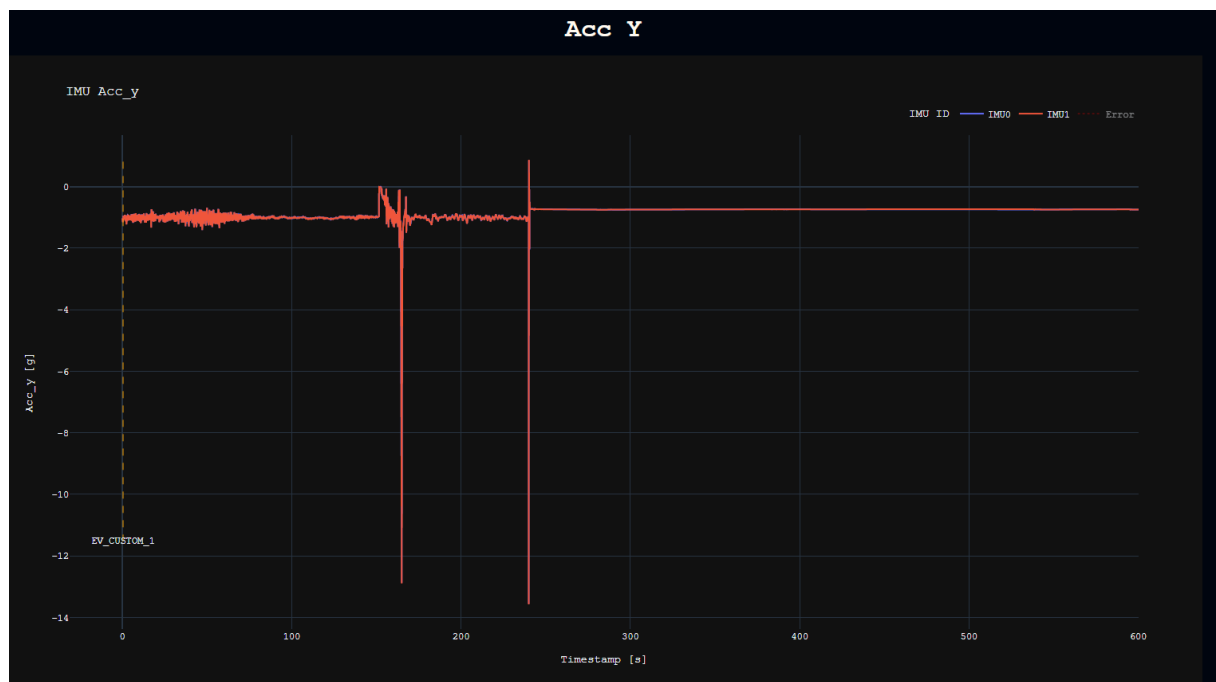
Figure 2.14 HDT 2: Acceleration Data obtained from CATS (SRAD) FC
