General survey of bus frontal collisions: is regulation needed?

M Matolcsv

Scientific Society of Mechanical Engineers (GTE), Budapest, Hungary

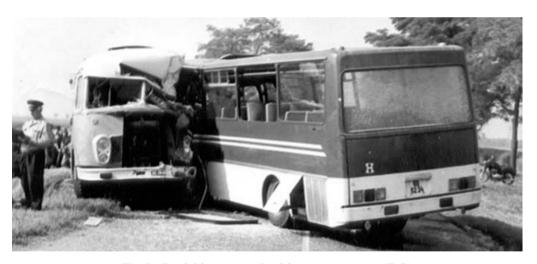
- 2. Partial (offset) impact on the DC. The final 'result' is very similar whether this impact comes at a certain angle or parallel to the centre plane of the vehicle (see Fig. 3). This offset impact can influence the DC to its total height or be concentrated below the windscreen (see Fig. 4(b)).
- 3. Partial (offset) impact on the door side of the bus front (see Fig. 4(a)).
- 4. Partial impact with a pole-like object (see Fig. 5). This is a special kind of impact because of the type of object. It can be central, left, or right side impact.

Fig. 3 Partial impact on the driver compartment (DC)

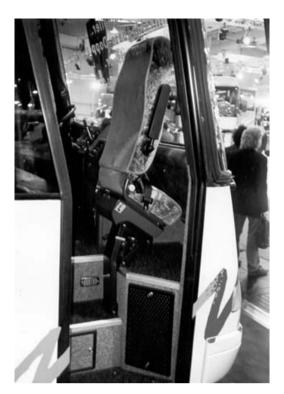
- 1. To assure a certain survival space for the crew, which could be an interesting task considering the seat location as shown in Fig. 11.
- 2. To keep the crew and the crew seat in the original position.

Fig. 11 Special position of crew seat

It will be noticed that the crew seat position shown in Fig. 11 is strongly related to the problem of evacuation, too.
