The impact of design on material corrosion: An illustrative exampleM. Victoria Biezma ^a, Diego Agudo ^{a,*}^a Materials Science and Engineering Department, University of Cantabria, 39004,
Santander, Spain

Figure 1 (a, b). Studied footbridge exterior view and dimensions

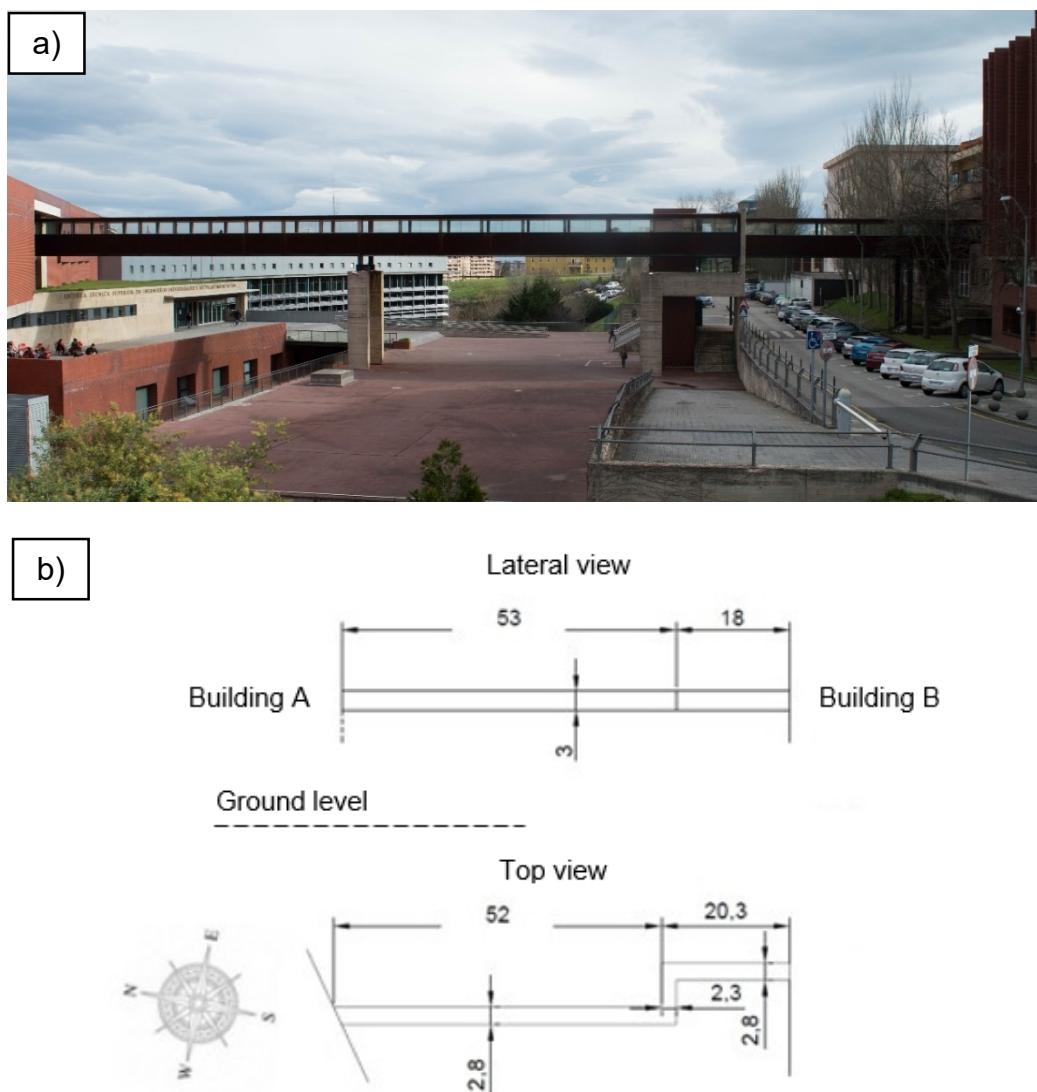
This footbridge has been in service for less than 25 years, yet it shows important signs of corrosion in its steel frame structure (Figures 2 and 3), as this phenomenon has not been appropriately considered during the design stage of the project. In addition to this, maintenance has not been carried out, aggravating the corrosion problems.

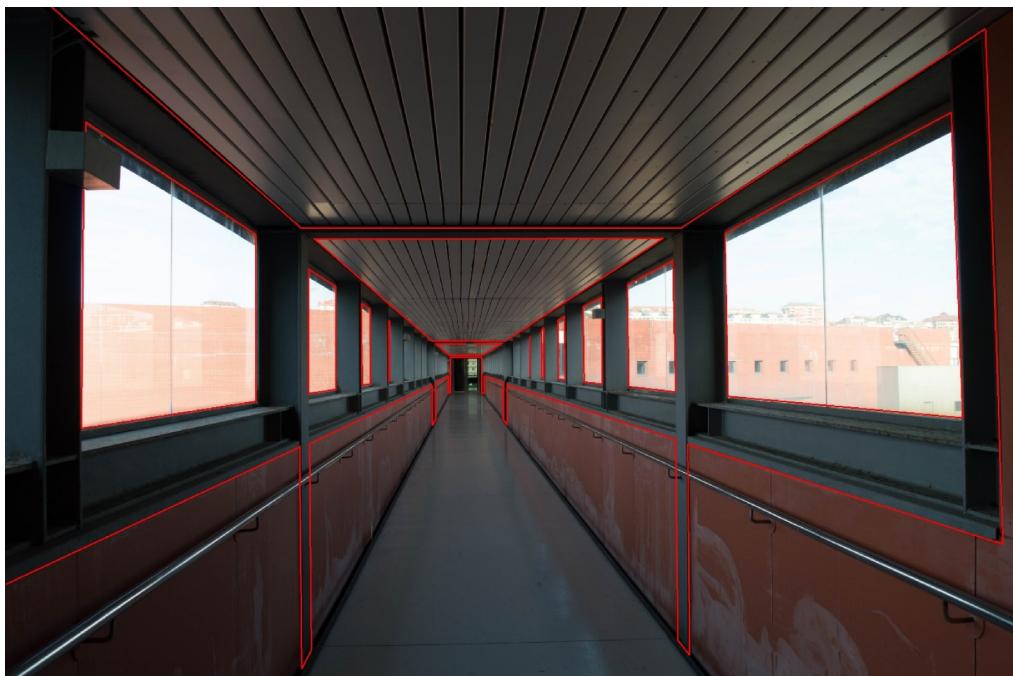
Figure 2. Steel frame structure of the footbridge (outlined in red)

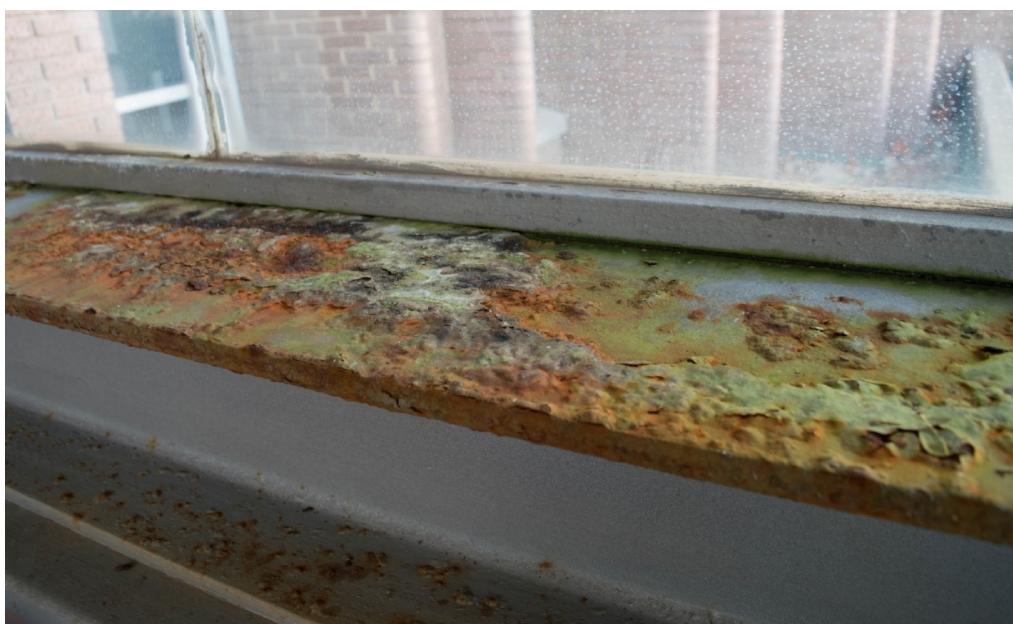
Figure 3. Corrosion damage in the footbridge structure

These corrosion problems are of high relevance, as they provoke that the structural capabilities of the steel frame are undermined, which can potentially cause the failure of the footbridge. The structural weakening is produced because, during the corrosion process, a part of the steel transforms into corrosion products and therefore reduces the effective section of the beam and, consequently, its mechanical properties.

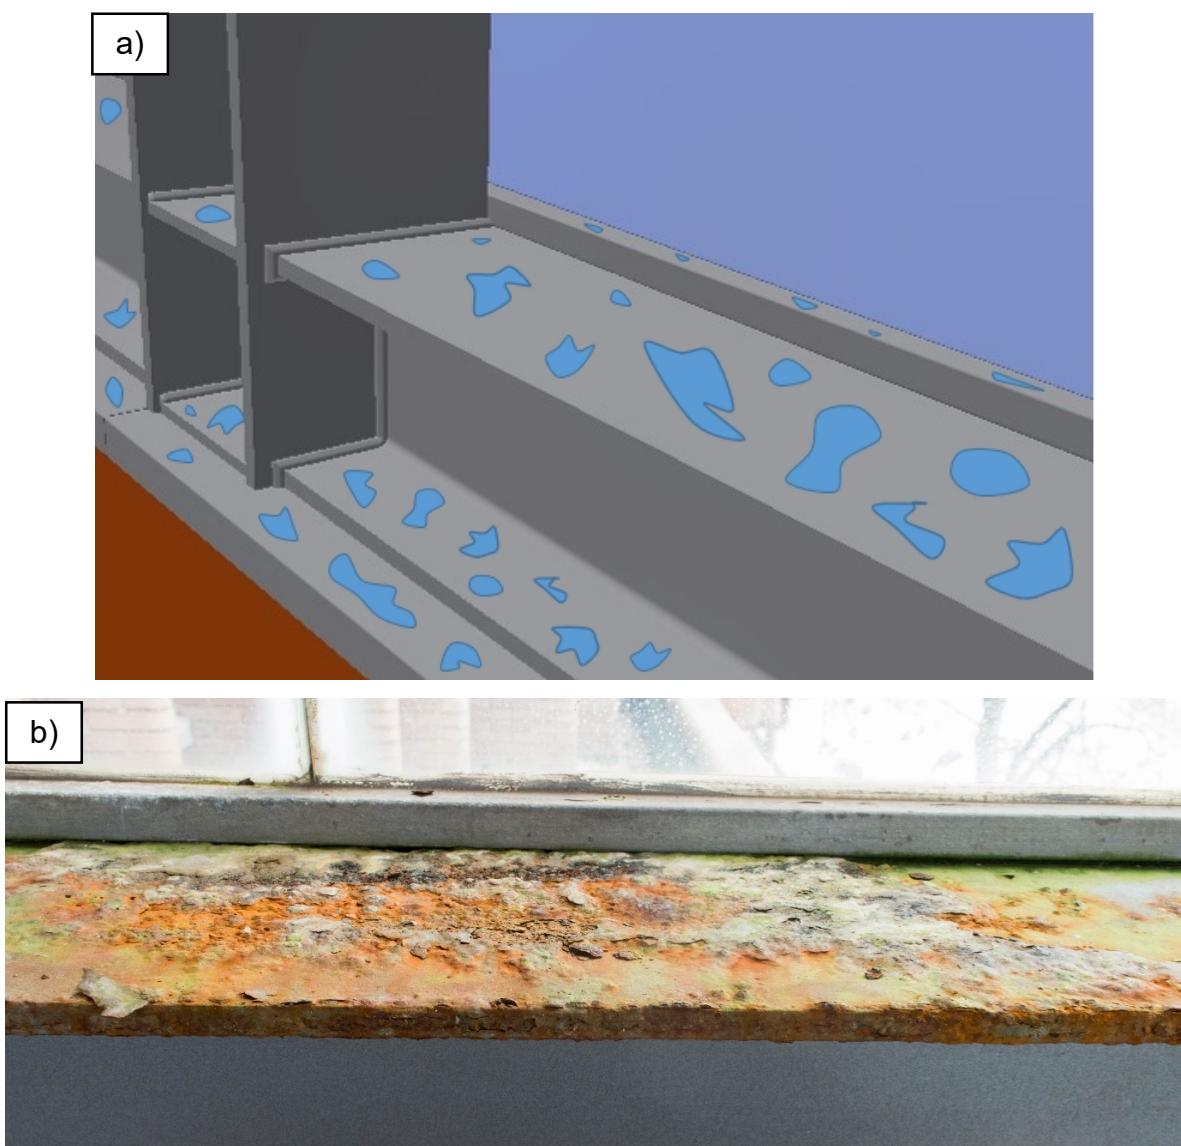
The structure presents a significant amount of horizontal surfaces, which difficult the drainage of the condensation liquid that drips from the windows due to gravity. In Figure 4a, a schematic drawing of this problem is shown.

The retained liquid acts as the electrolyte for the corrosion reaction, which combined with the low quality of the protective coating, causes deterioration in the horizontal surfaces. The corrosion damage caused by this phenomenon can be observed in the majority of the structure (Figure 4b).

Figure 4 (a, b). Corrosion issues in the horizontal surfaces

This design mistake cannot be solved geometrically without creating a great alteration in the initial design. For this reason, this complication will be addressed only with the previously mentioned long-lasting, high-quality, coating protocol.

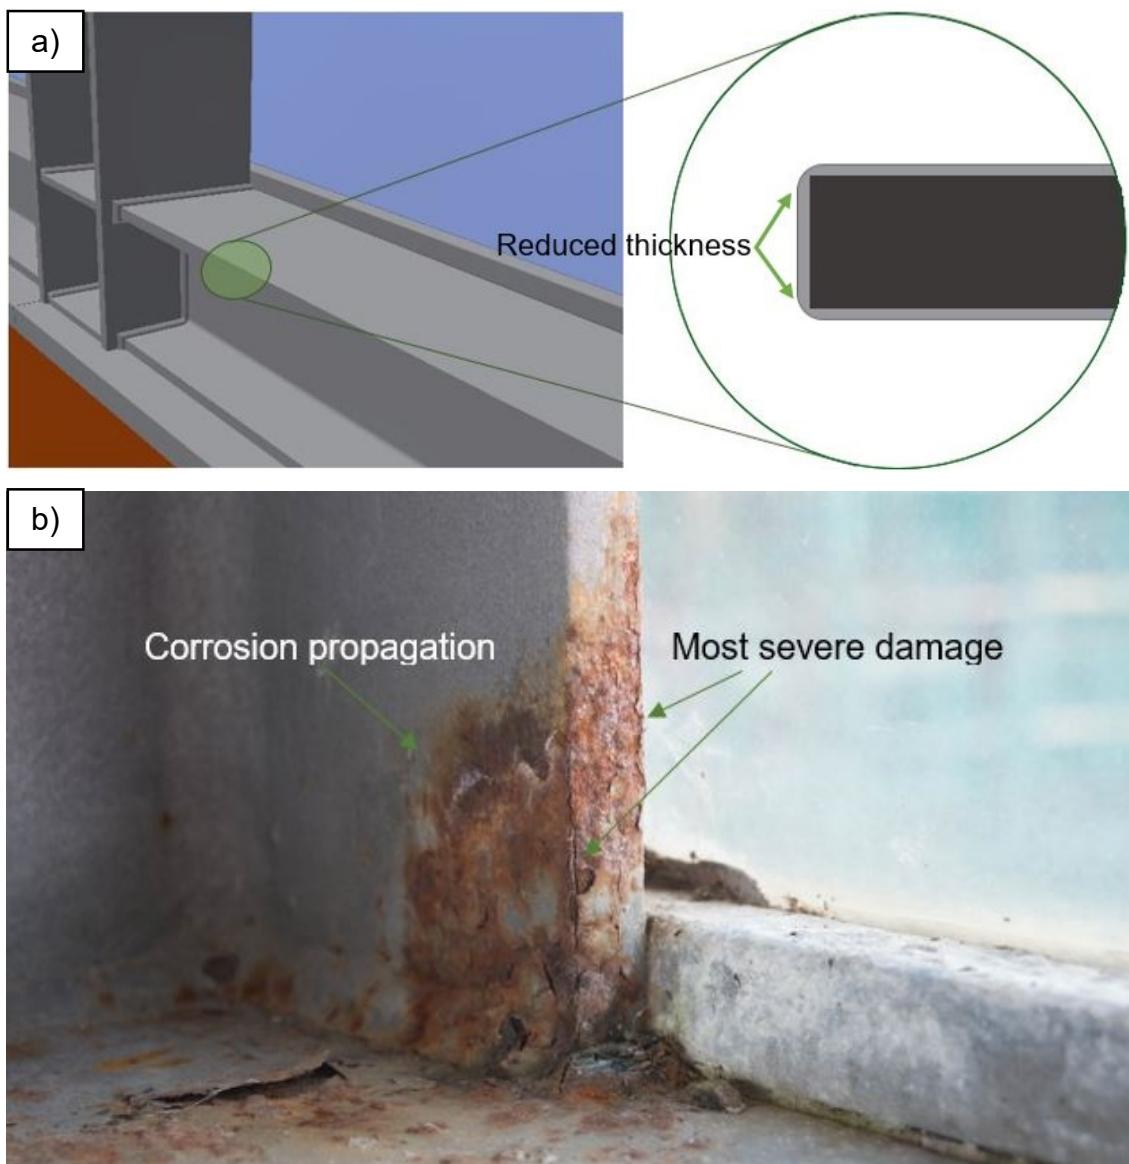
The geometry of the HEB structural steel beams presents 90° edges that provoke discontinuities of the coating thickness as shown in Figure 5a because, during application, the liquefied paint tends to flow away from the acute angles due to gravity. This design mistake affects both horizontal and vertical beam elements.

As a result of this, the 90° edges of the beam act as a weak spot in which the corrosion process tends to start. Figure 5b illustrates the severe damage caused in one of the vertical beam edges of the structure.

Figure 5 (a, b). Corrosion issues in the beam 90° edges

In Figure 5b, it can be appreciated that the most severe damage is localized in the 90° edge of the beam. Moreover, a propagation pattern can be observed, which means that the corrosion process began at the 90° edge and then proceeded to affect the plain surface of the beam.

All of the exposed 90° edges of the beams should be mechanized with a 2 mm radius. This action guarantees that a uniform coating layer can be formed during the application and drying processes, as can be seen in Figure 12, thus providing the best possible anticorrosive protection.

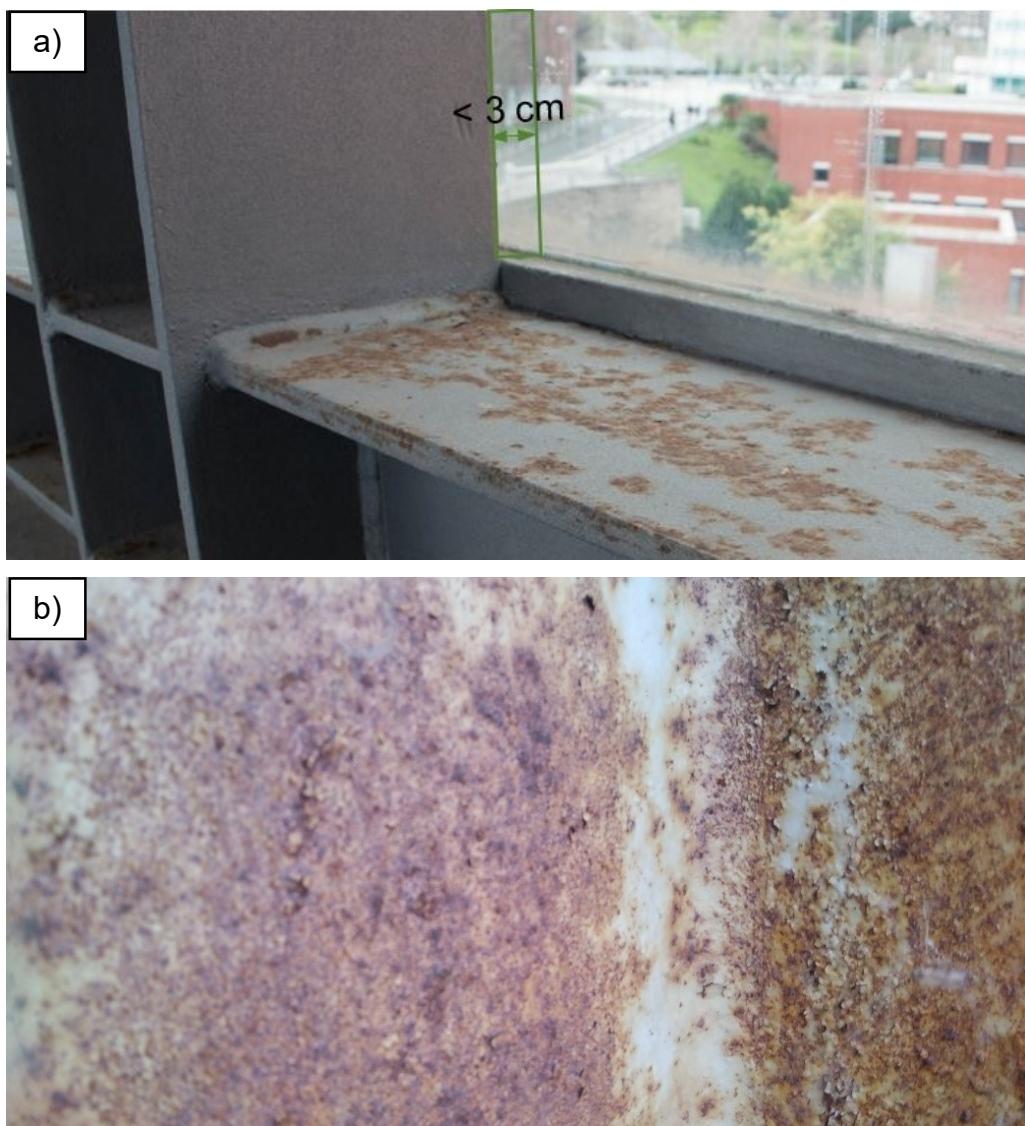
The part of the vertical beams that faces the windows is not accessible for inspection nor maintenance, as the space between the beams and the windows is smaller than 3 centimetres (Figure 6a).

The main problem of this design mistake is that it causes the illusion that the vertical beams of the structure are not affected by corrosion, as the visible part from inside the footbridge appears to be in good condition. Figure 6b shows the posterior part of one of the vertical beams, taken by introducing a camera in the reduced space between the beam and the window, where an advanced state of corrosion can be observed.

Figure 6 (a, b). Corrosion issues in the posterior part of the vertical beams

As with the horizontal surfaces, this problem is not solved by modifying the geometry. The corrosion protection of the areas with lack of access also relies on the proposed coating protocol.

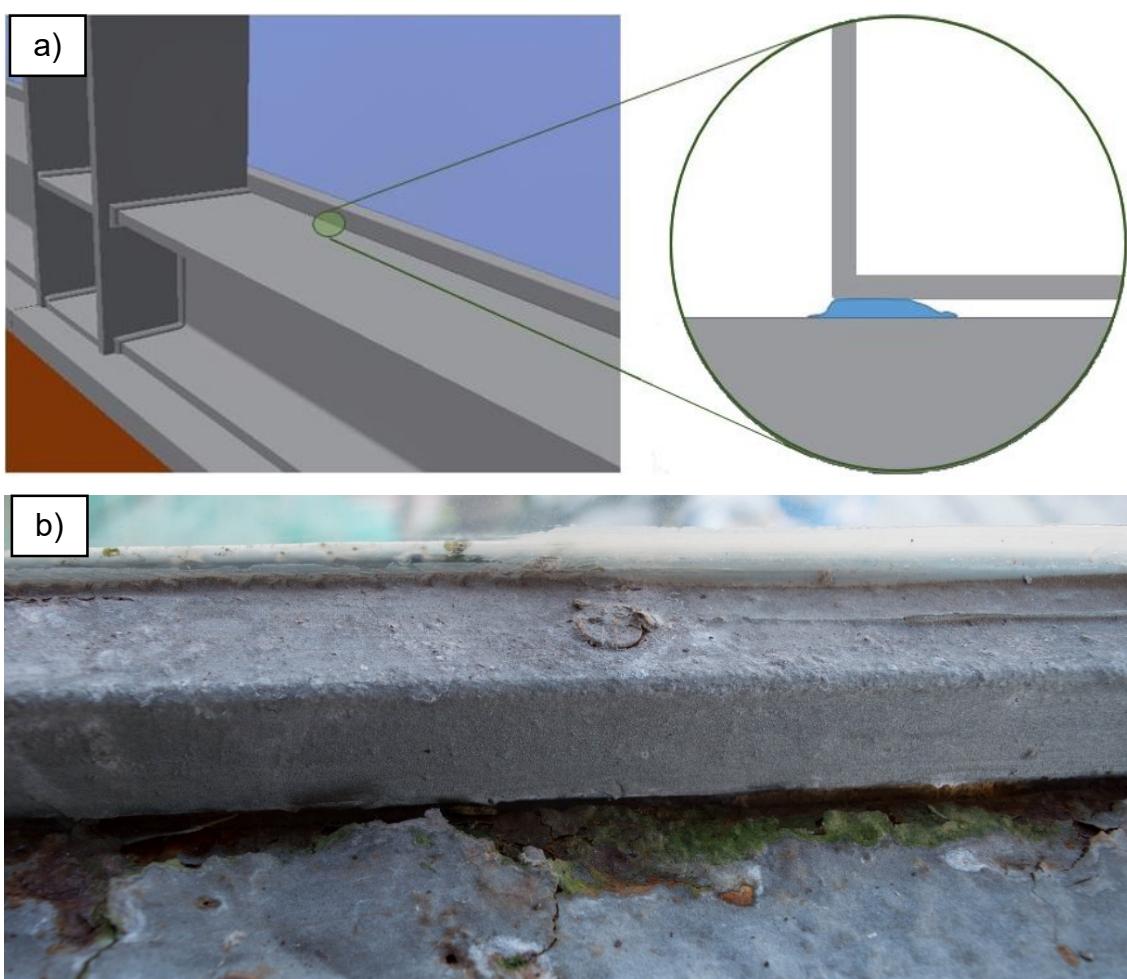
The structure presents crevices, especially in the junction between the beams and the windows steel frames. These crevices provoke retentions of water and moisture (Figure 7a), as they allow liquid penetration and difficult drainage due to the fact that the natural airflow is reduced inside the crevice. Moreover, as the protective paint coating was applied after assembly, the protective layer is not uniform inside the crevice, as the paint cannot penetrate evenly.

The retained water accentuates the crevice corrosion that inherently occurs when these geometrical complications are present. Furthermore, when the corrosion process starts inside the crevice, it tends to propagate towards the rest of the beam. This phenomenon has created important damage, as shown in Figure 7b.

Figure 7 (a, b). Corrosion issues in the crevices

All the crevices of the structure should be sealed with a high-quality mono-component adhesive with high mechanical performance (Figure 13). This option has been chosen over continuous welding due to the fact that the window frame perimeter cannot be welded as it needs to have a certain movement freedom in order to absorb the thermal expansions.

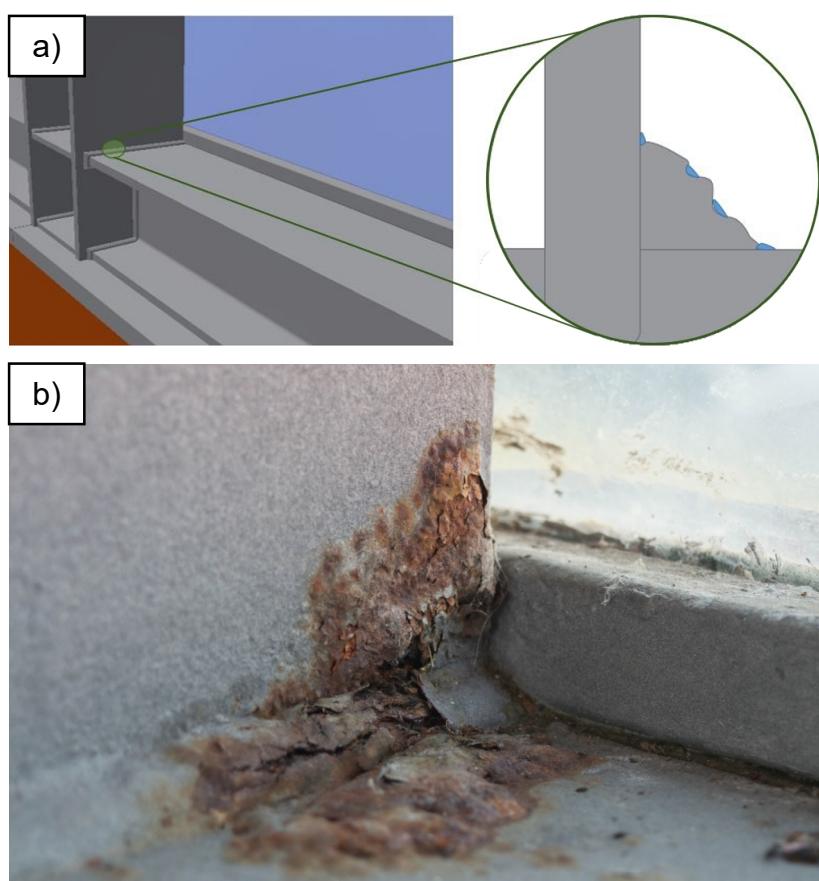
- Firstly, the weld beads introduce geometrical discontinuity on the surface, as they add additional material. Moreover, weld beads often have porous zones (Figure 8a) that allow for liquid retention and favour the formation of not uniform coating layers.
- On the other hand, welding processes signify that the material suffers high thermal stress and, if the cooling process is not controlled, the internal structure of the welded metal is distorted, facilitating the corrosion initiation and propagation.

The effect of the combination of the aforementioned processes can be observed in the footbridge structure, where the weld beads show evident signs of corrosion, as can be observed in Figure 8b.

Figure 8 (a, b). Corrosion issues in the weld beads

All of the welds of the structure should be continuous and mechanized after application if needed to provide a homogeneous surface (Figure 14) without any significant pores, addition

material accumulations nor weld projections, so that a continuous protective coating film can be formed and dirt and water retentions are less likely to occur.

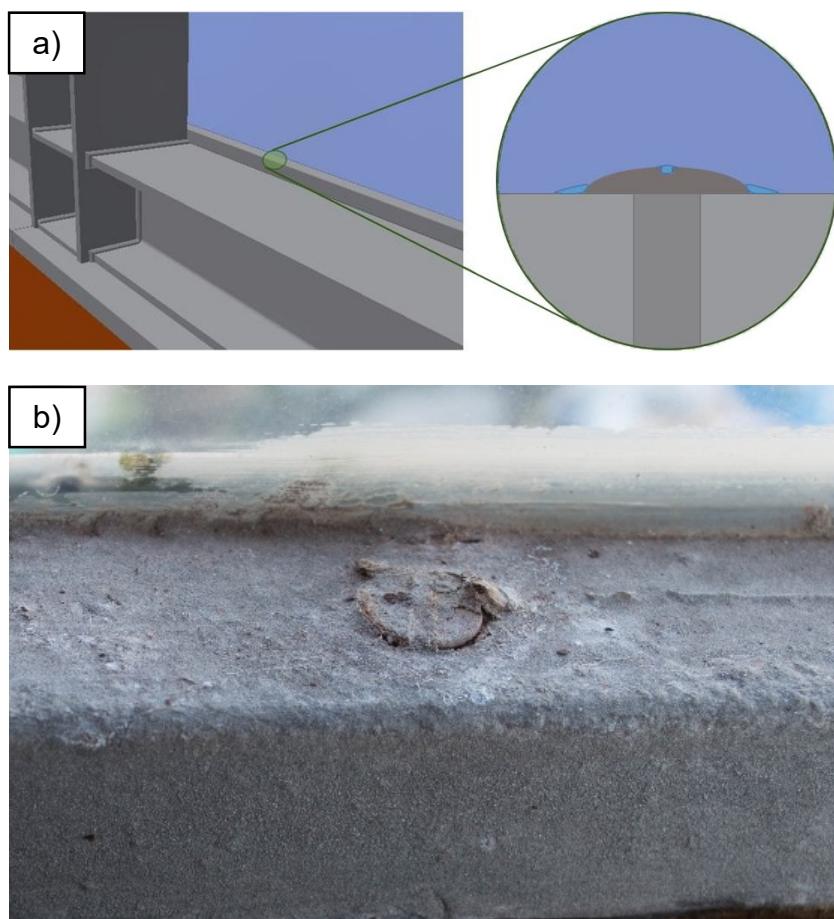
To realize the junction between the structural beams and the window frames, a joining method via bolts was selected. Bolt heads create a geometrical discontinuities in the structure while favouring galvanic corrosion if the material of the joined metals and the bolt is not exactly the same composition wise.

The geometrical discontinuities generate water and dirt retentions (Figure 9a), while hindering the formation of a uniform protective layer. Figure 9b illustrates the discontinuities previously mentioned. Notwithstanding, this design mistake has not shown yet obvious signs of corrosion. Most likely, the root cause for the lack of corrosion products in these points, is that the bolt geometry and material had been properly selected, creating a tight seal and impeding galvanic corrosion.

Figure 9 (a, b). Corrosion issues around the bolts

The bolted joint method is maintained, because even with the actual advanced state of corrosion of the structure, the periphery of the bolts does not show corrosion signs. However, certain points need to be considered:

- The bolt size needs to be selected accordingly to provide a tight seal without protruding over the jointed parts
- The bolt material composition needs to be the same as the one of the joined metals
- The correct installation of the bolts has to be visually verified before the beginning of the coating protocol

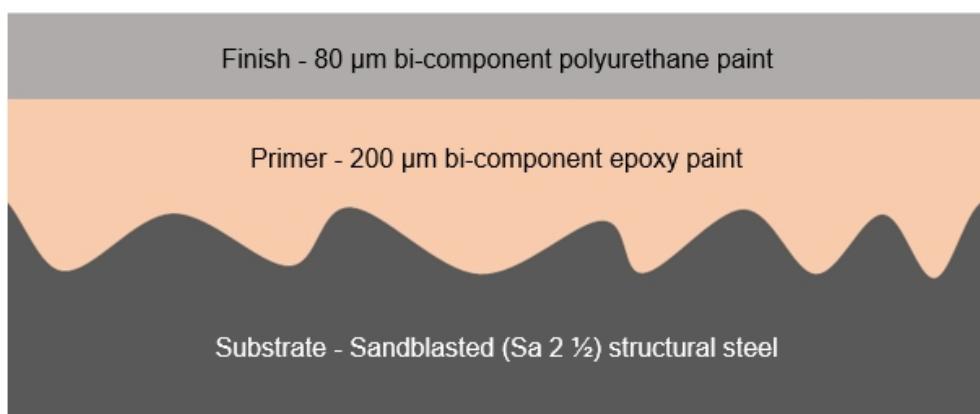
Figure 11. Scheme of the proposed protective paint system

These indeterminacies in the coating protocol, combined with the lack of a maintenance program, have contributed for the quick appearance of the corrosion, and can be determined to be the root cause of the corrosion problems of the footbridge. However, the design mistakes that are addressed in the following subsections, have exacerbated the severity of the attack.

The proposed coating protocol, designed with the help of the recommendations of one of the most respected coating manufacturers, is depicted in Figure 11.

This high quality coating protocol ensures, according to the manufacturer, at least 15 years before the first maintenance in a heavy-duty atmosphere. A long lasting coating protocol has been selected taking into consideration the actual state of lack of maintenance and the fact that some of the design mistakes cannot be solved modifying the geometry of the structure.
