The impact of design on material corrosion: An illustrative example

M. Victoria Biezma ^a, Diego Agudo ^{a,*}

^a Materials Science and Engineering Department, University of Cantabria, 39004, Santander, Spain

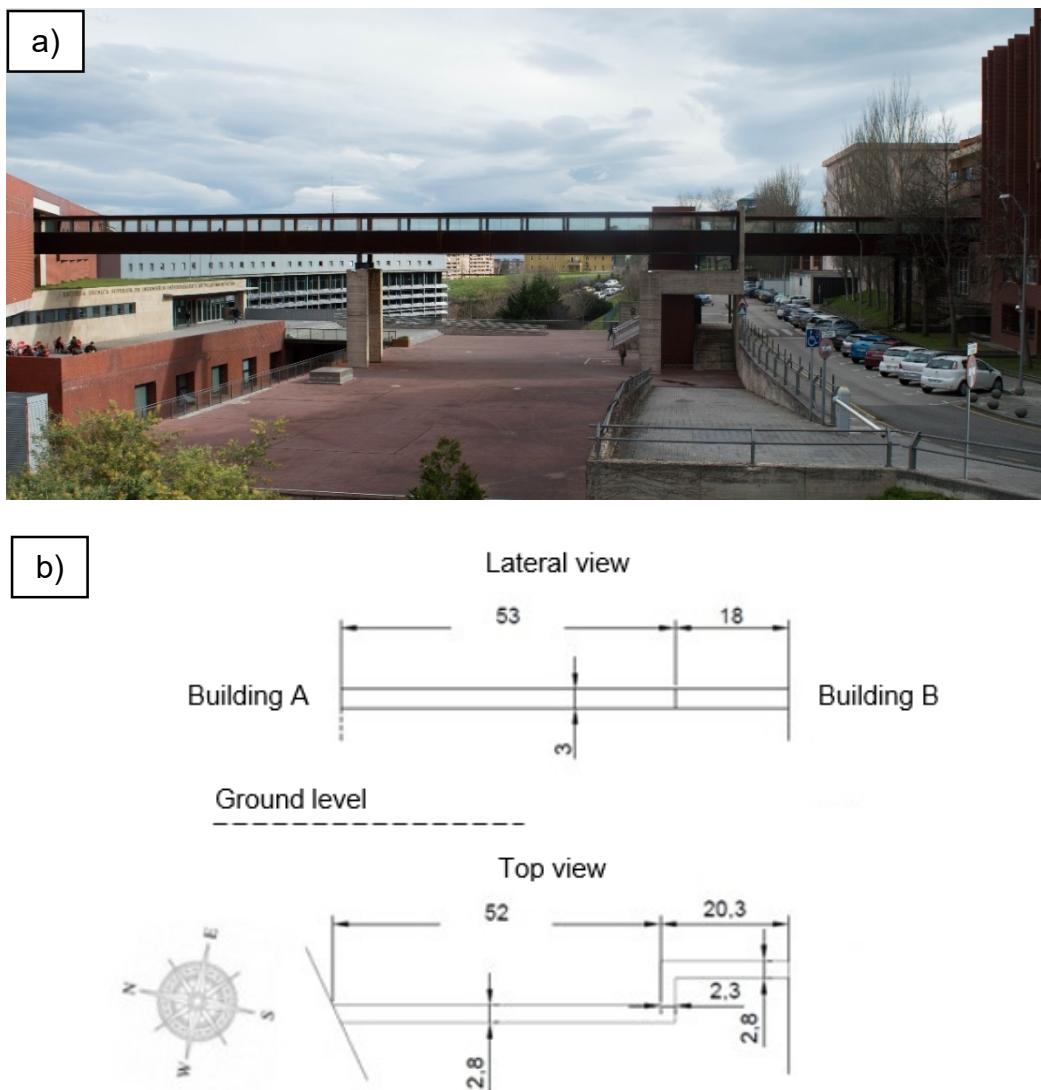
Figure 1 (a, b). Studied footbridge exterior view and dimensions

This footbridge has been in service for less than 25 years, yet it shows important signs of corrosion in its steel frame structure (Figures 2 and 3), as this phenomenon has not been appropriately considered during the design stage of the project. In addition to this, maintenance has not been carried out, aggravating the corrosion problems.

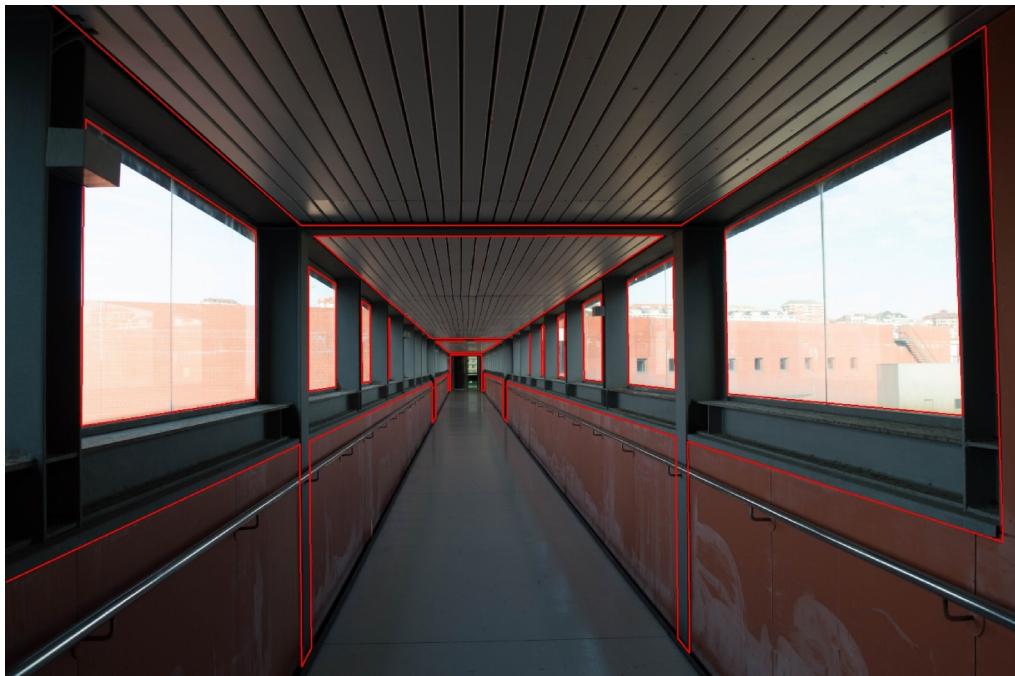
Figure 2. Steel frame structure of the footbridge (outlined in red)

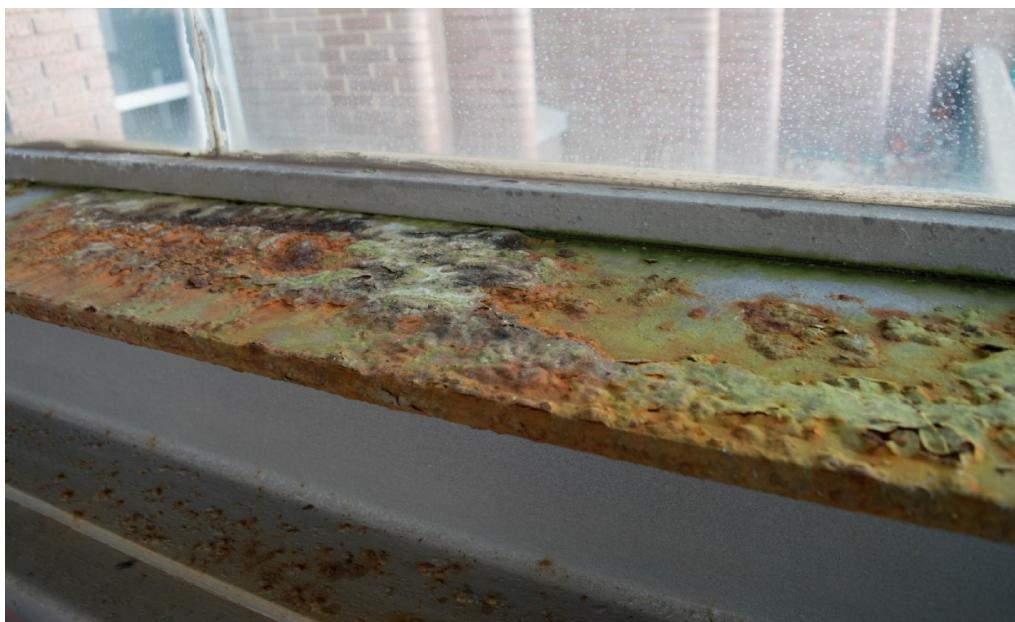
Figure 3. Corrosion damage in the footbridge structure

These corrosion problems are of high relevance, as they provoke that the structural capabilities of the steel frame are undermined, which can potentially cause the failure of the footbridge. The structural weakening is produced because, during the corrosion process, a part of the steel transforms into corrosion products and therefore reduces the effective section of the beam and, consequently, its mechanical properties.

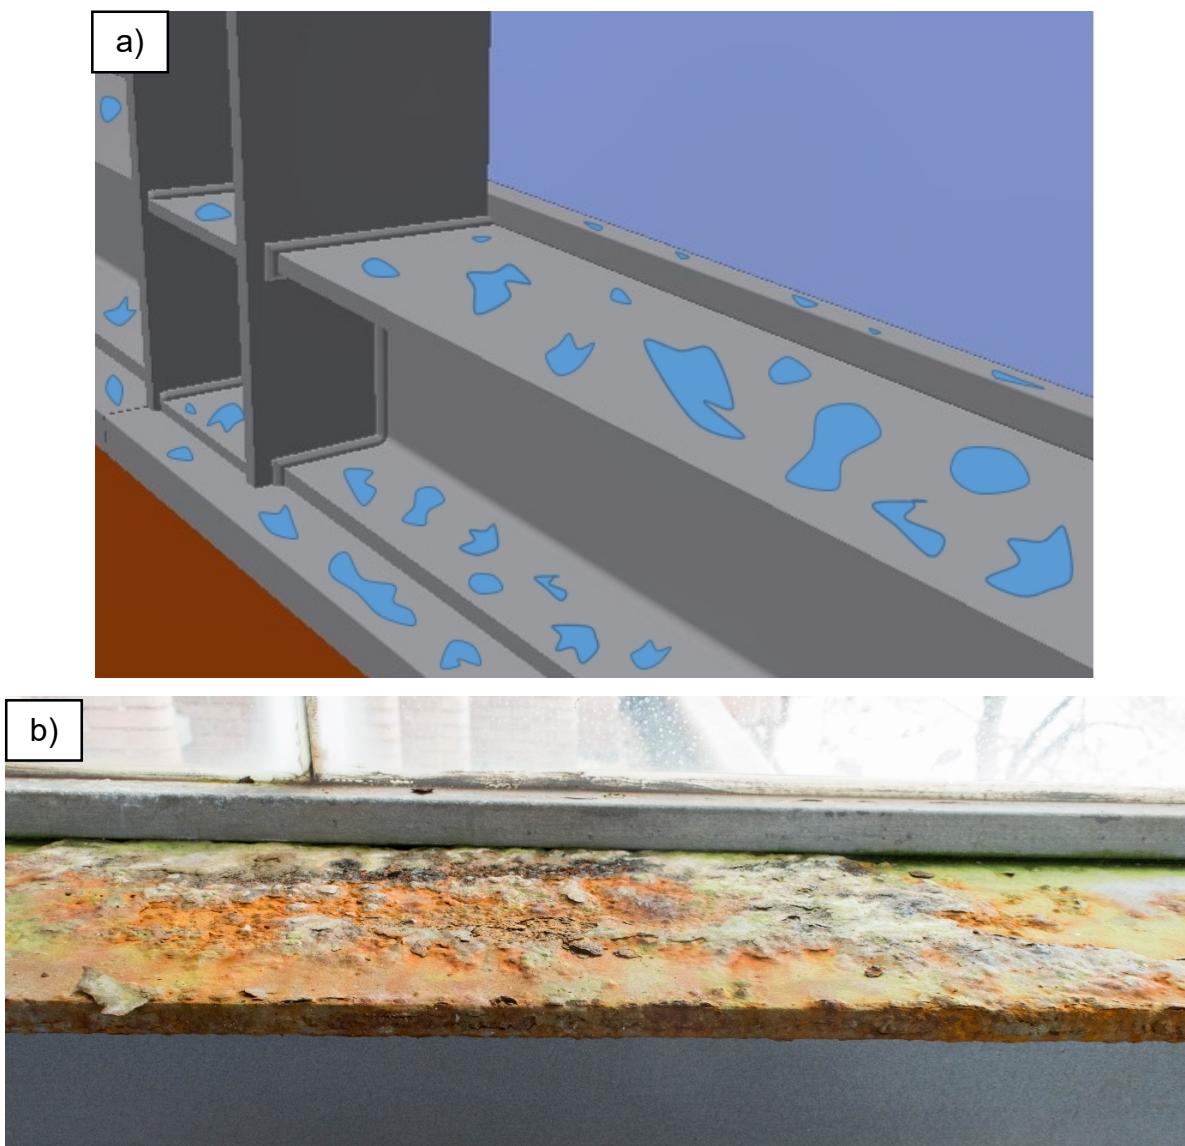
The structure presents a significant amount of horizontal surfaces, which difficult the drainage of the condensation liquid that drips from the windows due to gravity. In Figure 4a, a schematic drawing of this problem is shown.

The retained liquid acts as the electrolyte for the corrosion reaction, which combined with the low quality of the protective coating, causes deterioration in the horizontal surfaces. The corrosion damage caused by this phenomenon can be observed in the majority of the structure (Figure 4b).

Figure 4 (a, b). Corrosion issues in the horizontal surfaces

This design mistake cannot be solved geometrically without creating a great alteration in the initial design. For this reason, this complication will be addressed only with the previously mentioned long-lasting, high-quality, coating protocol.

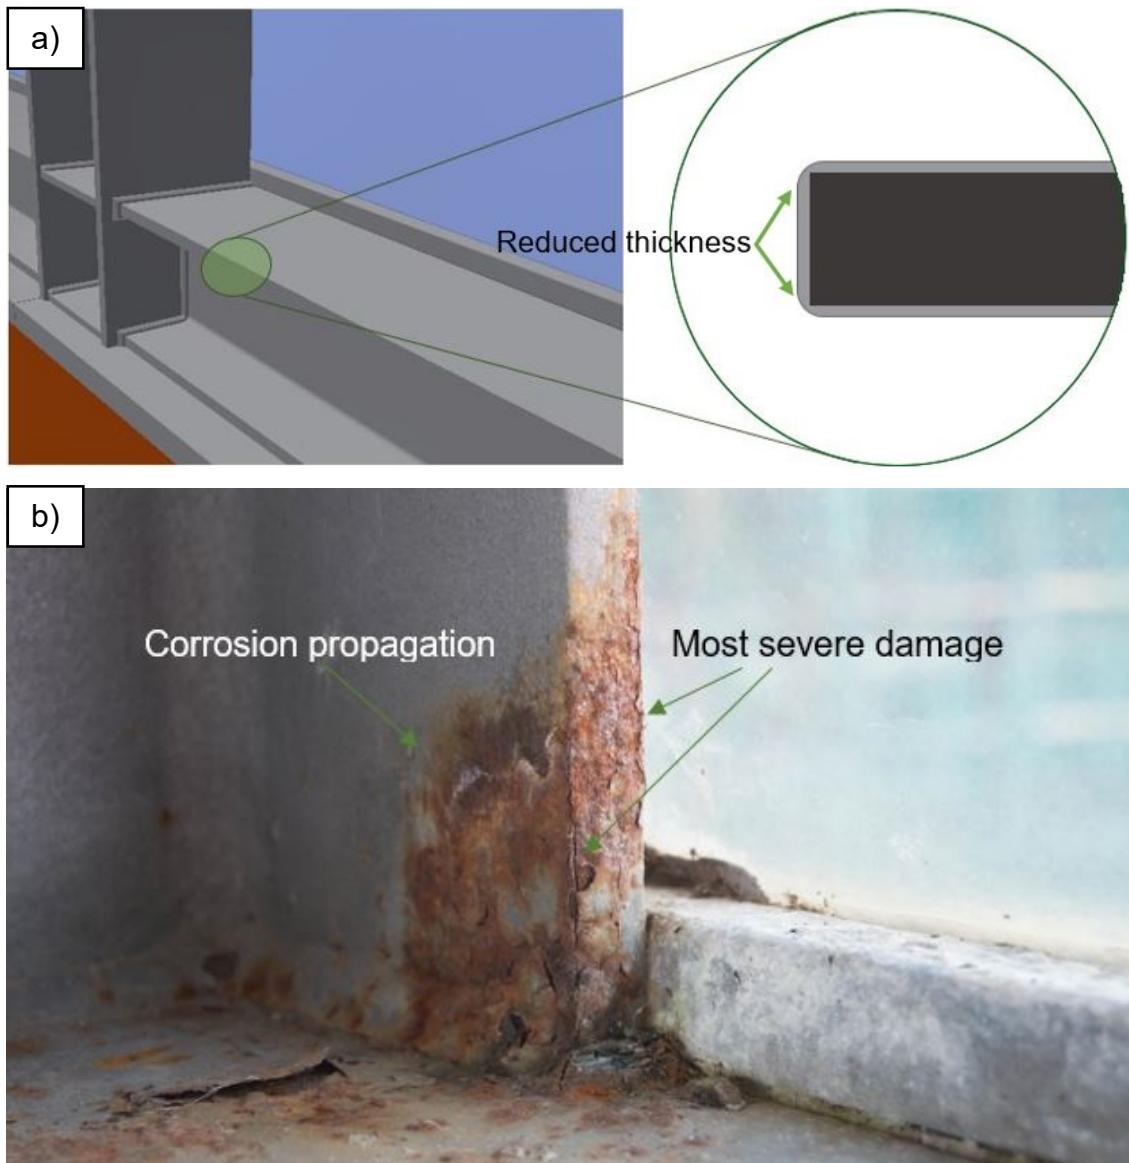
The geometry of the HEB structural steel beams presents 90° edges that provoke discontinuities of the coating thickness as shown in Figure 5a because, during application, the liquefied paint tends to flow away from the acute angles due to gravity. This design mistake affects both horizontal and vertical beam elements.

As a result of this, the 90° edges of the beam act as a weak spot in which the corrosion process tends to start. Figure 5b illustrates the severe damage caused in one of the vertical beam edges of the structure.

Figure 5 (a, b). Corrosion issues in the beam 90° edges

In Figure 5b, it can be appreciated that the most severe damage is localized in the 90° edge of the beam. Moreover, a propagation pattern can be observed, which means that the corrosion process began at the 90° edge and then proceeded to affect the plain surface of the beam.

All of the exposed 90° edges of the beams should be mechanized with a 2 mm radius. This action guarantees that a uniform coating layer can be formed during the application and drying processes, as can be seen in Figure 12, thus providing the best possible anticorrosive protection.

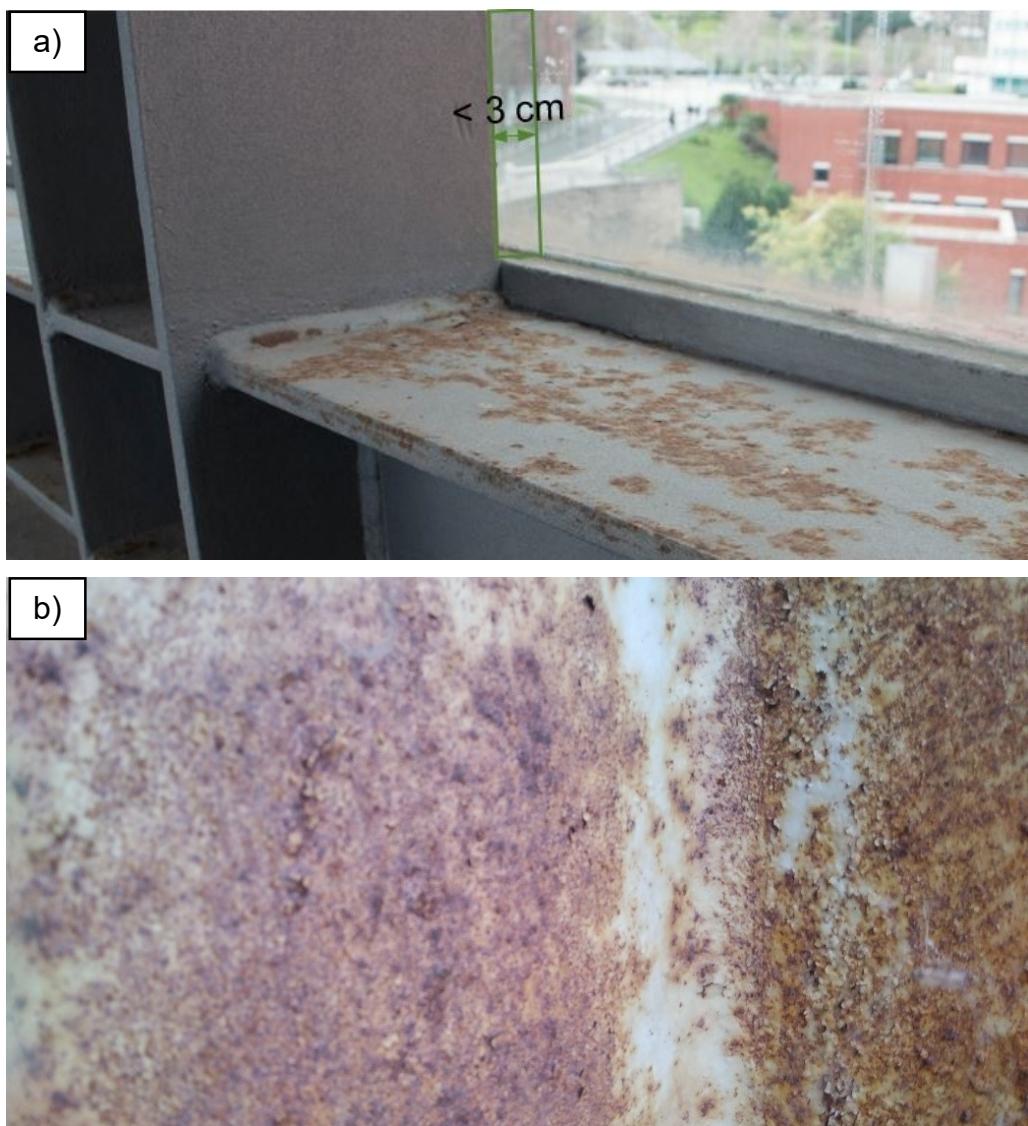
The part of the vertical beams that faces the windows is not accessible for inspection nor maintenance, as the space between the beams and the windows is smaller than 3 centimetres (Figure 6a).

The main problem of this design mistake is that it causes the illusion that the vertical beams of the structure are not affected by corrosion, as the visible part from inside the footbridge appears to be in good condition. Figure 6b shows the posterior part of one of the vertical beams, taken by introducing a camera in the reduced space between the beam and the window, where an advanced state of corrosion can be observed.

Figure 6 (a, b). Corrosion issues in the posterior part of the vertical beams

As with the horizontal surfaces, this problem is not solved by modifying the geometry. The corrosion protection of the areas with lack of access also relies on the proposed coating protocol.

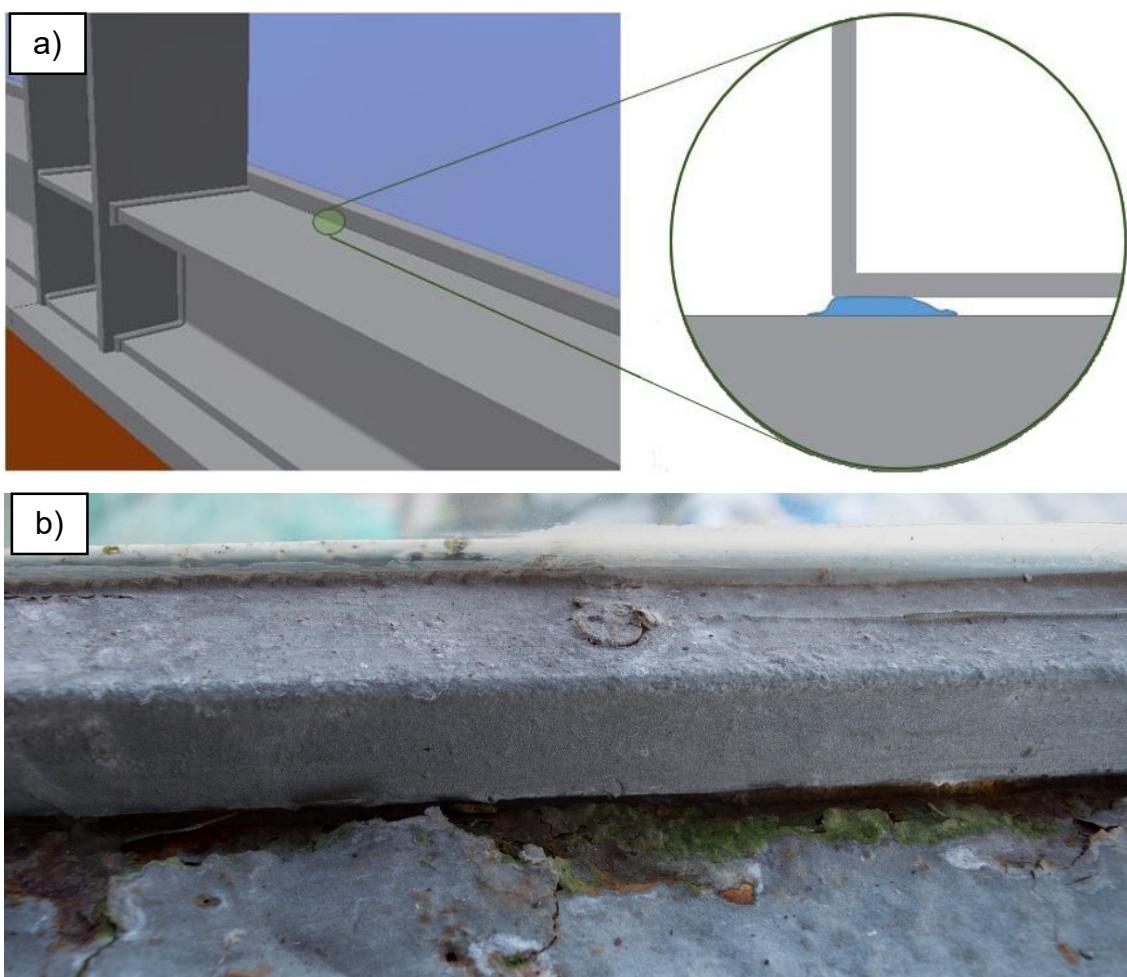
The structure presents crevices, especially in the junction between the beams and the windows steel frames. These crevices provoke retentions of water and moisture (Figure 7a), as they allow liquid penetration and difficult drainage due to the fact that the natural airflow is reduced inside the crevice. Moreover, as the protective paint coating was applied after assembly, the protective layer is not uniform inside the crevice, as the paint cannot penetrate evenly.

The retained water accentuates the crevice corrosion that inherently occurs when these geometrical complications are present. Furthermore, when the corrosion process starts inside the crevice, it tends to propagate towards the rest of the beam. This phenomenon has created important damage, as shown in Figure 7b.

Figure 7 (a, b). Corrosion issues in the crevices

All the crevices of the structure should be sealed with a high-quality mono-component adhesive with high mechanical performance (Figure 13). This option has been chosen over continuous welding due to the fact that the window frame perimeter cannot be welded as it needs to have a certain movement freedom in order to absorb the thermal expansions.

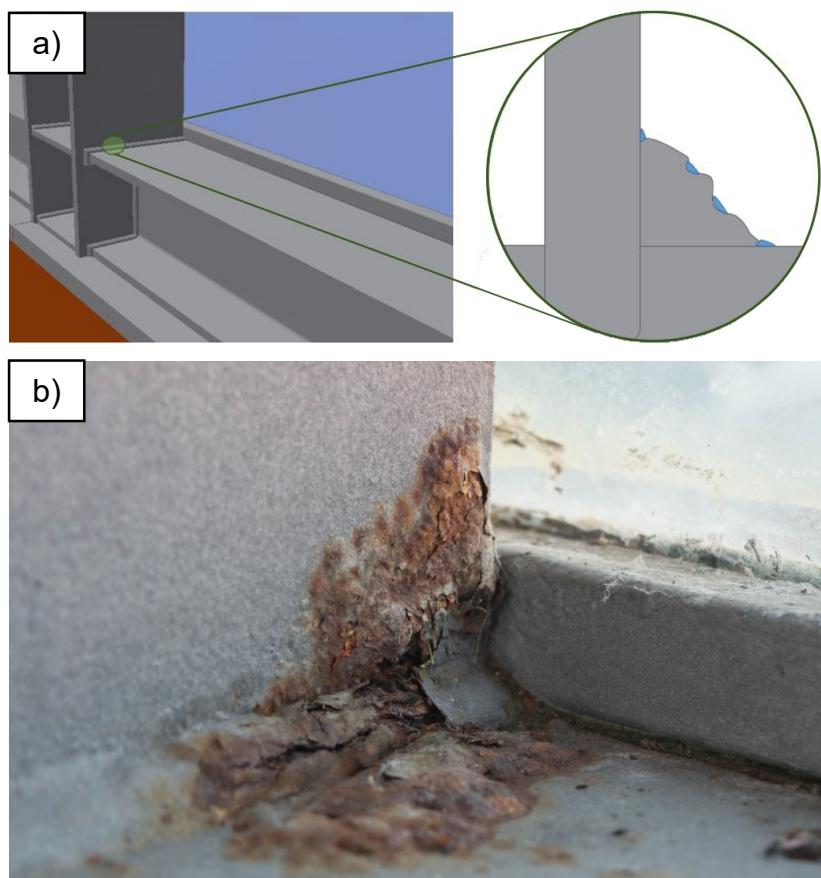
- Firstly, the weld beads introduce geometrical discontinuity on the surface, as they add additional material. Moreover, weld beads often have porous zones (Figure 8a) that allow for liquid retention and favour the formation of not uniform coating layers.
- On the other hand, welding processes signify that the material suffers high thermal stress and, if the cooling process is not controlled, the internal structure of the welded metal is distorted, facilitating the corrosion initiation and propagation.

The effect of the combination of the aforementioned processes can be observed in the footbridge structure, where the weld beads show evident signs of corrosion, as can be observed in Figure 8b.

Figure 8 (a, b). Corrosion issues in the weld beads

All of the welds of the structure should be continuous and mechanized after application if needed to provide a homogeneous surface (Figure 14) without any significant pores, addition

material accumulations nor weld projections, so that a continuous protective coating film can be formed and dirt and water retentions are less likely to occur.

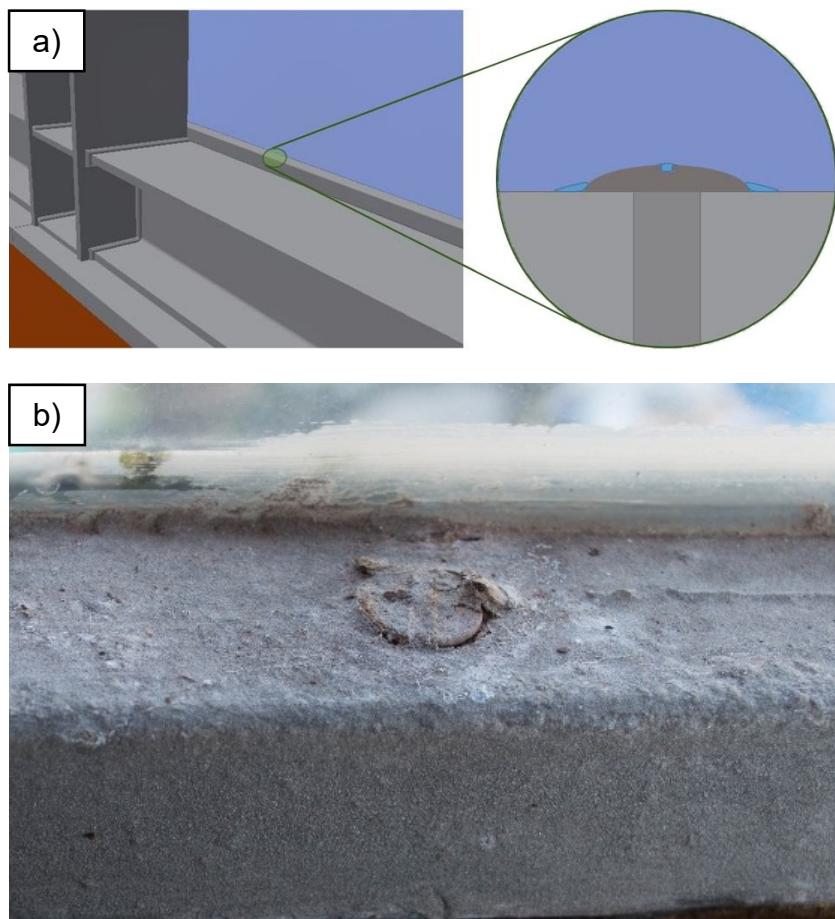
To realize the junction between the structural beams and the window frames, a joining method via bolts was selected. Bolt heads create a geometrical discontinuities in the structure while favouring galvanic corrosion if the material of the joined metals and the bolt is not exactly the same composition wise.

The geometrical discontinuities generate water and dirt retentions (Figure 9a), while hindering the formation of a uniform protective layer. Figure 9b illustrates the discontinuities previously mentioned. Notwithstanding, this design mistake has not shown yet obvious signs of corrosion. Most likely, the root cause for the lack of corrosion products in these points, is that the bolt geometry and material had been properly selected, creating a tight seal and impeding galvanic corrosion.

Figure 9 (a, b). Corrosion issues around the bolts

The bolted joint method is maintained, because even with the actual advanced state of corrosion of the structure, the periphery of the bolts does not show corrosion signs. However, certain points need to be considered:

- The bolt size needs to be selected accordingly to provide a tight seal without protruding over the jointed parts
- The bolt material composition needs to be the same as the one of the joined metals
- The correct installation of the bolts has to be visually verified before the beginning of the coating protocol
