# Corrosion Damage Assessment and Numerical Modeling Assisted Design of the Cathodic Protection for a Dry Dock Serving Large Vessels in the Gulf of Mexico

We report the engineering work and numerical modeling for the complete diagnosis and refurbishing of the cathodic protection system for the largest dry dock in Mexico. The dry dock is located in the shore of the Gulf of Mexico at Tampico City and it is capable of serving ships as long as 250 meters. South bound this dry dock is the largest ship repair facility all the Atlantic coast until Panama. We report results of an overall diagnosis of corrosion damages of sheet piling, reinforced concrete, and pilings. Also we report an overall surface and underwater polarized potential measurement mappings. The cathodic protection of the dry dock components was fully redesigned. A complete new design was proposed to accomplish a sound distribution of impressed current anodes all along the steel sheet pilings, and the "dolphin" pilings. At the "dolphin" a new design for the anode support and its protection was developed. One of its main features of the anode supports is the allowance of 90° of bending freedom so the anodes supports could m

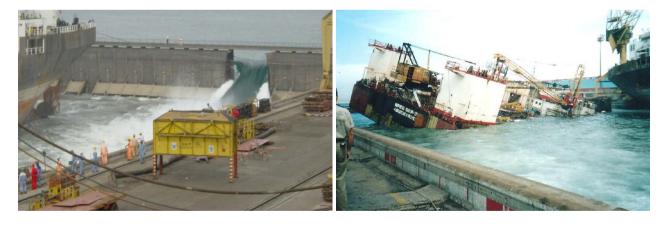
The Lock Gate is an extremely important element of the dry dock. When the Gate is closed, it must maintain the dock dry by resisting a high pressure generated by the water from the river. A Lock Gate failure could cause a non-controlled flooding of the dry dock, just like in Dubai on March 27 of 2002 (figure 2), when the lock gate of the dry dock failed to contain the water causing vast material damages and loss of life of more than 20 people that were performing maintenance works on 5 docked ships[2].

Figure 2. Lock Gate failure on March 27 of 2002 in Dubai.
