ROAD FAILURES AND RELATED HAZARDS ALONG THE BLUE RIDGE
PARKWAY, NORTH CAROLINA

A thesis submitted to the faculty of
San Francisco State University
In partial fulfillment of
The requirements for
The degree

Master of Science
In
Applied Geosciences

Robert Joseph Sas, Jr.

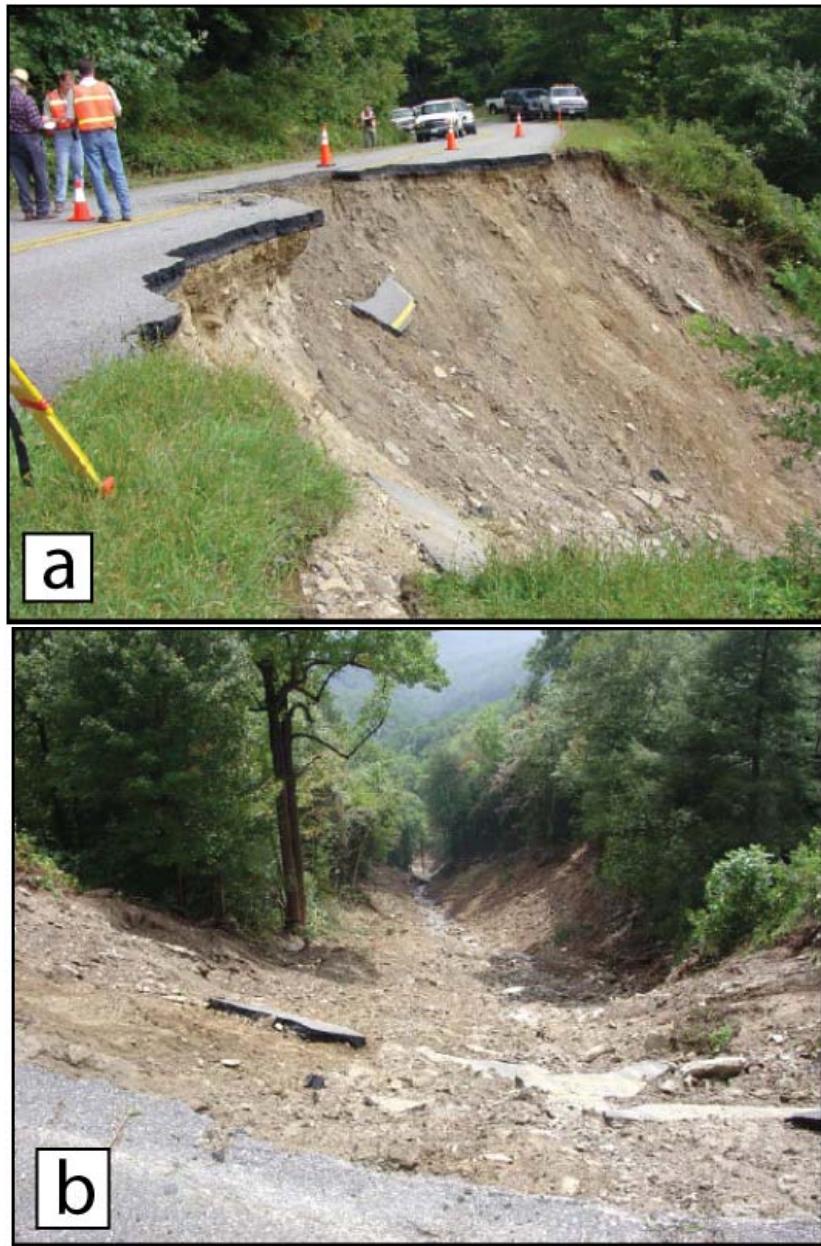
The failure around milepost 348.8 (Fig. 1) was a more substantial slope movement in that its eroded sediment entered a steep mountain tributary and traveled over a mile from its source (debris flow tracks shown in Fig. 2). The event likely started as a rotational slide on a planar fill-slope that translated to a debris flow (Fig. FS1). Although the volume of material originating from the fill was modest, the momentum carried by the mass allowed the continual accumulation of natural debris stored in the stream channels below, thus allowing the flow to travel nearly two miles. The failure also affected an adjacent overlook. The main scarp displays an arcuate pattern and extends a

full two feet into the southbound lane. The failure slope was steep, ranging from 45° to 67° (Federal Highway Administration, 2004).

Figure 1. Road-fill failure (a) and debris flow (b) at milepost 348.8, Blue Ridge Parkway.
Photographs courtesy of Federal Highway Administration.

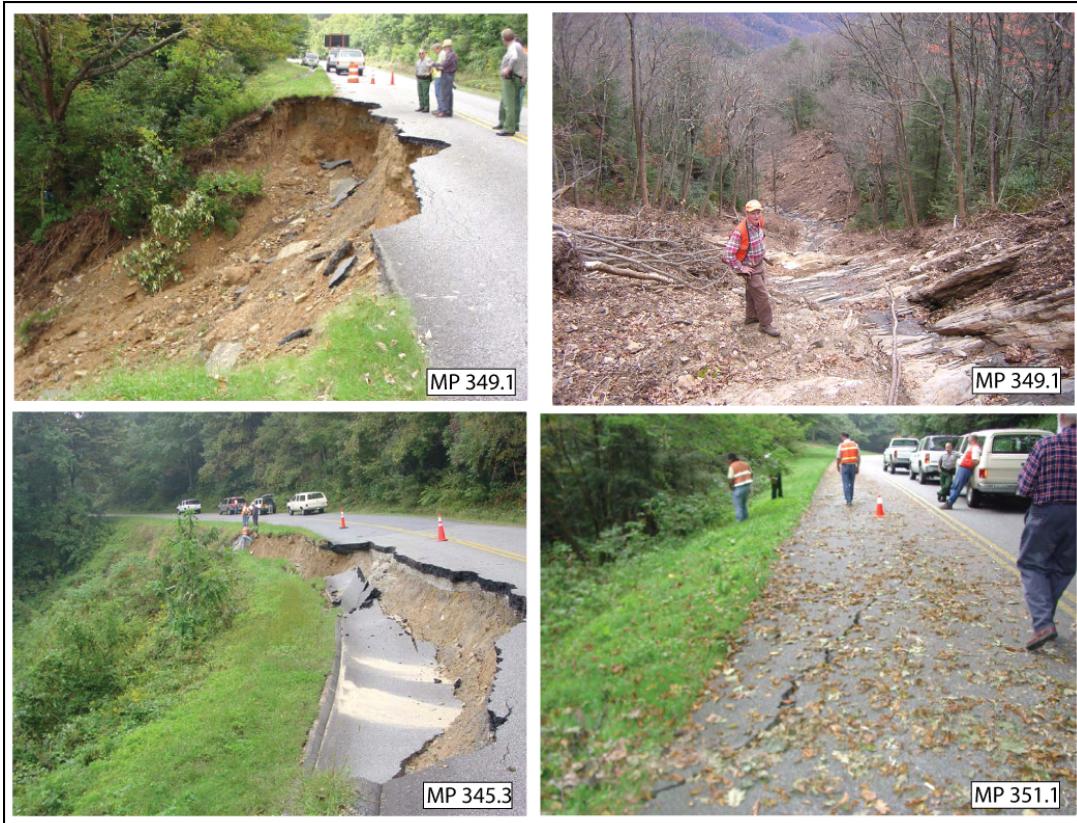
The four road-fill failures in the study area triggered by Hurricane Frances occurred along a six mile stretch from MP 345.3 to 351.1 (Fig. 5; Fig. 1), just southeast of the peak of Mount Mitchell (Latham, 2006). Two other fill-failures previous to 2004 were mapped in the field based on clear signs of reconstruction/mitigation (i.e., segment of newer pavement, rock gabions, and modern drainage structures); however no other specific information is available for these sites.

Figure 5. Photographs of road-fill failures and downslope impacts, shown by milepost (MP). Photographs courtesy of North Carolina Geological Survey and Federal Highway Administration.

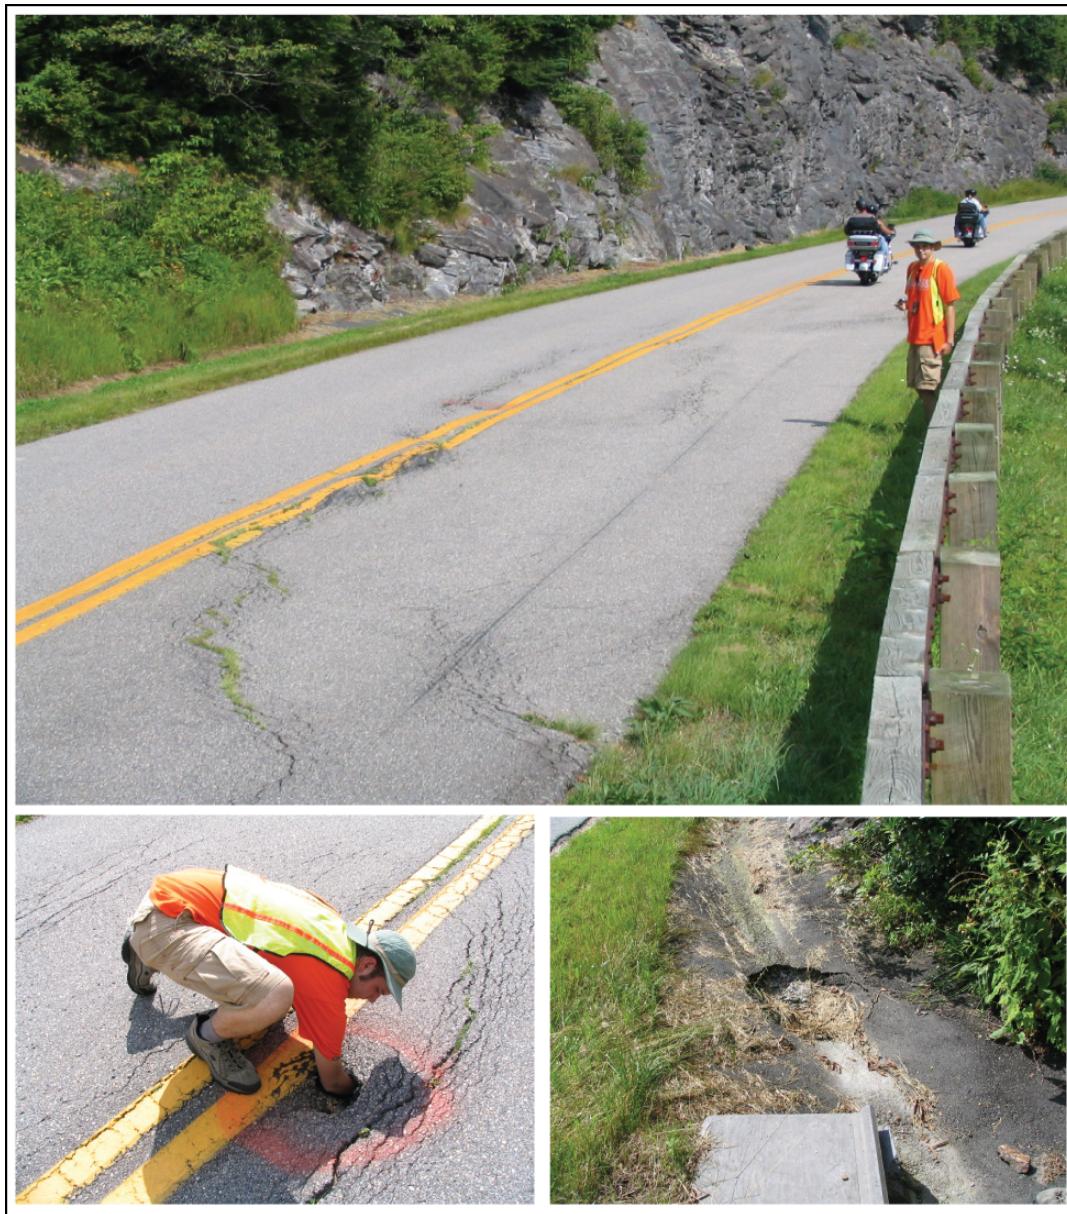
Degraded and failing culverts were observed in the field and were a contributing factor in road-fill failure (Fig. 10). One difficulty in observation was inability to see beyond the first few meters of pipe even with the aid of a high-powered flashlight. Nonetheless, locations of undermined and collapsed pavement often coincided with the orientation of culverts beneath the road surface.

Figure 10. Photograph of collapsed, undermined pavement indicating fill instability.

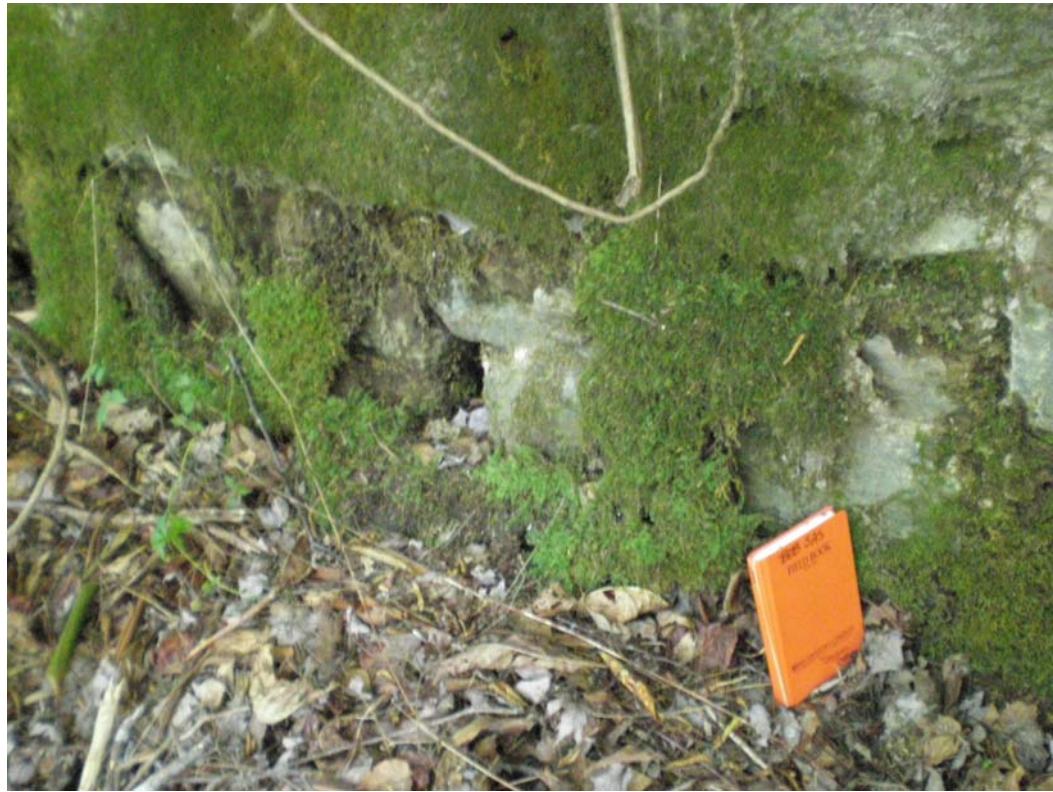
thickness of the moss growing on a retaining wall built to stabilize the toe of a fillslope provides evidence of the undesirable drainage condition of this fill-slope (Fig. 9). The moss detached from the wall due to flowing water, as evidenced by calcite mineralization. Linear discontinuities observed in moss growing on the wall face provided evidence that the concrete-grout that adheres individual rock cobbles together had degraded. As the minerals in the concrete-grout weather through time, the permeability increases leading to increased seepage. Additional observational evidence of seepage included small, dripstone and stalactitic structures of precipitating minerals, predominately calcite (Fig. 12).

Figure 11. Biological and mineralogical evidence of prolonged, undesirable drainage condition of fill-slope (May 2007).

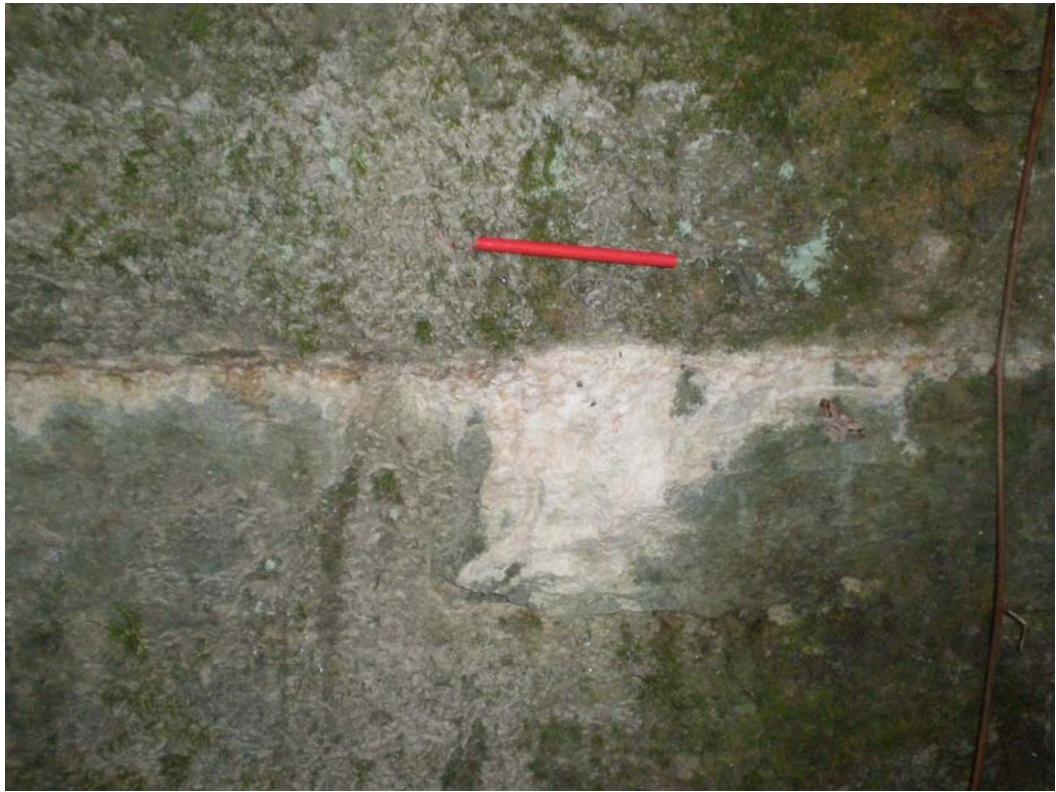
The calcite mineralization process is complex considering the variable mineral content of shallow groundwater percolating through soil and in-situ rocks, in addition to minerals weathered from the concrete-grout and surrounding chlorite-mica schist cobbles in the wall. Went (1969) also suggests that this type of secondary-mineralization may have dependence on biological factors, such as fungal growth. Growth rates for calcium carbonate stalactites with similar formation conditions and issuing from similar materials, including concrete and limestone, range from ~0.02 to 1 in./yr. (Johnston, 1930; Ellis, 1931; Ver Steeg, 1932; Richards, 1932). A factor complicating comparison to these studies is the presence of vegetation and runoff to cause significantly different hydrologic conditions around the fill-slope compared to the hydrology of caves and bridges (Ver

Figure 12. Dripstone on retaining wall resulted from seepage through concrete-grout (May 2007).

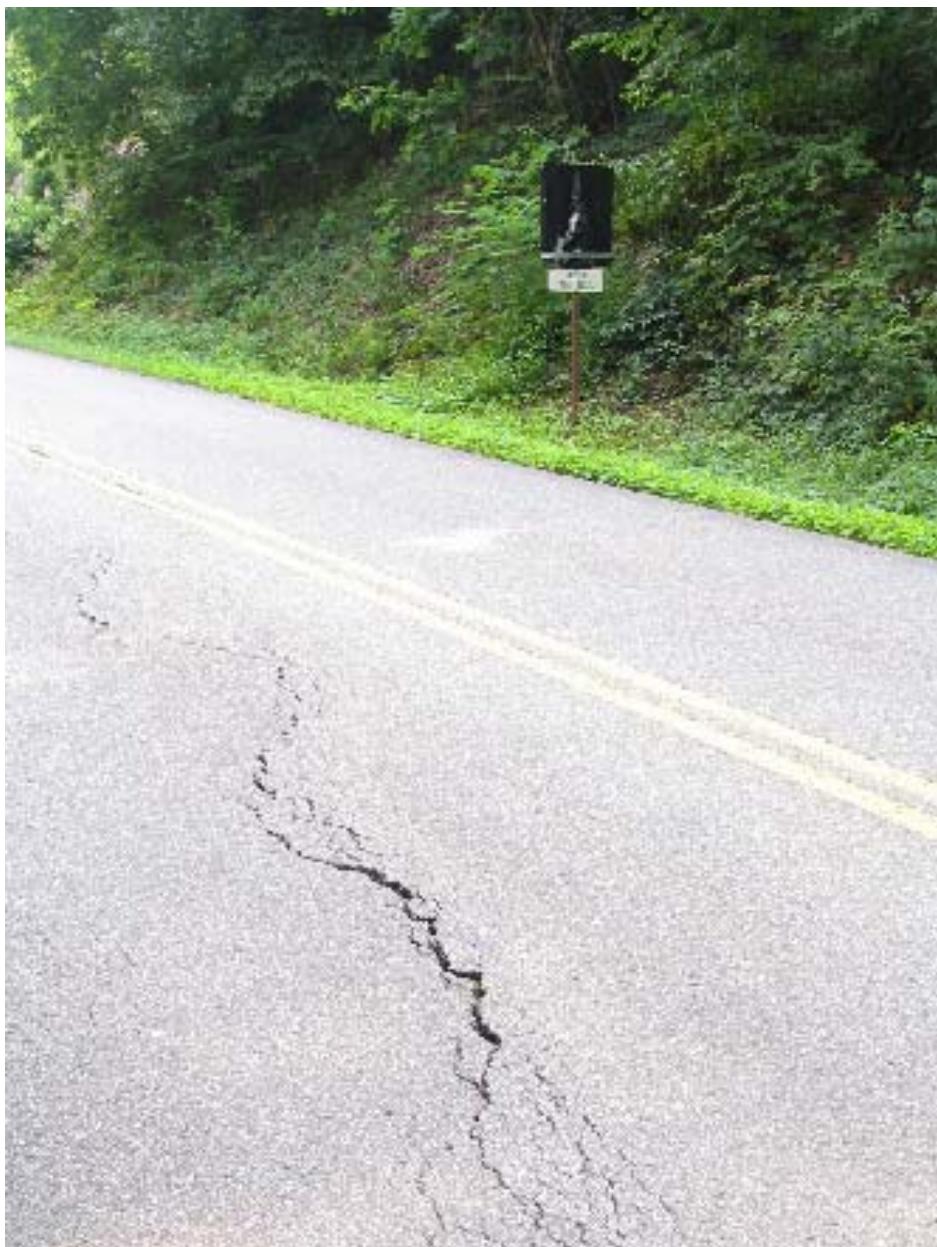
Site 14 – Arcuate form pavement crack shows lateral and vertical displacement.

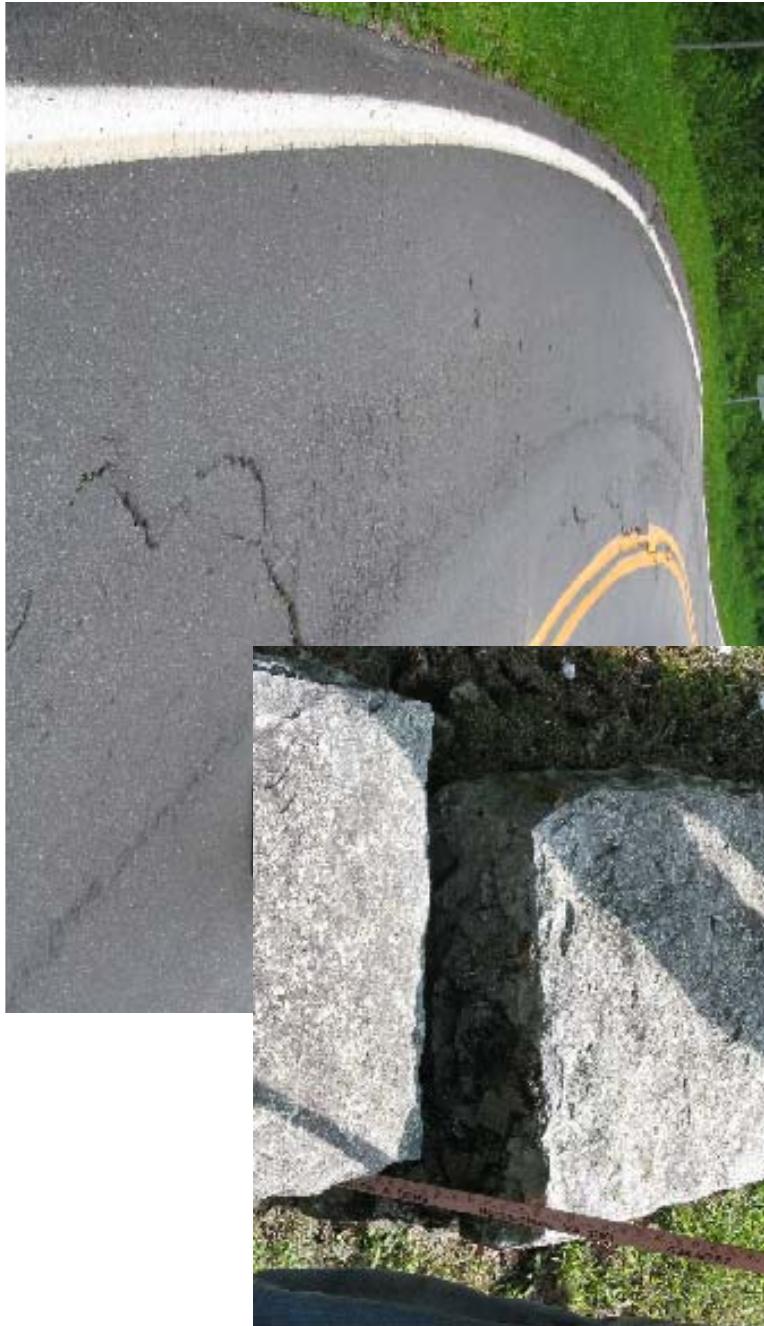
Site 15 – Pavement cracks are sign of reactivation of repaired fill-slope in 2004. Wall-displacement occurred during original failure.

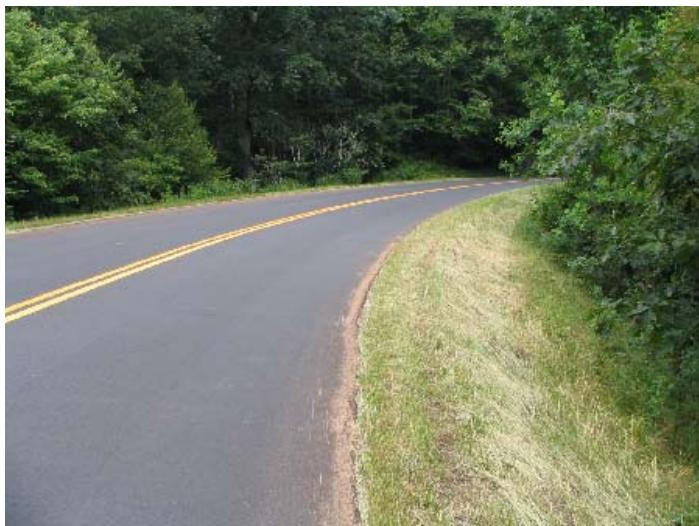
Site 17 – Failure repair previous to September 2004

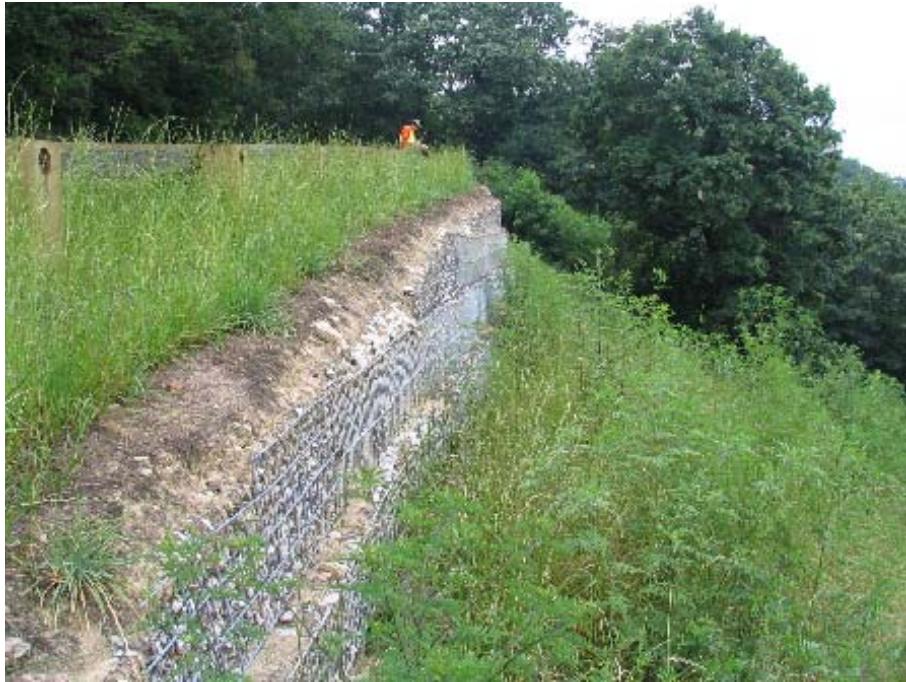
Site 18 – Rock gabion used to mitigate failure at MP 348.8
