# DEPARTMENT OF CIVIL ENGINEERING

## A MINI PROJECT REPORT ON TRAFFIC VOLUME SURVEY & ROAD SAFETY ANALYSIS

*A Case Study of IIT (ISM) Main Gate*

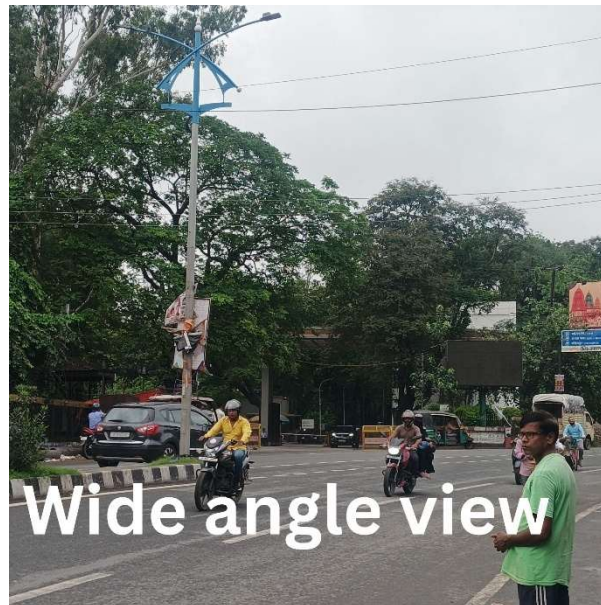
**Figure 4: Overall View of Study Area**

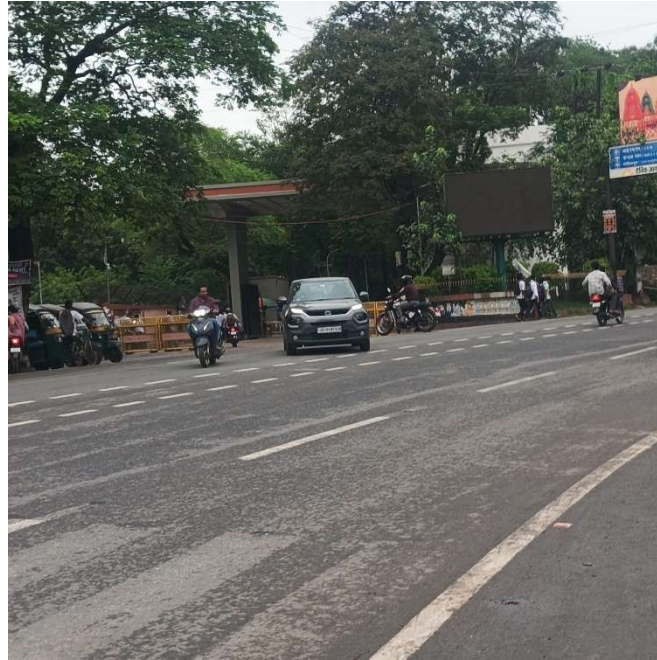
- Carriageway: paved, two-lane two-way, with visible wear in sections.
- Signage: a mix of regulatory and directional signs, some faded or missing.
- Street lighting: functional along the main stretch, sparse near the junction.
- Drainage: covered drains along most of the stretch, with isolated open sections.
- Speed breakers: present near the main gate, partially worn.

**Figure 5: Existing Road Geometry**

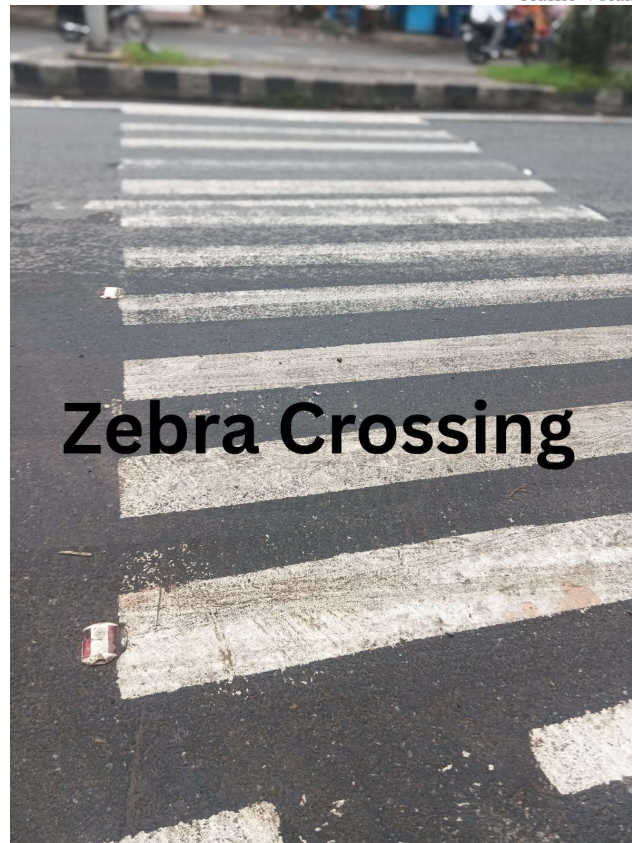
**Figure 7: Zebra Crossing**

| Safety Feature | Observed Status | Remarks |
|---|---|---|
| Zebra Crossing | faded | Present near main gate |

- Install a clearly marked zebra crossing at the main pedestrian conflict point.
- Repaint faded lane markings and provide edge lines to improve lane discipline.
- Install convex mirrors at sight-restricted points to improve visibility.
- Install warning and regulatory signage (speed limit, no-parking zones).
- Increase traffic police presence during identified peak hours (8:30–8:45 AM and 5:30–5:45 PM).

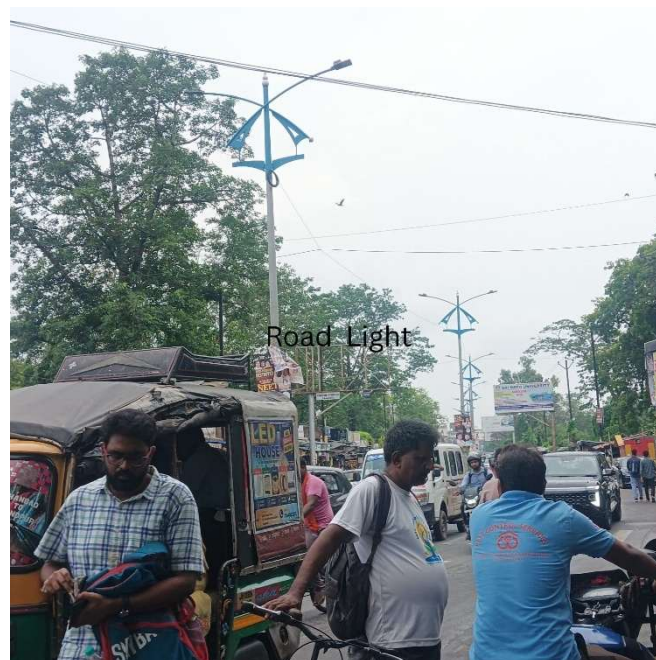
**Figure 8: Street Lighting Arrangement**

| Safety Feature | Observed Status | Remarks |
|---|---|---|
| Street Lighting | Functional, sparse near junction | Additional poles recommended |

- Improve street lighting along sections identified as inadequately lit.
- Provide a continuous, obstruction-free footpath for pedestrians.
- Designate formal parking bays to discourage illegal roadside parking.
- Relocate or regulate street vendors encroaching on the carriageway.

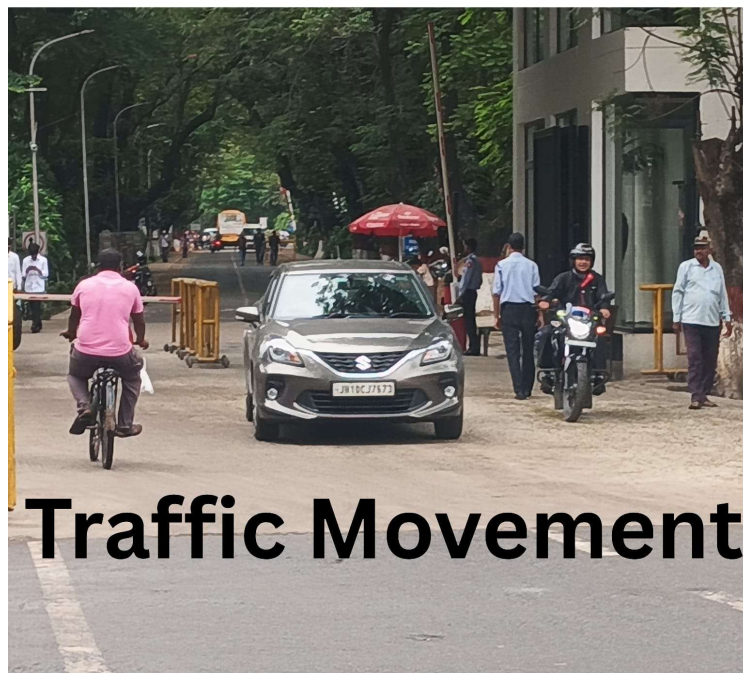
**Figure 9: Traffic Movement During Morning Peak Hour**

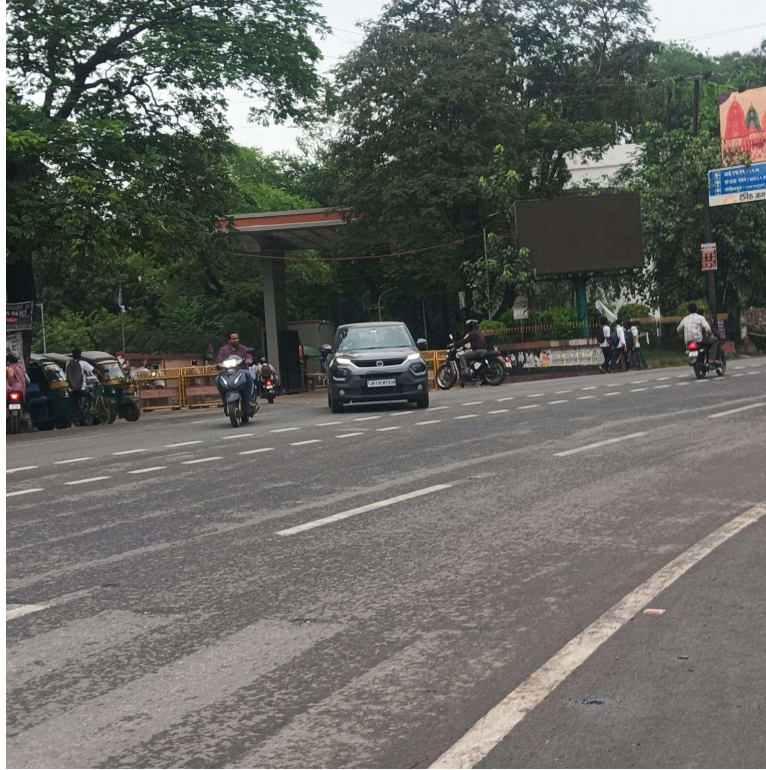
**Figure 10: Traffic Movement During Evening Peak Hour**

The dominance of two-wheelers combined with the absence of dedicated lane discipline contributes significantly to the observed congestion, as two-wheelers frequently weave between larger vehicles, reducing effective lane capacity. The presence of on-street parking and roadside encroachment further narrows the usable carriageway width, compounding delays during peak periods.

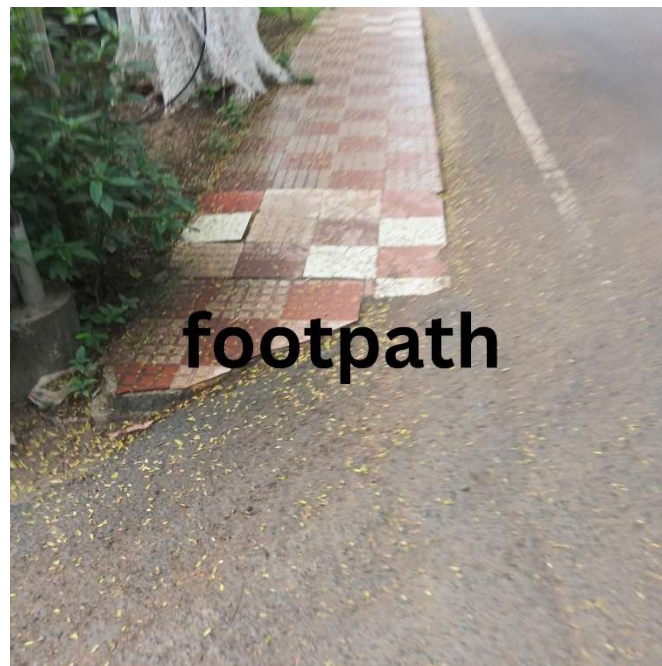
**Figure 12: Footpath Condition**

| Safety Feature | Observed Status | Remarks |
|---|---|---|
| Footpath | Discontinuous / encroached | Needs continuous, obstruction-free path |

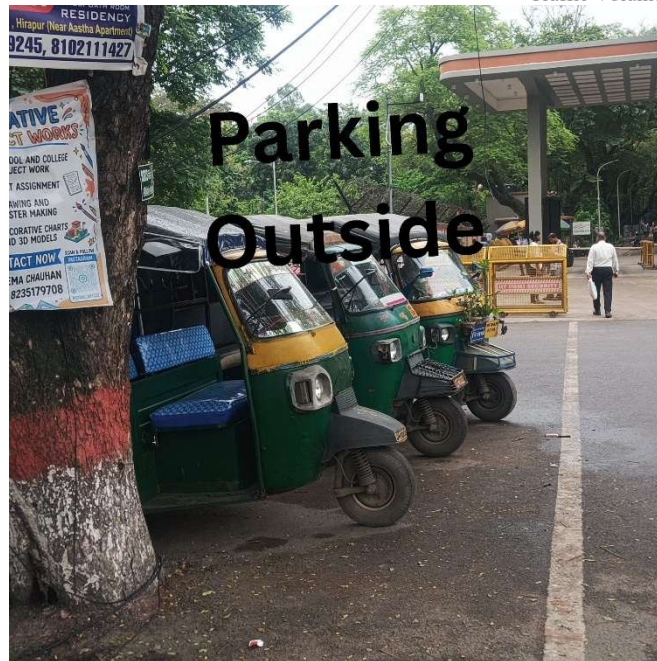
**Figure 13: Roadside / Illegal Parking**

| Safety Feature | Observed Status | Remarks |
|---|---|---|
| Illegal Parking | Observed on both sides | Enforcement and designated bays needed |
