Title:	Flag Poles in front of library	
Description	The Flag Poles in grassed area in front of the Library Car Park need cleaning and/or	
	maintenance.	
	Rope on one pole has now snapped.	
Owner:	BPC	
Area:	Maintenance	
Status	BVS has given recommended action report to BPC	
Last Updated:	14/04/2023

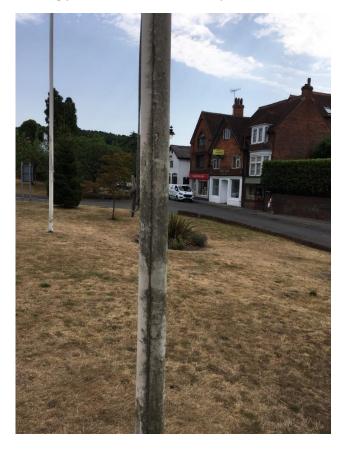
The flag poles in front of the library need to be cleaned and possibly require some maintenance.

12/04/2023: Halyard on flagpole nearest to the fir tree has snapped. It was also noted that the same pole is leaning.

- Leaning Pole:
  - The lean on the pole that is closer to the fir tree is due to movement of the concrete base. The hinged base plate is in good order.

- o Recommendation (having lowered/removed flagpole) is to:
    - Excavate around the current concrete base, say 1ft all round.
    - Level the baseplate.

- Infill with concrete
  - o It may be possible to correct the lean by 'shimming' the baseplate but even if practicable, is not a good long-term solution as the current concrete base may well move again.
