Title:	Flag Poles in front of library		
Description	The Flag Poles in grassed area in front of the Library Car Park need cleaning and/or		
	maintenance.		
	Rope on one pole has now snapped.		
Owner:	BPC		
Area:	Maintenance		
Status	Flagpoles now restrung in time for Coronation		
Last Updated:	29/04/2023

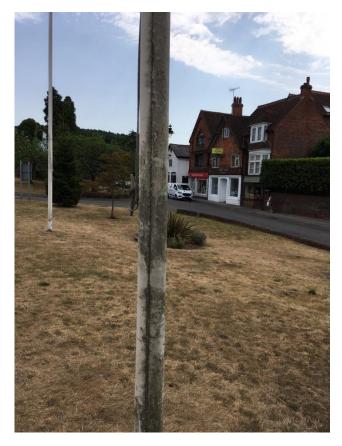
The flag poles in front of the library need to be cleaned and possibly require some maintenance.

12/04/2023: Halyard on flagpole nearest to the fir tree has snapped. It was also noted that the same pole is leaning.

- Leaning Pole:
  - The lean on the pole that is closer to the fir tree is due to movement of the concrete base. The hinged base plate is in good order.

29/04/2023: BVS with help from the Parish Clerk has restrung the flag poles in time for the Coronation. The leaning pole still needs to be corrected.

- o Recommendation (having lowered/removed flagpole) is to:
    - Excavate around the current concrete base, say 1ft all round.
    - Level the baseplate.

- Infill with concrete
  - o It may be possible to correct the lean by 'shimming' the baseplate but even if practicable, is not a good long-term solution as the current concrete base may well move again.
