Project Miura

Final Science Report

Colorado Space Grant Consortium

December 8, 2017

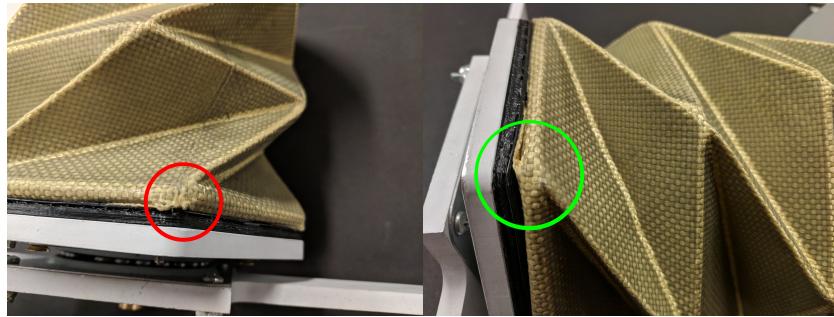
Figure 39: Images taken post flight showing reference tear in red. A normal, non-damaged corner is shown highlighted in green for comparison.

Under visual inspection, without the aid of magnifying lenses, the material had no visible failures. As a one square millimeter hole or tear would be noticeable by the human eye, this means that the payload material itself successfully completed the mission and is viable for a reusable, folding, extendable structure.
