# The present state of the site of Behbeit el-Hagar

#### Christine Favard-Meeks

### The site today

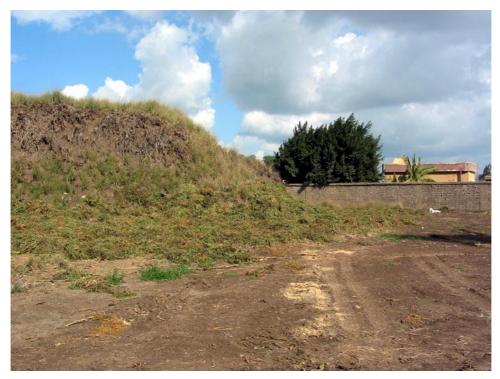
- At the entrance, on the south, the ancient wall on the left is outside the modern one, in the background (Fig. 1).
- On the eastern side, a rice plantation has replaced wheat fields. The temple behind the modern wall is now completely surrounded by housing (Fig. 2).
- On the western side, housing has developed on archaeological ground (Fig. 3).

Fig. 1 Area of the entrance to the temple.

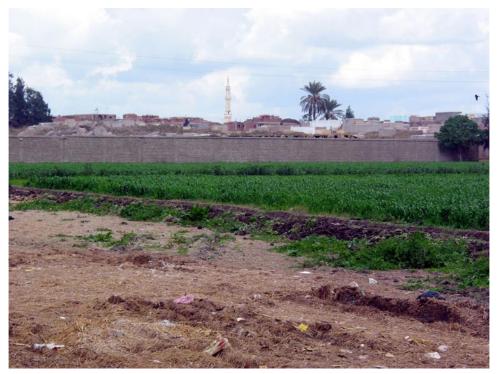
Fig. 2 Housing surrounding the temple.

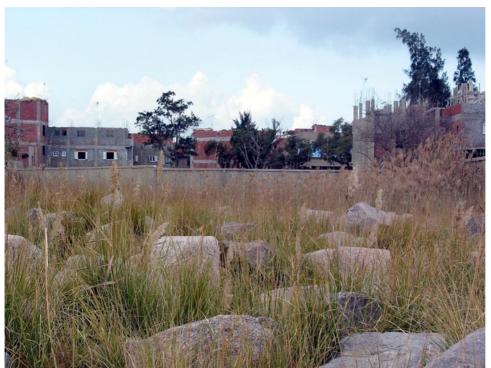
Fig. 3 Housing on archaeological ground to the west of the temple.

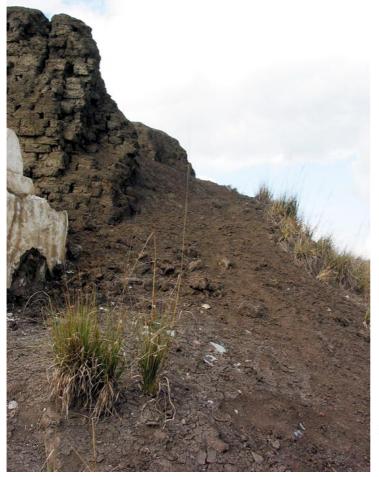
More than 50% of the archaeological ground has now been lost.<sup>3</sup> The ancient remains, outside the wall, are in danger. Fig. 4 shows the outer face of the northern wall.

Fig. 4 The outer face of the northern wall of the temple.

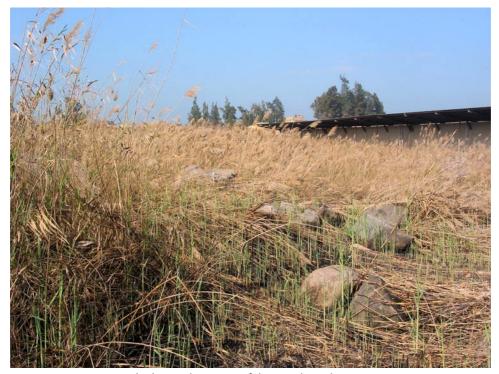
Moreover, other dangers have appeared within the modern enclosure. The nearby rice plantations maintain a permanent dampness which favours the development of a luxuriant vegetation (several types of reeds) whose rhizomes damage the archaeological ground. The removal of this vegetation is the first task which needs to be undertaken before starting the work. The vegetation on the North side is shown in Fig. 5, and the salt inside the hypostyle hall appears in Fig. 6.

Fig. 5 Vegetation inside the northern part of the temple enclosure.

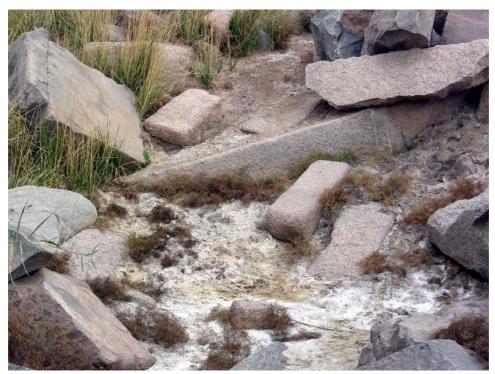
Fig. 6 Salt inside the hypostyle hall.

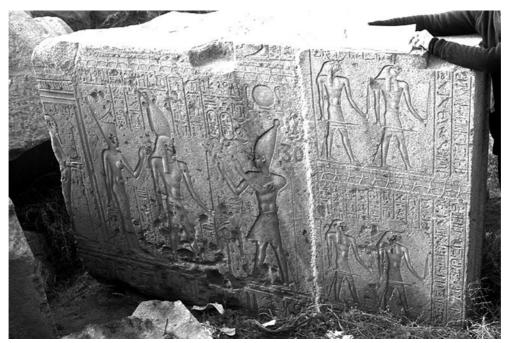
Fig. 7 Block with falcon and bull guardians in 1977.

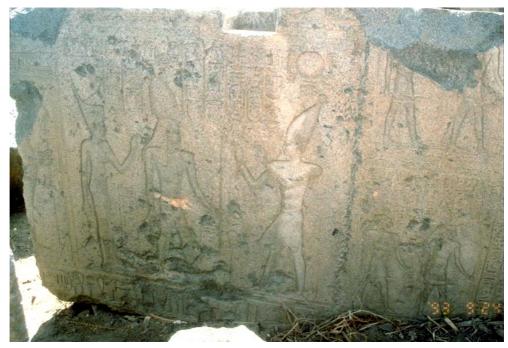
- As quite a few relief fragments from blocks intact in 1977 have been on auction sale since 1993, I gave files to the SCA which enabled their provenance to be established. This relates to the blocks which have been damaged (the heads have been cut off) since the 1977 photographic survey. See below Figs 7–12. I thank the Supreme Council of Antiquities who granted me the authorization, in January 2002, for returning to the site. I am most grateful to Prof. Dr. Gaballa A. Gaballa, then Principal Secretary of the SCA and Dr. Mohamed Abd-el Maksoud, General Director of the Department for Egyptian Antiquities of the Delta and Sinai, for the help they have thus given me. The SCA has subsequently been successful in retrieving some of the blocks, see, for example, Al Ahram Weekly 4–10 July 2002, no, 593, online at http://www.ahram.org.eg/weekly/2002/593/hr1.htm. Lastly I thank Nigel Strudwick for assistance in editing this article.

It would be possible in theory to reconstruct the granite ruins of the temple. However, a major difficulty with this is that the granite blocks have suffered from exposure to moisture. The treatment applied in the past few years by the SCA has stopped the progression of the damage, but the reliefs now suffer from other irreversible degradations, as shown by the following examples:

Fig. 8 Block in **Fig.** 7 in 2002.

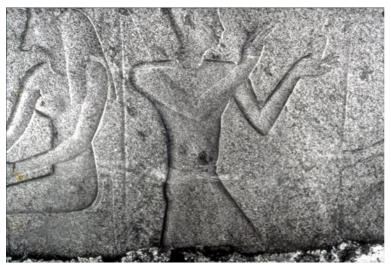
Fig. 9 Block with a cow goddess in 1977.

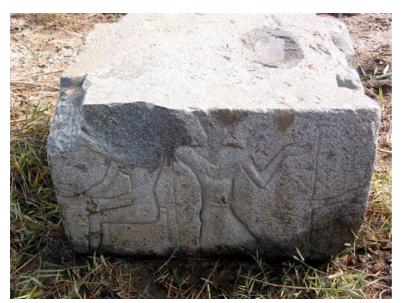
Fig. 10 Block in Fig. 9 in 2002.

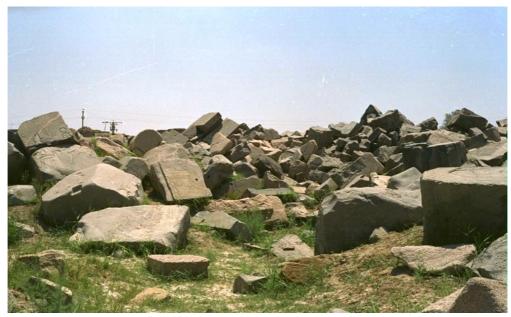
- Fig. 13. The western entrance in 1990. On the left, lying on the ground, the fallen blocks were decorated by Ptolemy III.
- The site must have been abandoned (there are no signs of a Christian presence) and over the centuries the temple has been used as a quarry, which partly explains its present state.

Fig. 13 The western entrance in 1990.

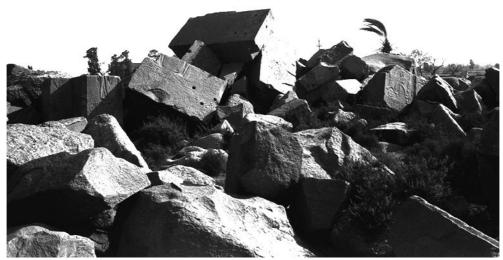
- Fig. 14. In 1977, a general view of the facade of the sanctuary of Isis decorated by Ptolemy II. This photo shows the different levels of destruction of the temple. The left wing could be entirely rebuilt while the right one, so much damaged, can be reconstructed on paper but the blocks on site are so scattered that it is difficult to distinguish them.

Fig. 14 General view of the facade of the sanctuary of Isis in 1977.

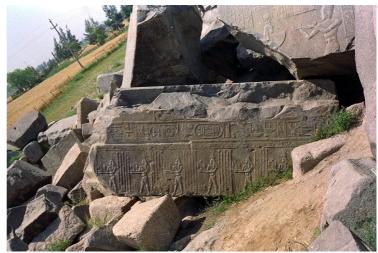
- Fig. 15. In 1990, the left side of Isis sanctuary facade. A pile of blocks.
- Fig. 16. The south wall of the sanctuary of Isis in 1990. Though much damaged, the huge blocks of dark grey granite suggest the same comments as R. Pococke's in 1743: '...it far exceeds anything I ever saw in this way'.

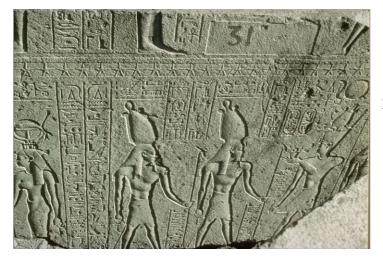
- Fig. 17. From the Osirian chapels on the eastern side, in 1977, a block of the chapel of Osiris Res-wedja showing the second register and part of the third register of the axial wall. On the right side, an offering to a double aspect of Osiris; on the left, Hat-Mehyt.

Fig. 17 A block of the chapel of Osiris Res-wedja in 1977.
