The present state of the site of Behbeit el-Hagar

Christine Favard-Meeks

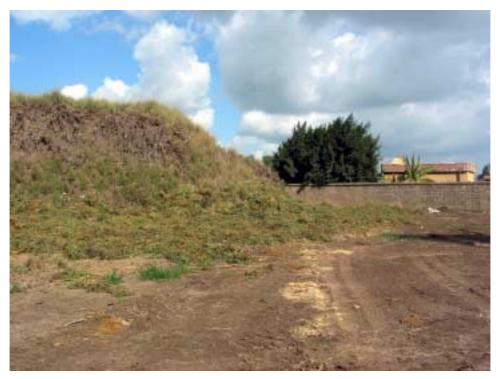
- At the entrance, on the south, the ancient wall on the left is outside the modern one, in the background (Fig. 1).
- On the eastern side, a rice plantation has replaced wheat fields. The temple behind the modern wall is now completely surrounded by housing (Fig. 2).
- On the western side, housing has developed on archaeological ground (Fig. 3).

Fig. 1 Area of the entrance to the temple.

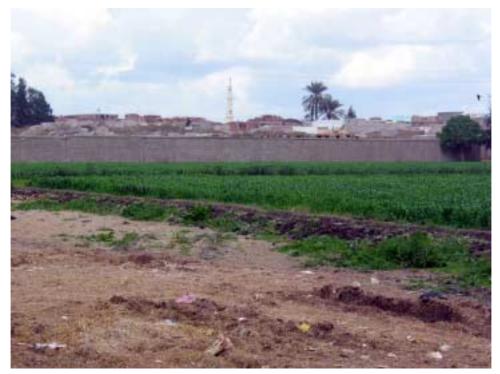
Fig. 2 Housing surrounding the temple.

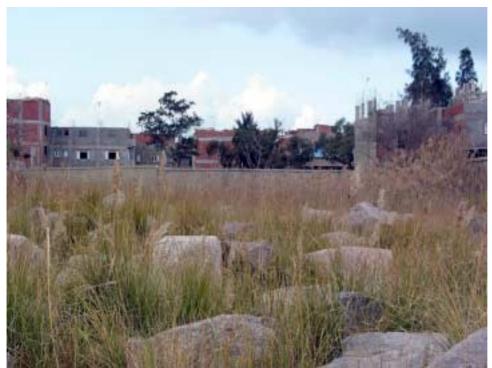
Fig. 3 Housing on archaeological ground to the west of the temple.

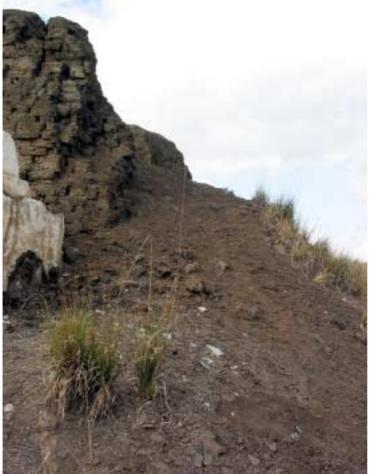
More than 50% of the archaeological ground has now been lost.³ The ancient remains, outside the wall, are in danger. Fig. 4 shows the outer face of the northern wall.

Fig. 4 The outer face of the northern wall of the temple.

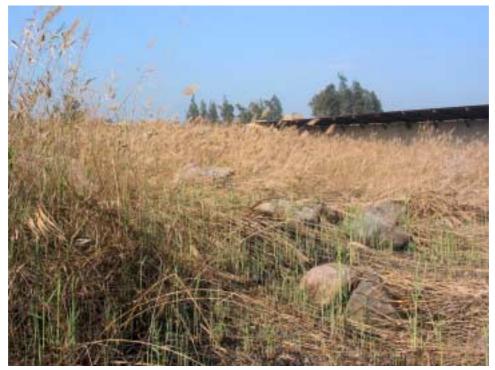
Moreover, other dangers have appeared within the modern enclosure. The nearby rice plantations maintain a permanent dampness which favours the development of a luxuriant vegetation (several types of reeds) whose rhizomes damage the archaeological ground. The removal of this vegetation is the first task which needs to be undertaken before starting the work. The vegetation on the North side is shown in Fig. 5, and the salt inside the hypostyle hall appears in Fig. 6.

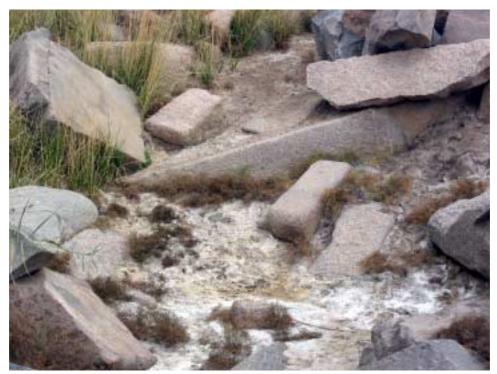
Fig. 6 Salt inside the hypostyle hall.

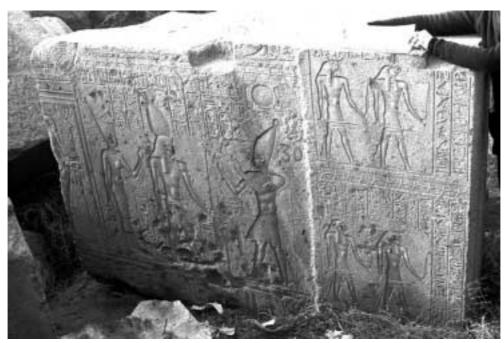
Fig. 7 Block with falcon and bull guardians in 1977.

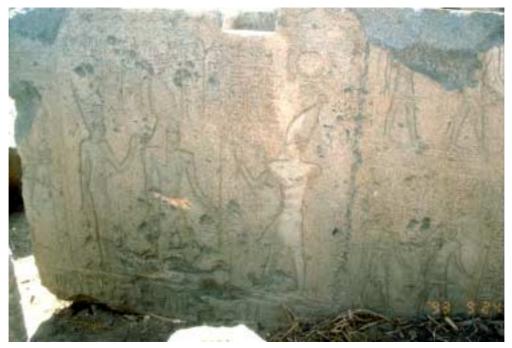
- As quite a few relief fragments from blocks intact in 1977 have been on auction sale since 1993, I gave files to the SCA which enabled their provenance to be established. This relates to the blocks which have been damaged (the heads have been cut off) since the 1977 photographic survey. See below Figs 7–12. I thank the Supreme Council of Antiquities who granted me the authorization, in January 2002, for returning to the site. I am most grateful to Prof. Dr. Gaballa A. Gaballa, then Principal Secretary of the SCA and Dr. Mohamed Abd-el Maksoud, General Director of the Department for Egyptian Antiquities of the Delta and Sinai, for the help they have thus given me. The SCA has subsequently been successful in retrieving some of the blocks, see, for example, Al Ahram Weekly 4–10 July 2002, no, 593, online at http://www.ahram.org.eg/weekly/2002/593/hr1.htm. Lastly I thank Nigel Strudwick for assistance in editing this article.

It would be possible in theory to reconstruct the granite ruins of the temple. However, a major difficulty with this is that the granite blocks have suffered from exposure to moisture. The treatment applied in the past few years by the SCA has stopped the progression of the damage, but the reliefs now suffer from other irreversible degradations, as shown by the following examples:

Fig. 8 Block in **Fig.** 7 in 2002.

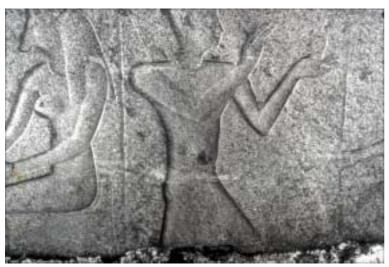
Fig. 9 Block with a cow goddess in 1977.

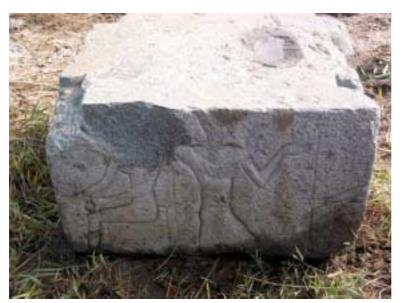
Fig. 10 Block in Fig. 9 in 2002.

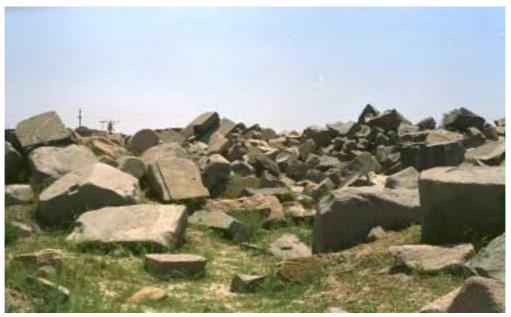
- Fig. 13. The western entrance in 1990. On the left, lying on the ground, the fallen blocks were decorated by Ptolemy III.
- The site must have been abandoned (there are no signs of a Christian presence) and over the centuries the temple has been used as a quarry, which partly explains its present state.

Fig. 13 The western entrance in 1990.

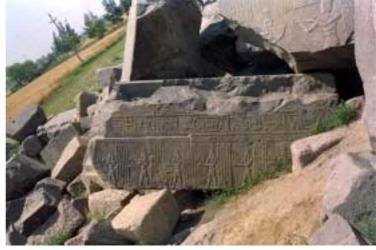
- Fig. 15. In 1990, the left side of Isis sanctuary facade. A pile of blocks.
- Fig. 16. The south wall of the sanctuary of Isis in 1990. Though much damaged, the huge blocks of dark grey granite suggest the same comments as R. Pococke's in 1743: '...it far exceeds anything I ever saw in this way'.

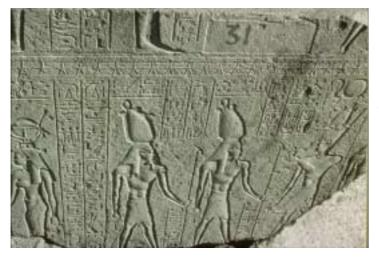
Fig. 17 A block of the chapel of Osiris Res-wedja in 1977.
