Inspection report

Final: JUN23.TCM.2

tikamoon

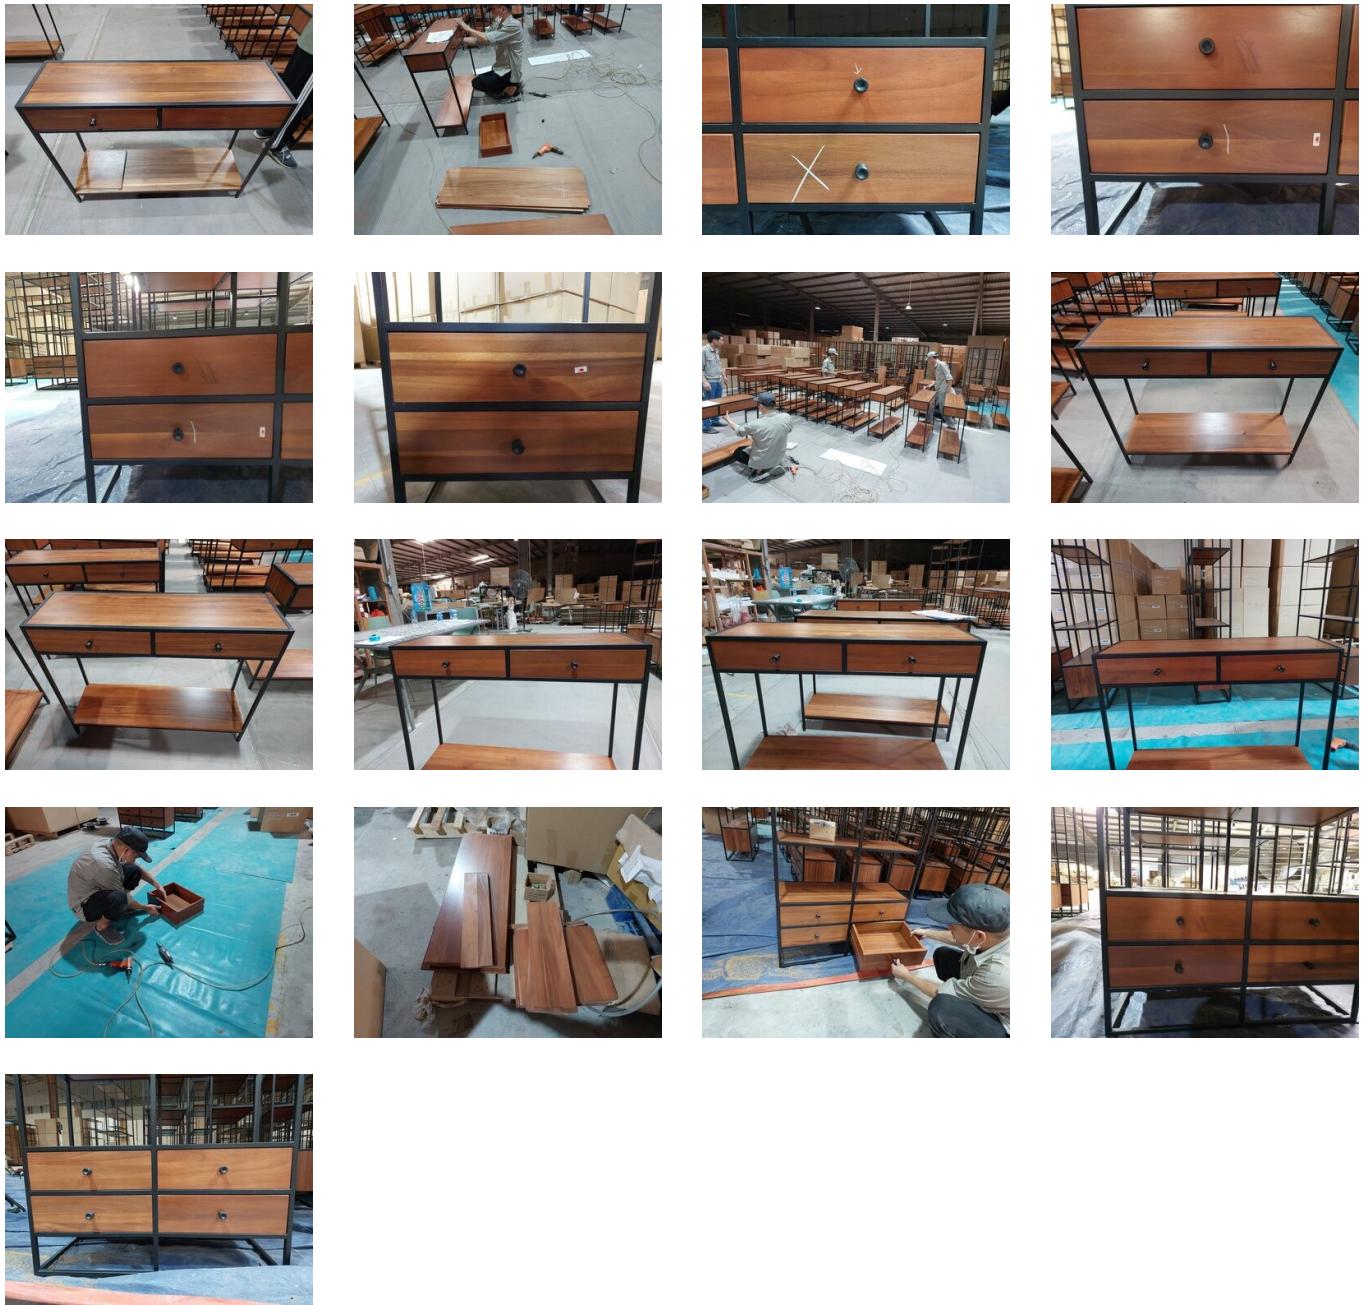
1	A-FI-1 Color not as per swatch [MAJOR]. Factory re-placed all defectives and inspector rechecked	MAJOR Items affected: 7
---	--	----------------------------

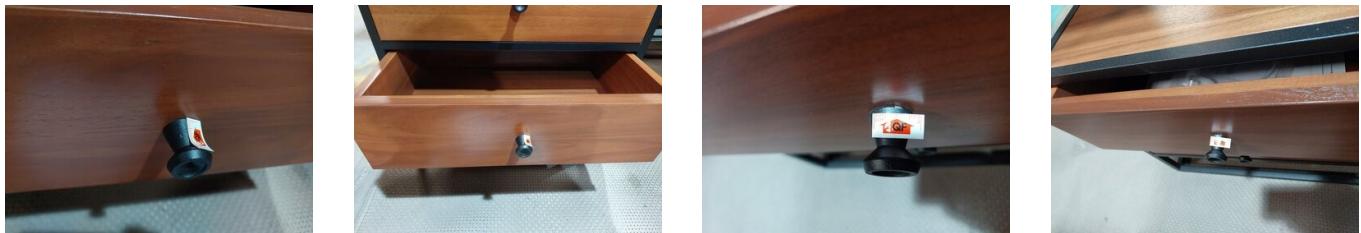
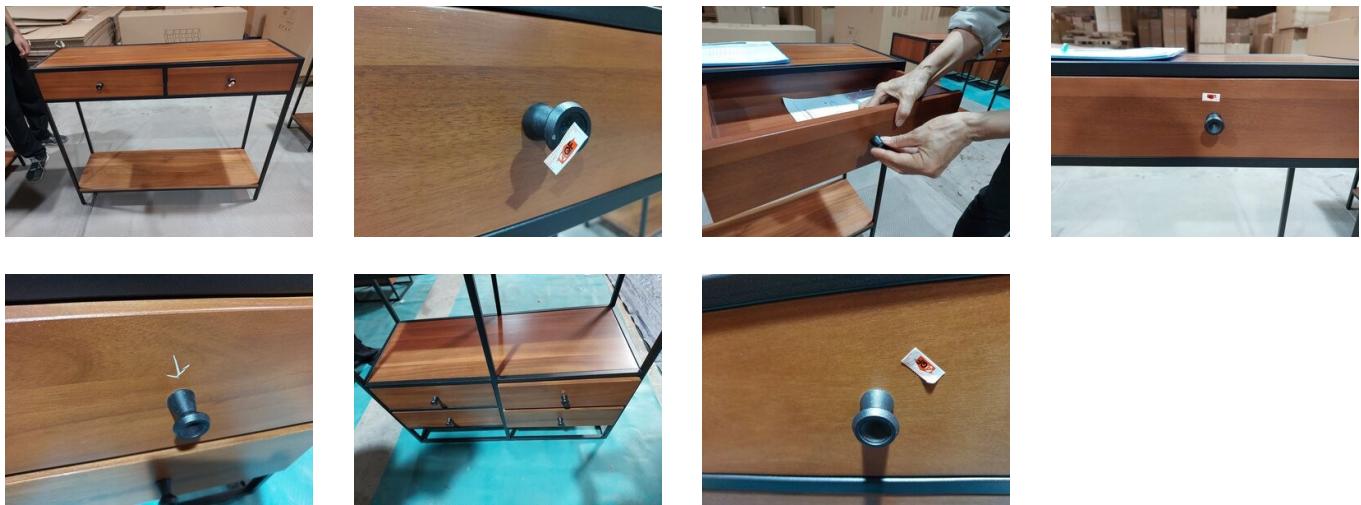
2	A-HA-1 Scratch / Dent / Chip off [MAJOR]. Factory re-placed all defectives and inspector rechecked	MAJOR Items affected: 6
---	--	----------------------------

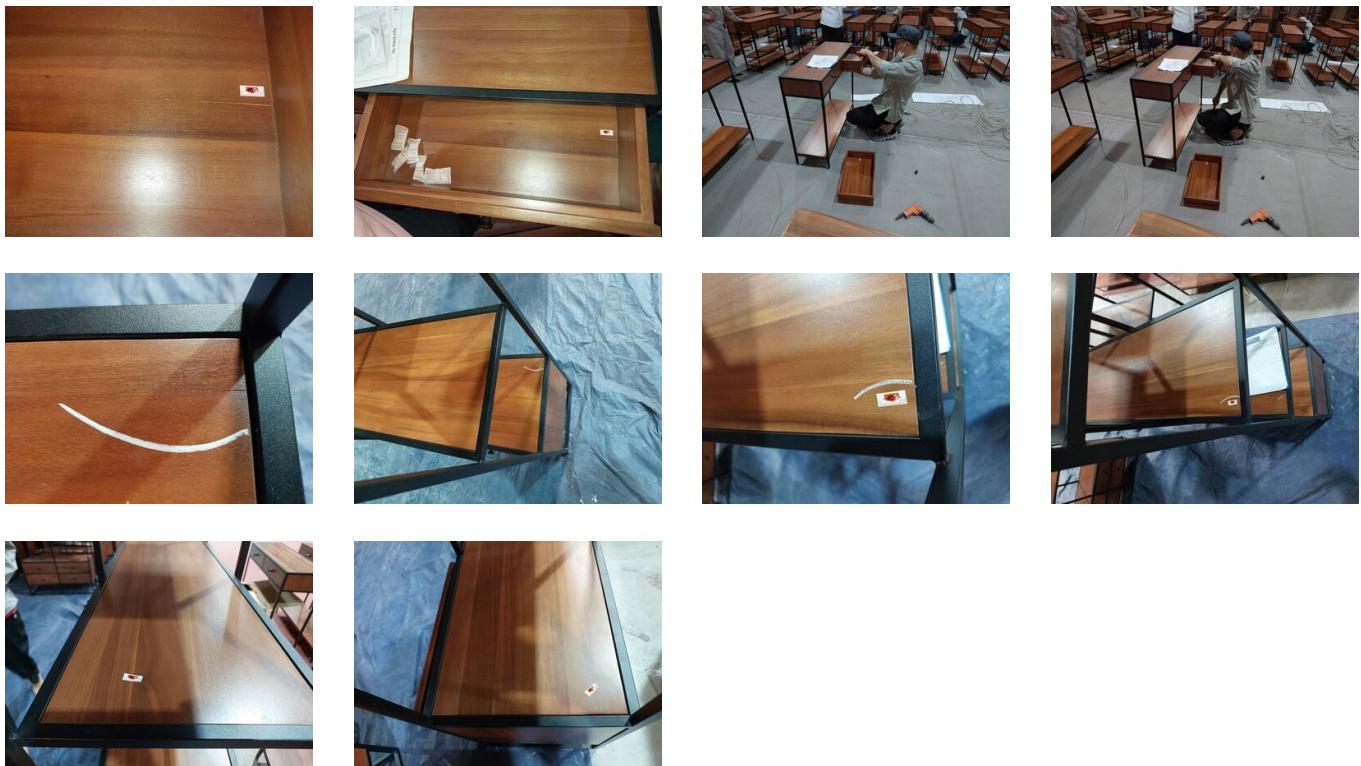
3 B-FP-3 Crack [MAJOR]. Factory re-placed all defectives and inspector rechecked

MAJOR
Items affected: 3

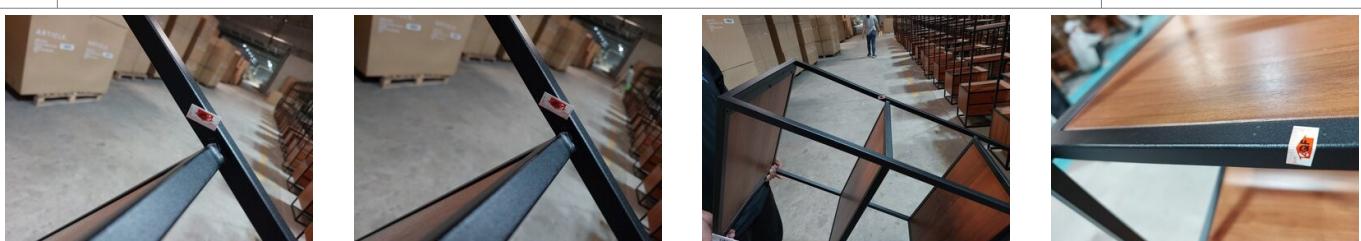
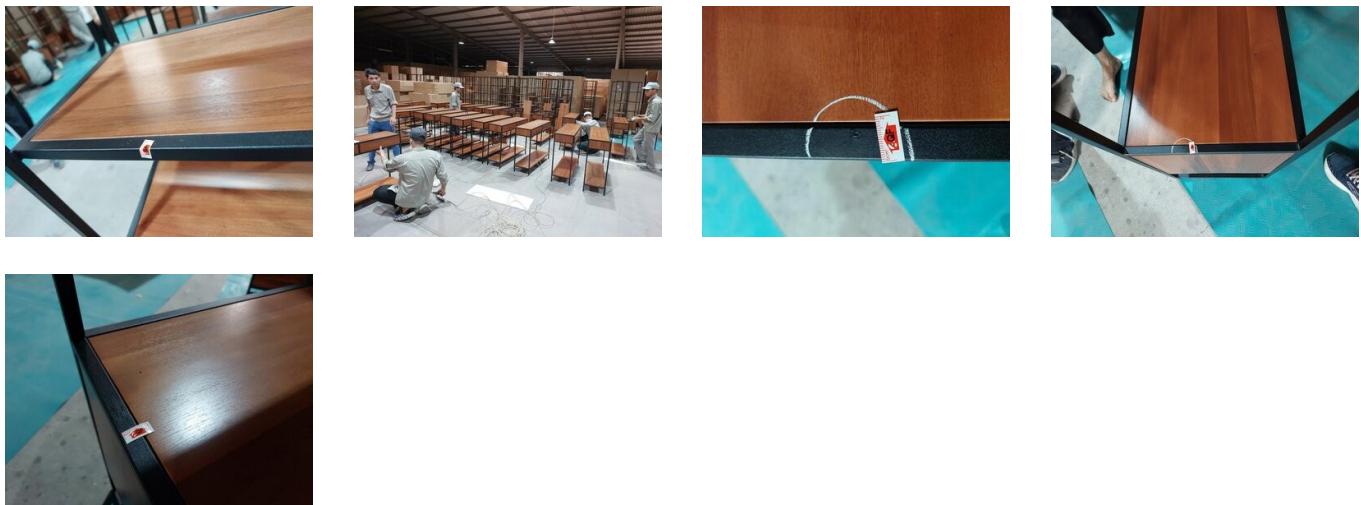
4 A-FP-4 Poor repair [MAJOR]. Factory repaired all defectives and inspector rechecked

MAJOR
Items affected: 3

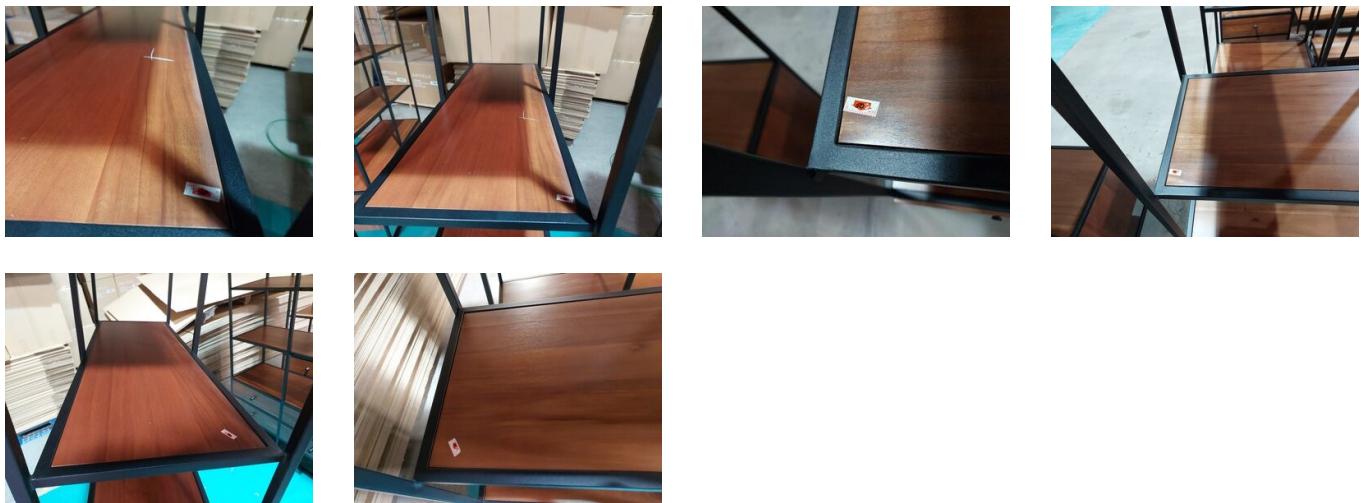
5	A-FI-2 Poor coating [MAJOR]. Factory repaired all defectives and inspector rechecked	MAJOR Items affected: 2
---	--	----------------------------

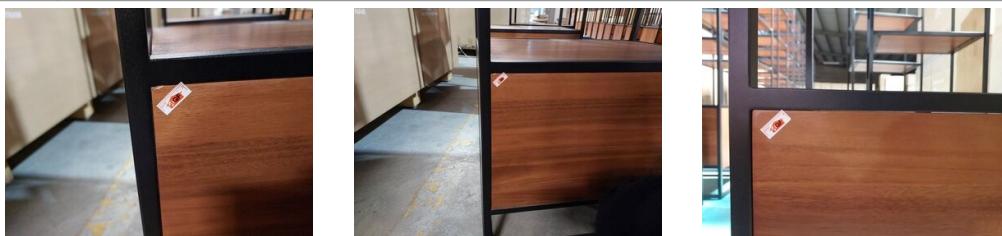
6	A-FP-5 Others. Dent wood - Factory repaired and inspector rechecked	MAJOR Items affected: 1
---	---	----------------------------

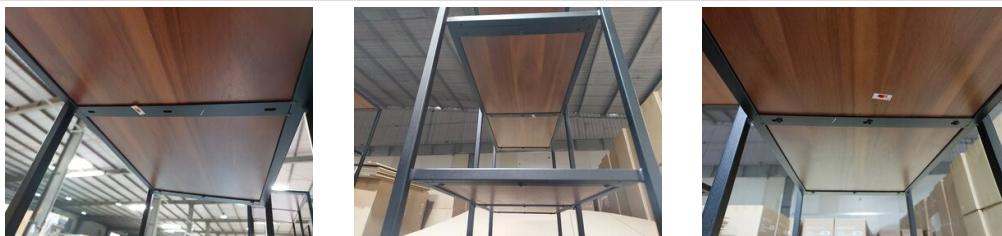
7	C-FP-5 Others. Missing drill screw - Factory repaired all defectives and inspector rechecked	MAJOR Items affected: 1
---	--	----------------------------

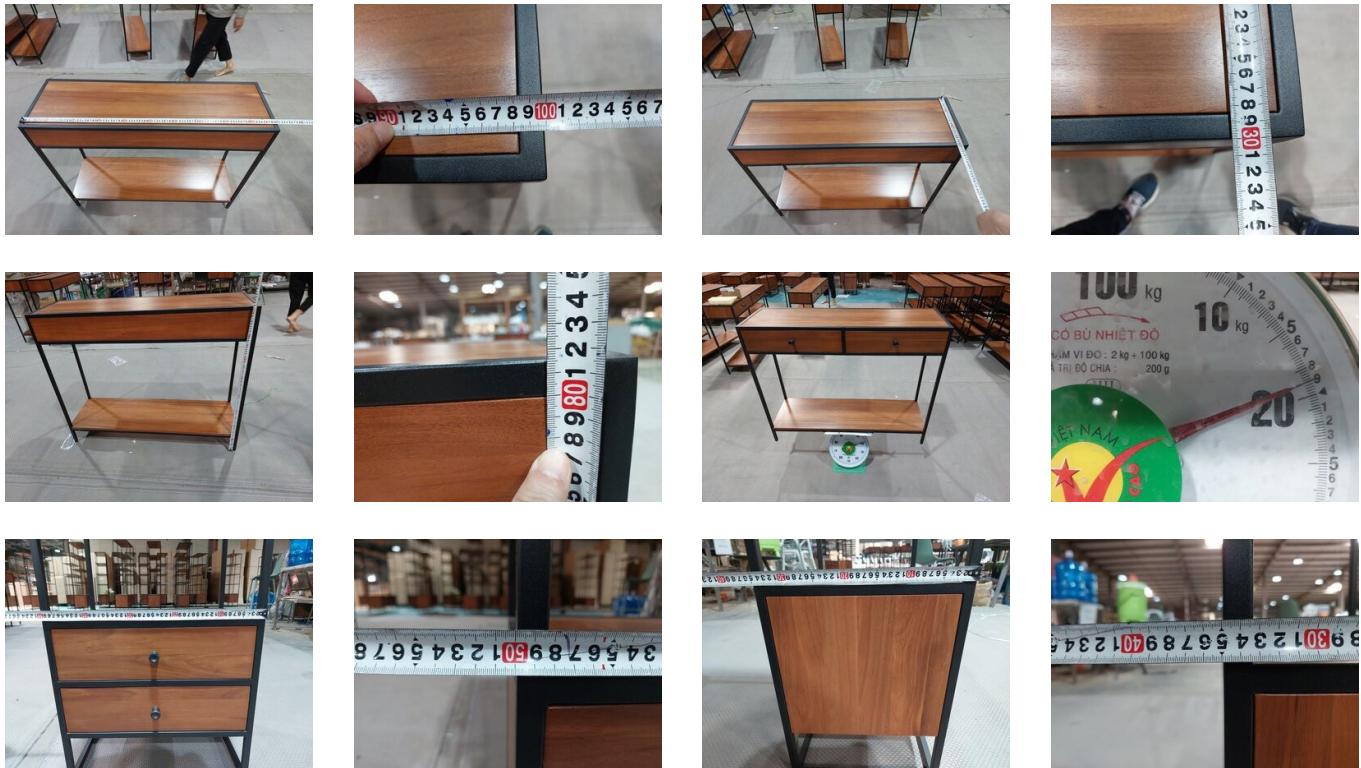
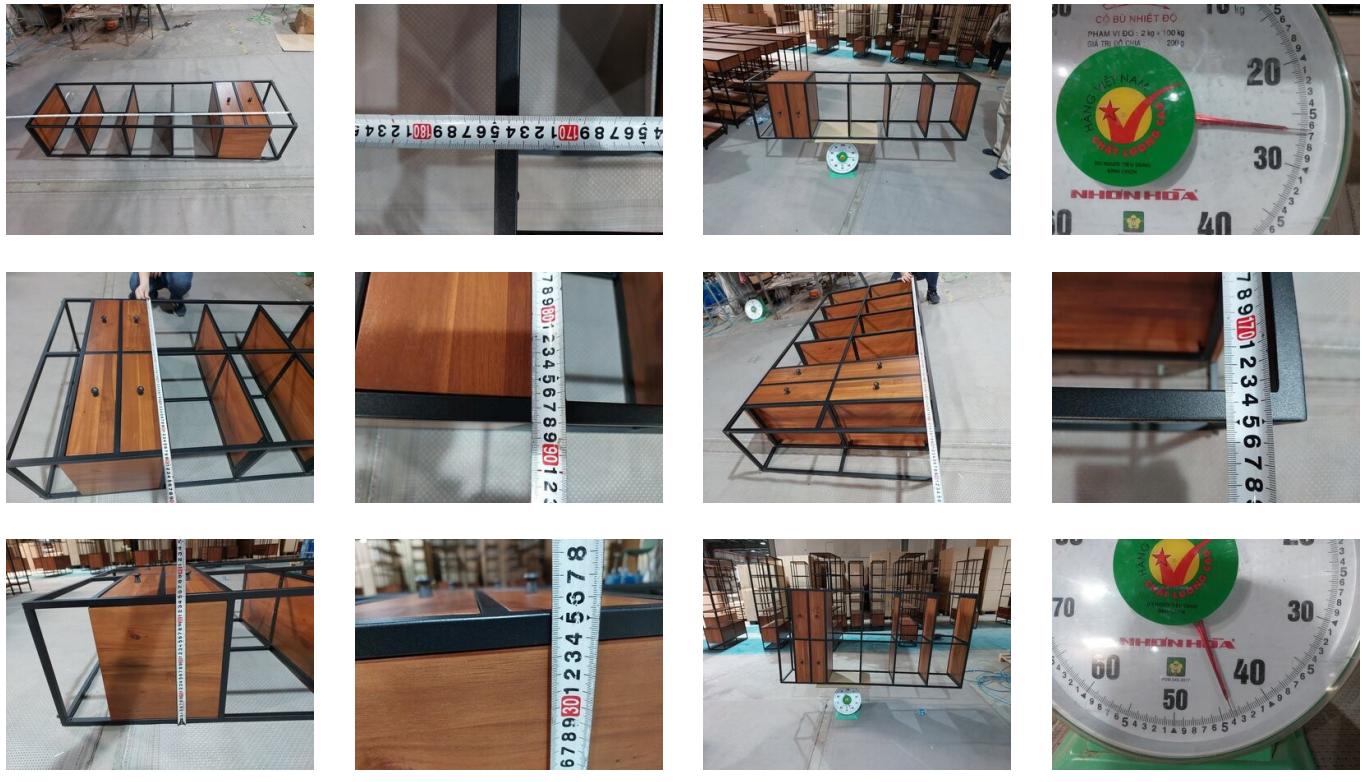
3.2	Dimension	Pending
The actual dimension of AGRA35_2 is 1750x500x350 cm instead as TECH Drawing 1750x540x350 cm
