# Roof Condition Assessment

Sample Business Park

## Building Diagnostic Robotics

Detailed roof condition findings and repair planning recommendations.

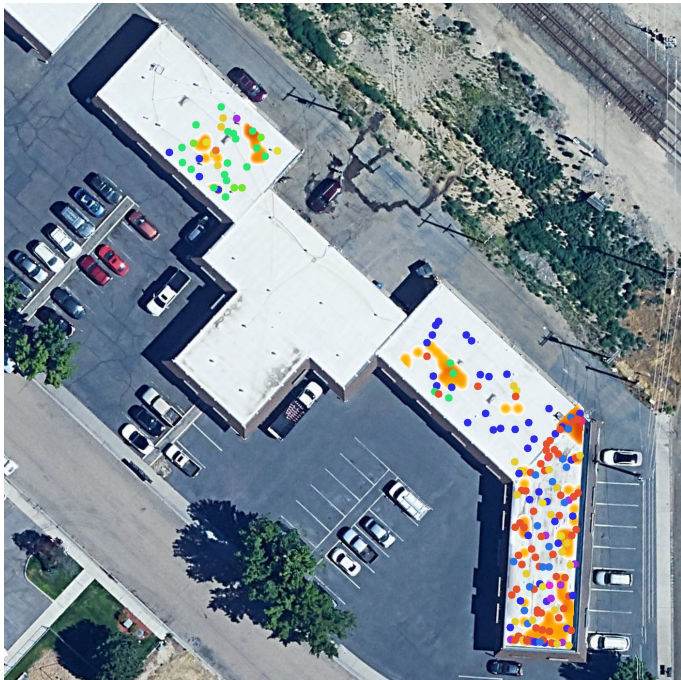
Figure 1.2. All observed deficiencies

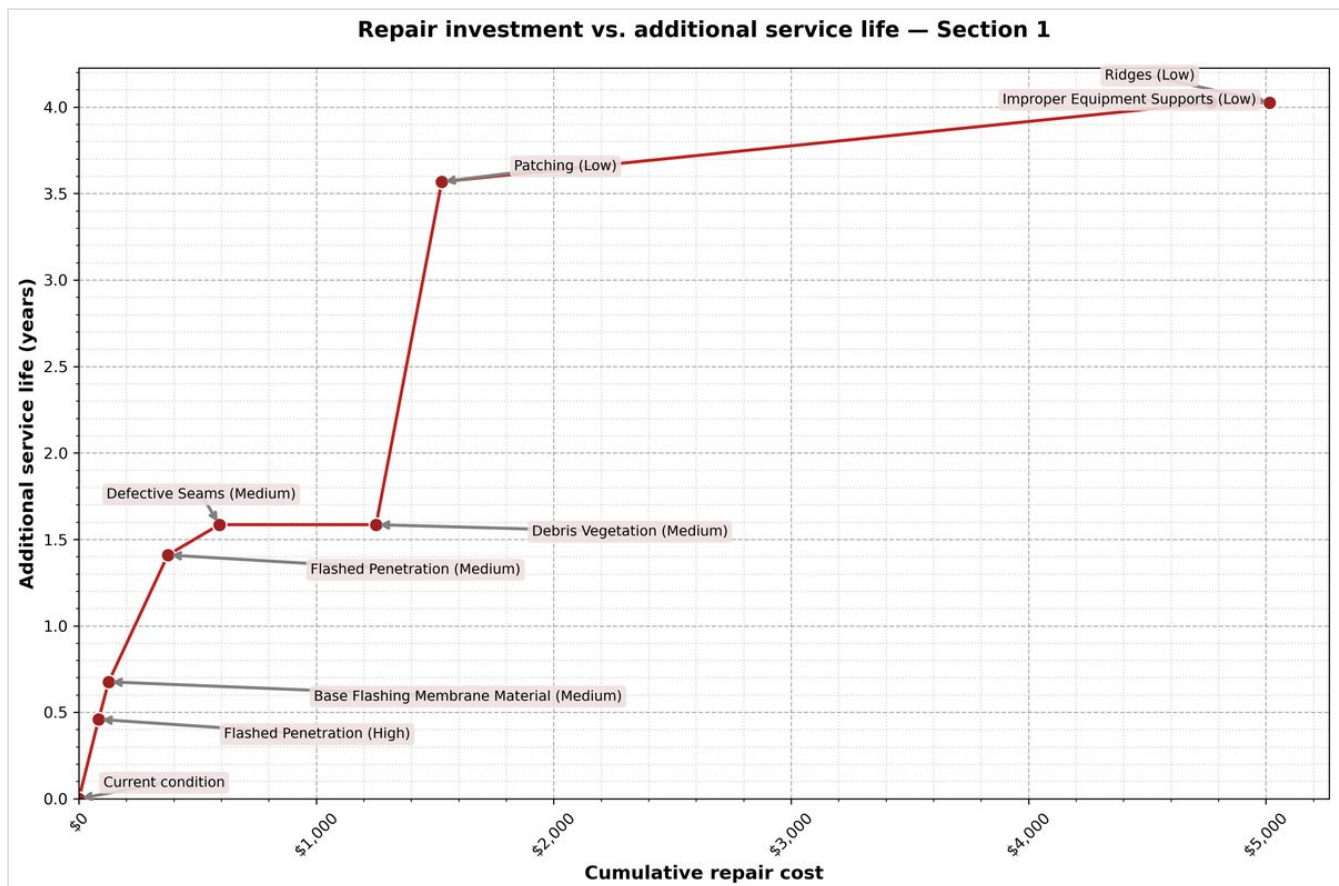
**Figure 3.1.** Section 1 repair investment vs. additional service life

Total Visual Defects: **50**

Roof condition: **Very Good (RCI 75)**

MRR recommendation: **Minor Repair Needed**

### Highest-return repairs (Section 1)

| Defect Type | Severity | Repair Cost | Additional Service Life |

**Table 3.1.** Highest-return repairs (Section 1) by additional service life

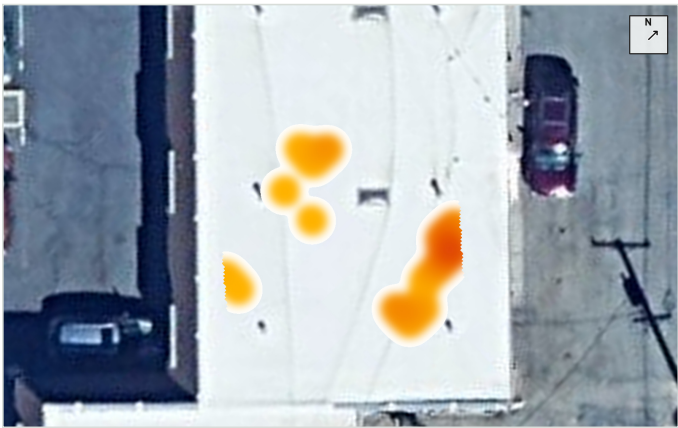
Figure 3.2. Below-membrane moisture

| Metric | Value |
|---|---|
| Moisture | 3.87% |

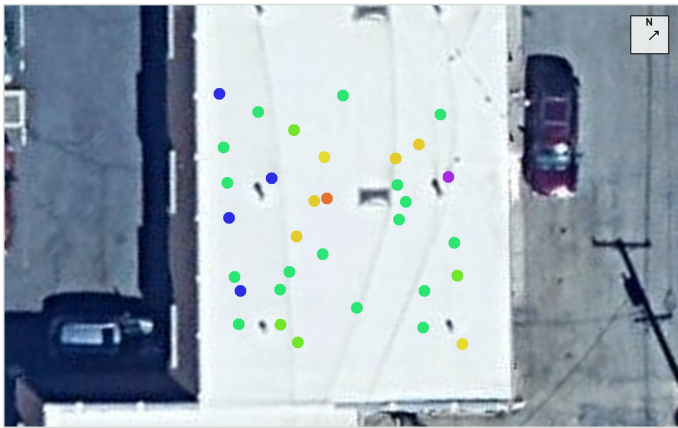
Figure 3.3. Visual defects

Table 3.3. Section 1 defect inventory

**Table 3.4.** Repair scope for Section 1

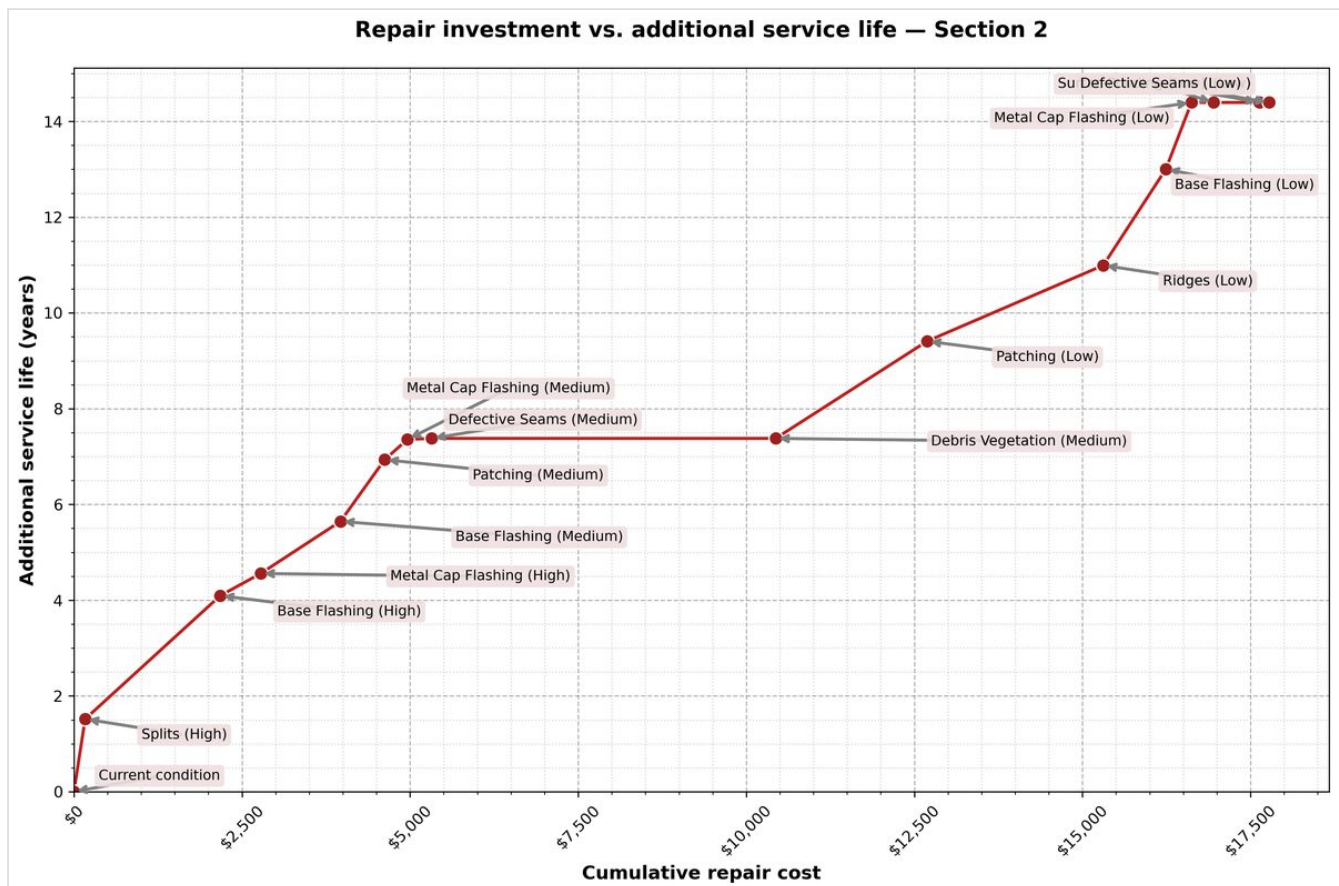
**Figure 4.1.** Section 2 repair investment vs. additional service life

Total Visual Defects: **188**

Roof condition: **Poor (RCI 35)**

MRR recommendation: **Replacement Probable**

#### Highest-return repairs (Section 2)

| Defect Type | Severity | Repair Cost | Additional Service Life |

**Table 4.1.** Highest-return repairs (Section 2) by additional service life

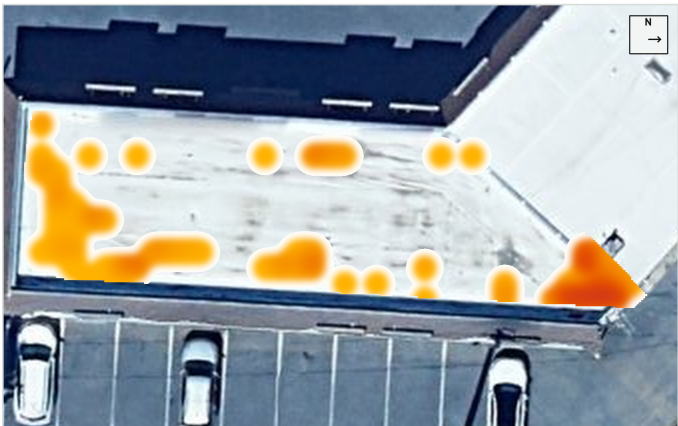
Figure 4.2. Below-membrane moisture

| Metric | Value |
|---|---|
| Moisture | 6.10% |

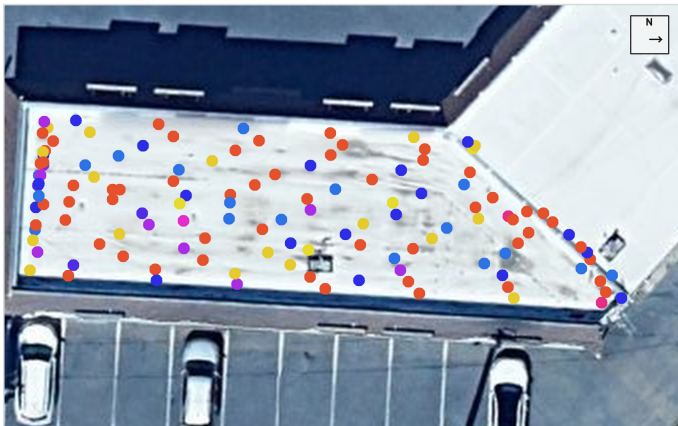
Figure 4.3. Visual defects

Table 4.3. Section 2 defect inventory

**Table 4.4.** Repair scope for Section 2

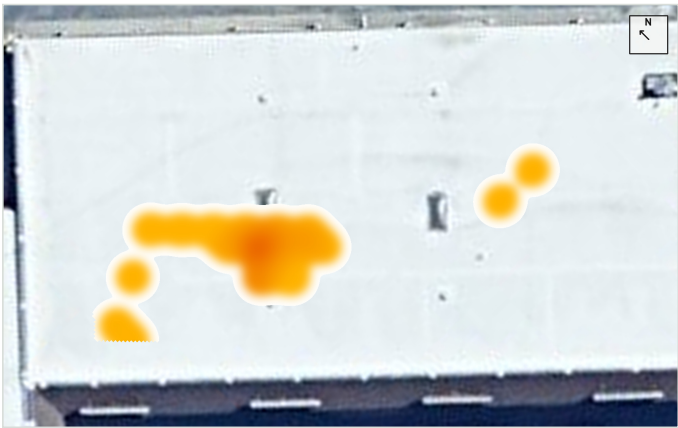
Figure 5.2. Below-membrane moisture

| Metric | Value |
|---|---|
| Moisture | 1.93% |

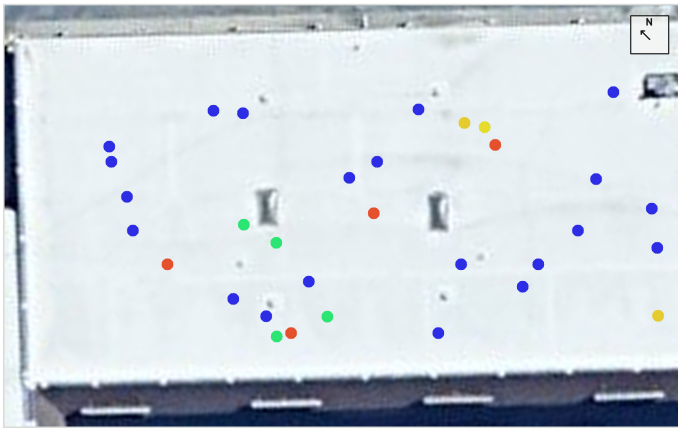
Figure 5.3. Visual defects

Table 5.3. Section 3 defect inventory

Table 5.4. Repair scope for Section 3
