# Visual Evidence Record

Sample Business Park

## Building Diagnostic Robotics

Visual evidence record supporting the roof condition assessment.

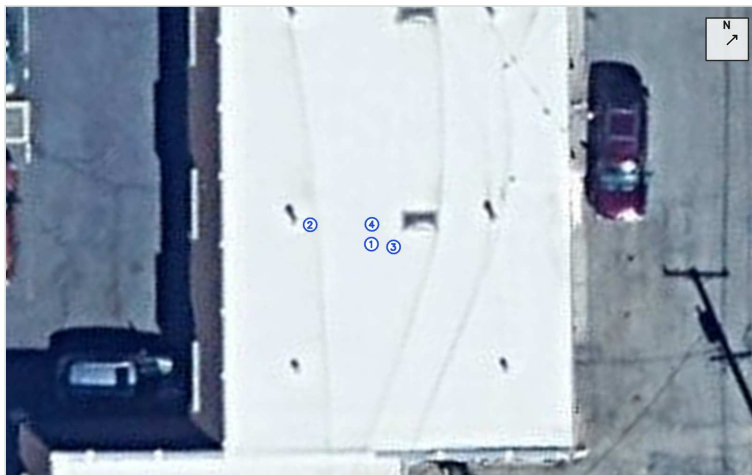
**Figure 2.1.** Section 1 — Debris And Vegetation capture locations

| Total Defects | 4 |
| Repair Priority | Medium |

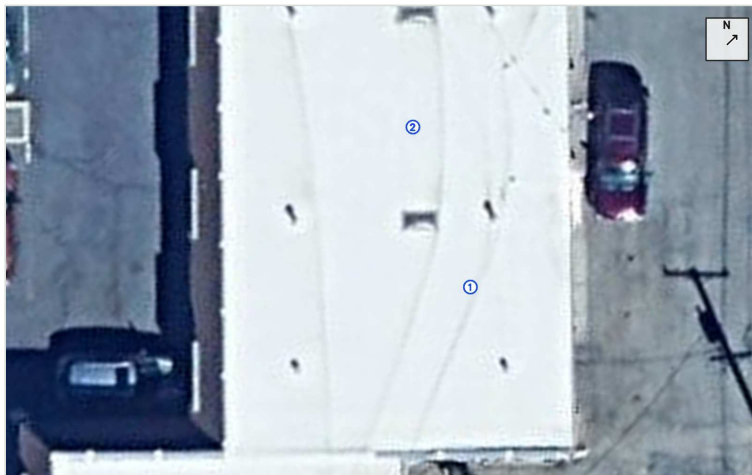
**Figure 2.3.** Section 1 — Defective Seams capture locations

| Total Defects | 5 |
| Repair Priority | Medium |

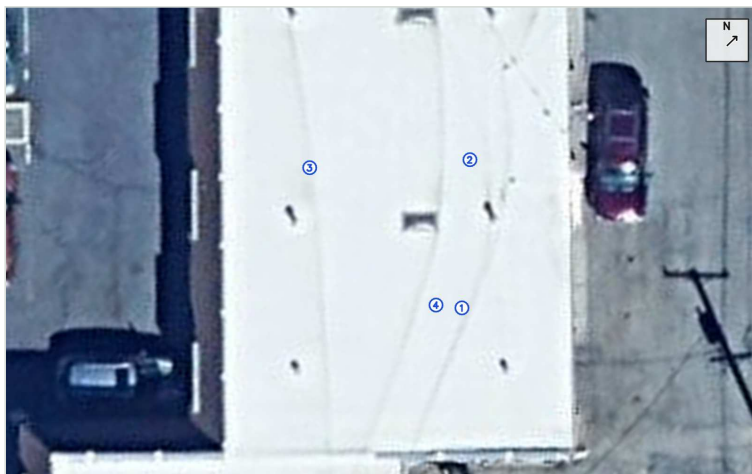
**Figure 2.5.** Section 1 — Flashed Penetrations capture locations

| Total Defects | 4 |
| Repair Priority | High |

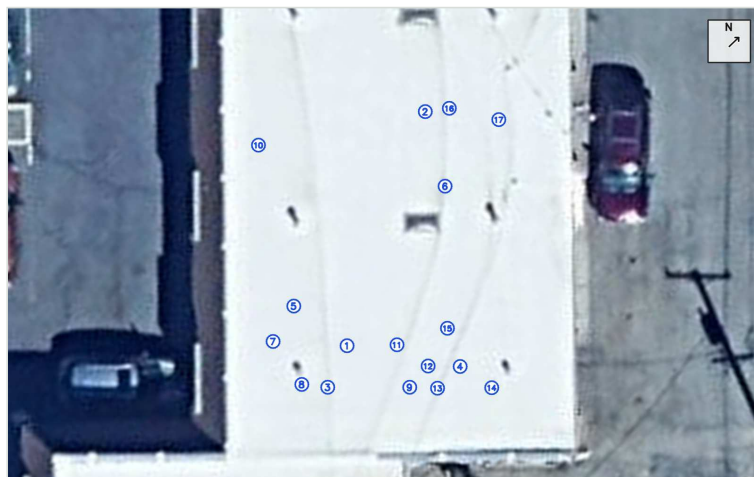
**Figure 2.7.** Section 1 — Improper Equipment Supports capture locations

| Total Defects | 29 |
| Repair Priority | Low |

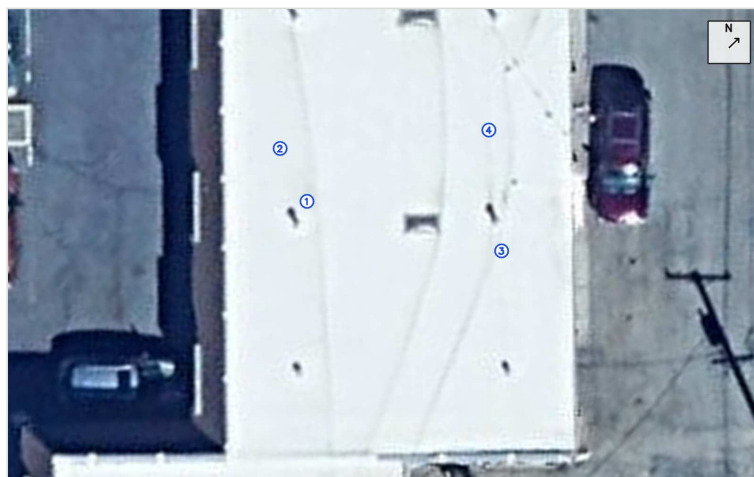
**Figure 2.11.** Section 1 — Patching capture locations

| Total Defects | 5 |
| Repair Priority | Low |

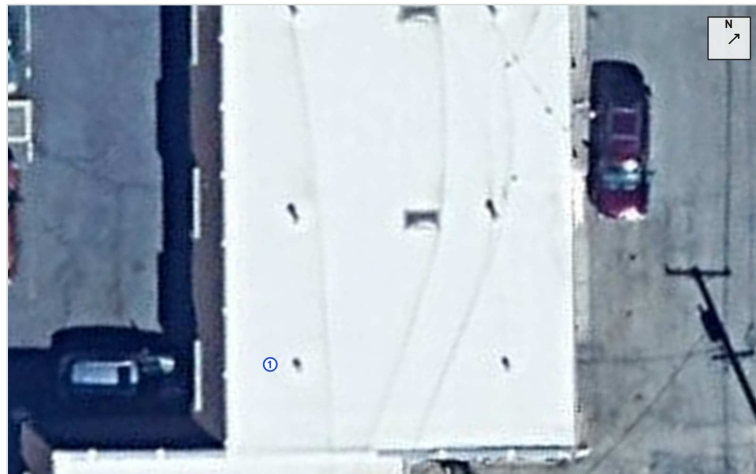
**Figure 2.13.** Section 1 — Base Flashing-Membrane Material capture locations

| Total Defects | 1 |
| Repair Priority | Medium |

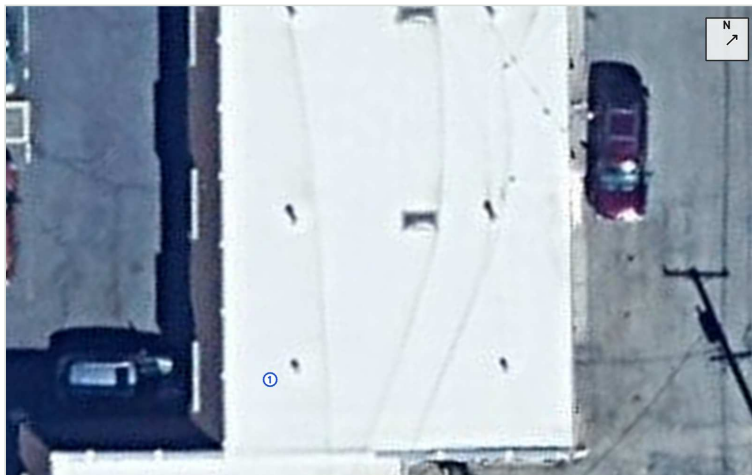
**Figure 2.15.** Section 1 — Ridges capture locations

| Total Defects | 2 |
| Repair Priority | Low |

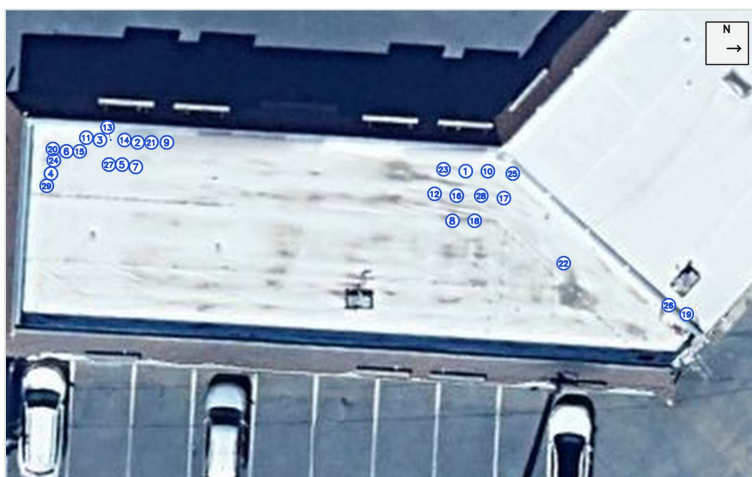
**Figure 2.17.** Section 2 — Debris And Vegetation capture locations

| Total Defects | 33 |
| Repair Priority | Medium |

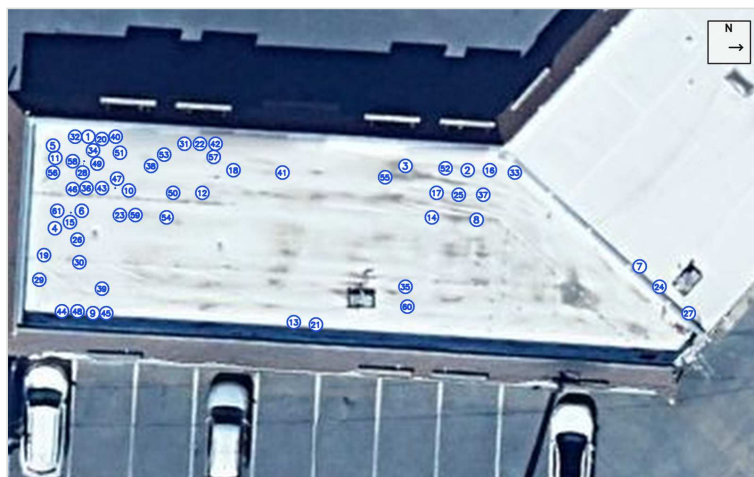
**Figure 2.23.** Section 2 — Base Flashing capture locations

| Total Defects | 73 |
| Repair Priority | High |

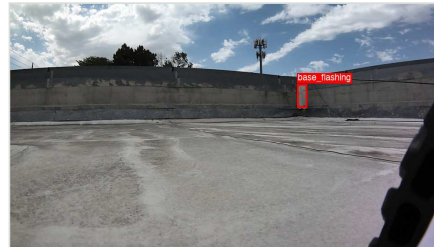
(e) Capture 59 - 1 Defect

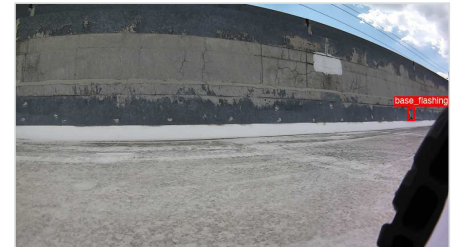
(f) Capture 60 - 1 Defect

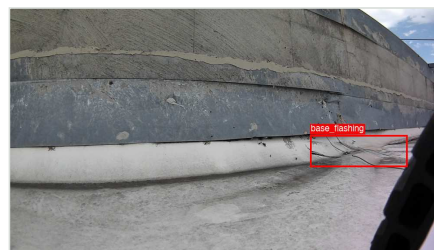
(a) Capture 61 - 1 Defect

## Metal Cap Flashing

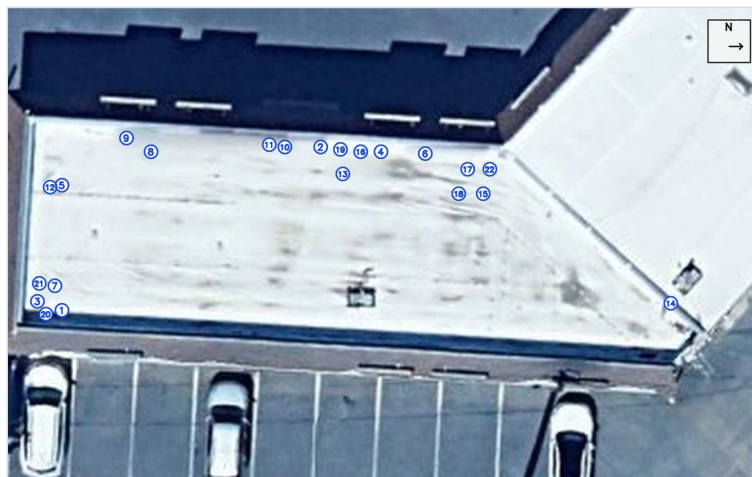
**Figure 2.35.** Section 2 — Metal Cap Flashing capture locations

| Total Defects | 23 |
| Repair Priority | High |

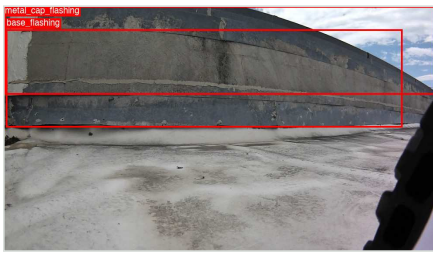
(a) Capture 1 - 1 Defect

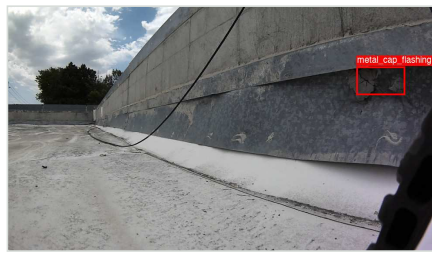
(b) Capture 2 - 1 Defect

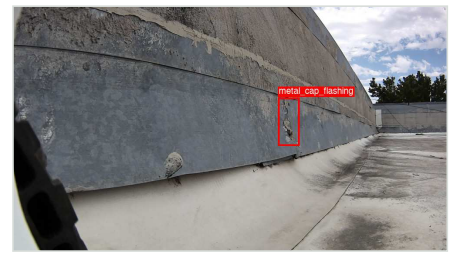
(c) Capture 3 - 1 Defect

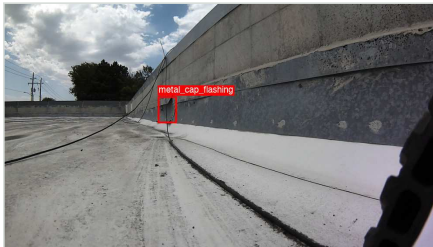
(d) Capture 4 - 1 Defect

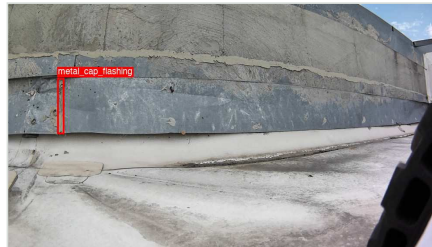
(e) Capture 5 - 1 Defect

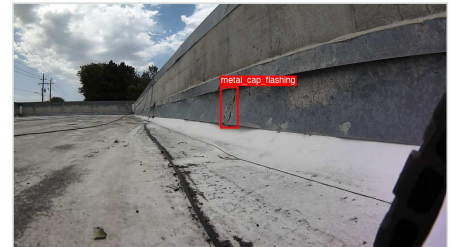
(f) Capture 6 - 1 Defect

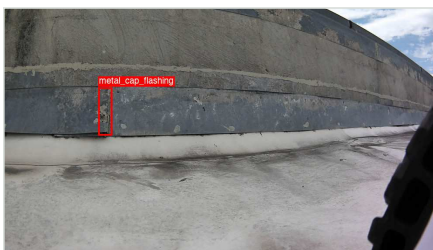
(a) Capture 7 - 1 Defect

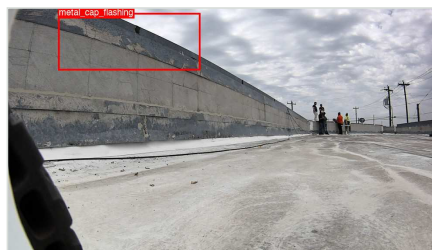
(b) Capture 8 - 1 Defect

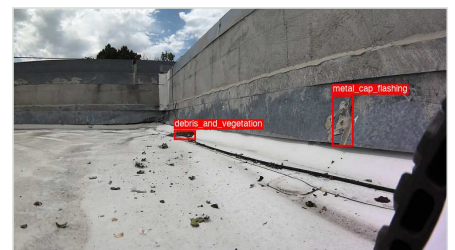
(c) Capture 9 - 1 Defect

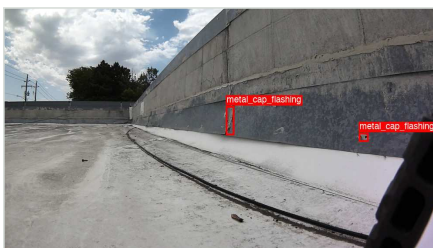
(d) Capture 10 - 2 Defects

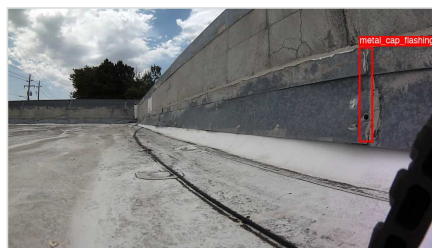
(e) Capture 11 - 1 Defect

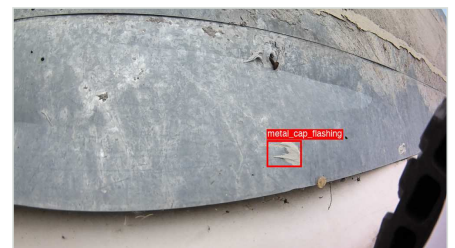
(f) Capture 12 - 1 Defect

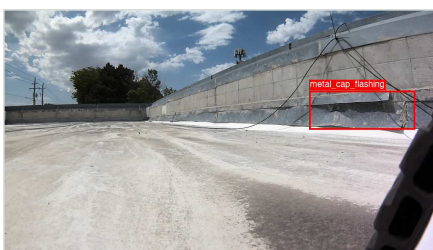
(a) Capture 13 - 1 Defect

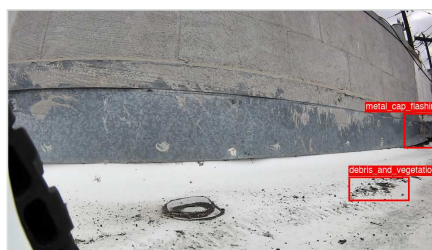
(b) Capture 14 - 1 Defect

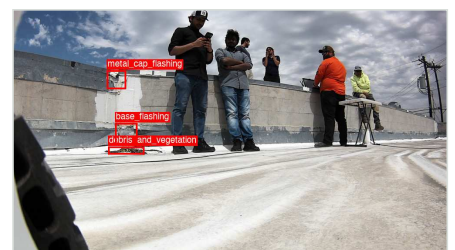
(c) Capture 15 - 1 Defect

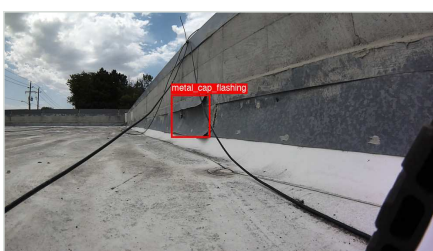
(d) Capture 16 - 1 Defect

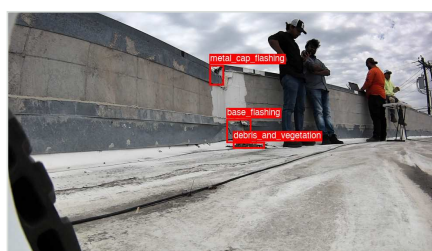
(e) Capture 17 - 1 Defect

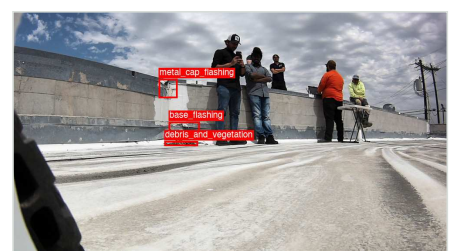
(f) Capture 18 - 1 Defect

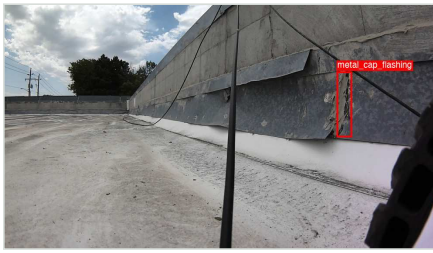
(a) Capture 19 - 1 Defect

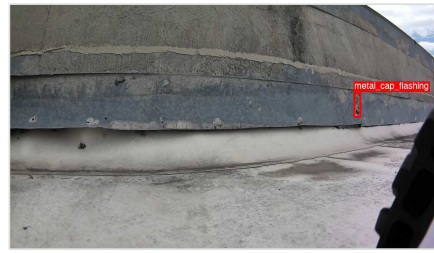
(b) Capture 20 - 1 Defect

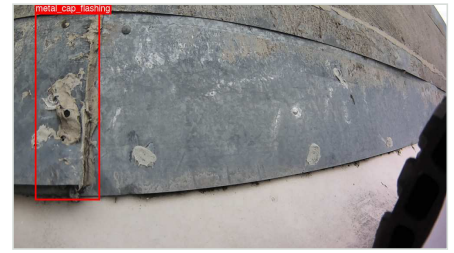
(c) Capture 21 - 1 Defect

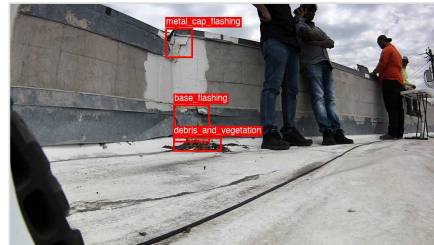
(d) Capture 22 - 1 Defect

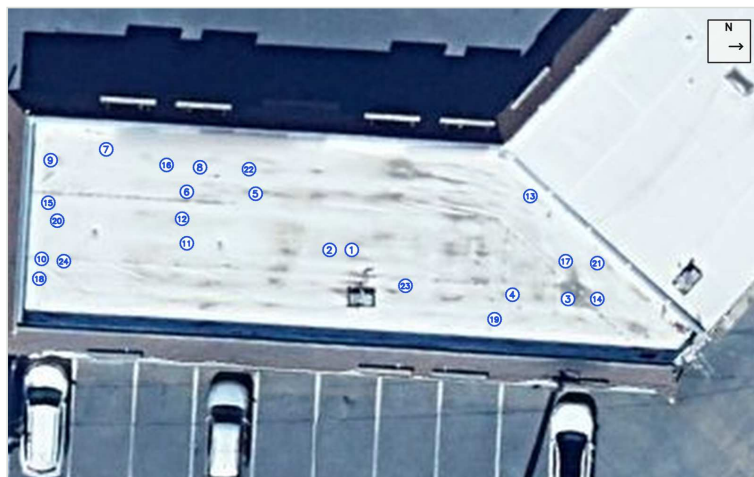
**Figure 2.40.** Section 2 — Patching capture locations

| Total Defects | <b>33</b> |
| Repair Priority | <b>Medium</b> |

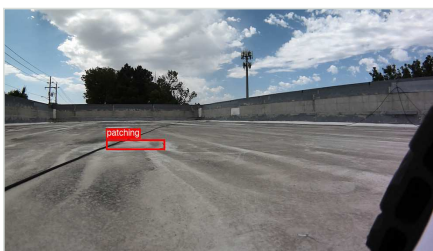
## Patching

(a) Capture 1 - 1 Defect

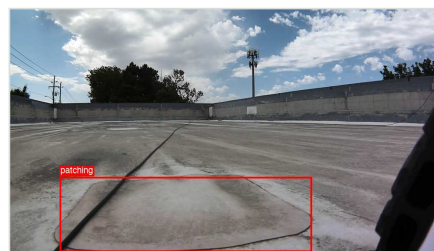
(b) Capture 2 - 1 Defect

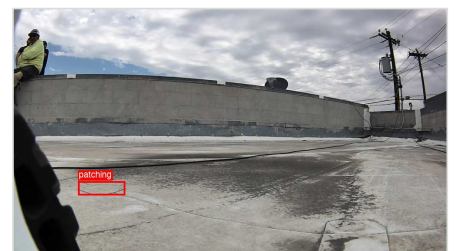
(c) Capture 3 - 1 Defect

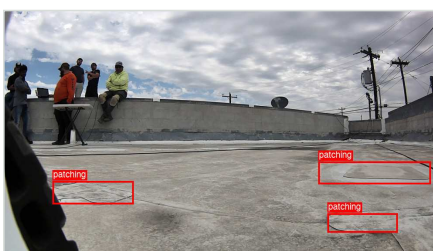
(d) Capture 4 - 3 Defects

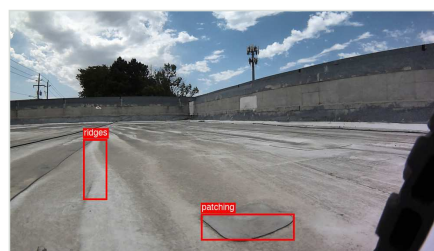
(e) Capture 5 - 1 Defect

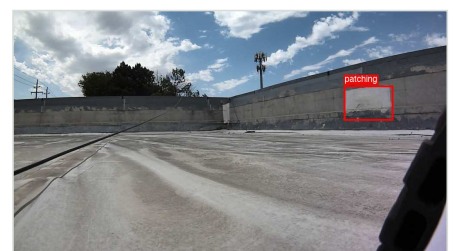
(f) Capture 6 - 1 Defect

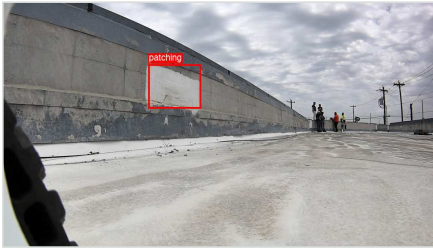
(a) Capture 7 - 1 Defect

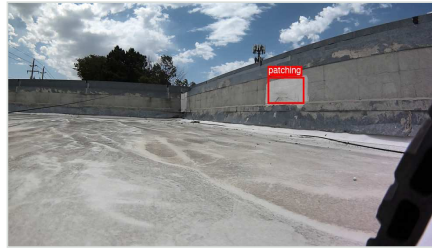
(b) Capture 8 - 1 Defect

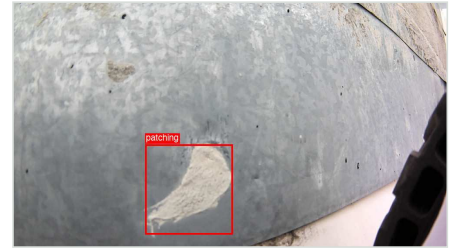
(c) Capture 9 - 1 Defect

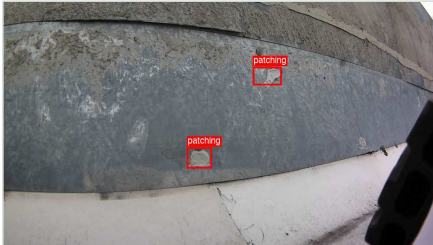
(d) Capture 10 - 2 Defects

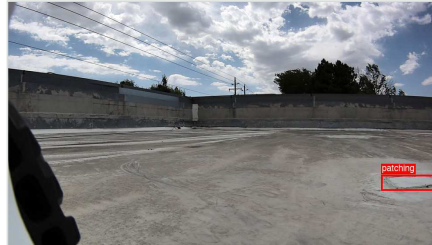
(e) Capture 11 - 1 Defect

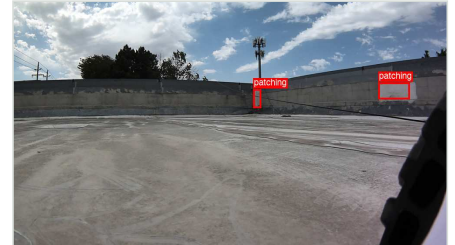
(f) Capture 12 - 2 Defects

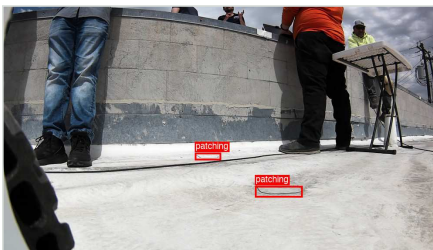
(a) Capture 13 - 2 Defects

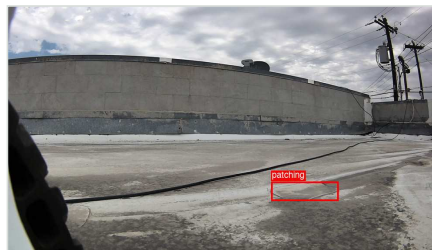
(b) Capture 14 - 1 Defect

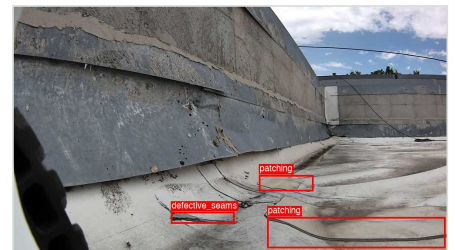
(c) Capture 15 - 2 Defects

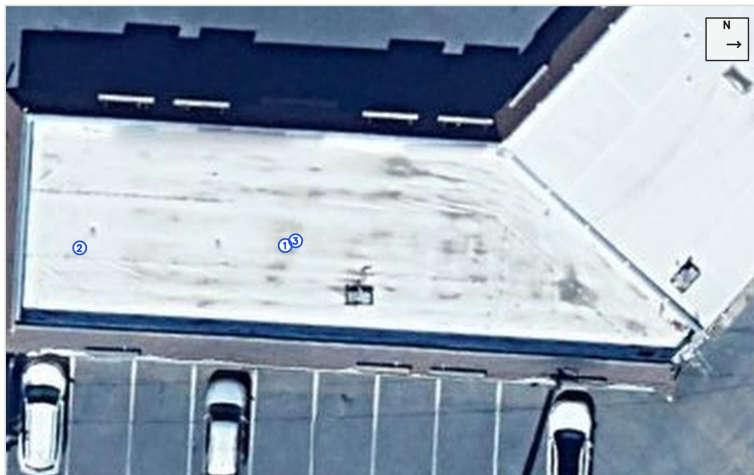
**Figure 2.45.** Section 2 — Ponding capture locations

| Total Defects | <b>3</b> |
| Repair Priority | <b>Low</b> |

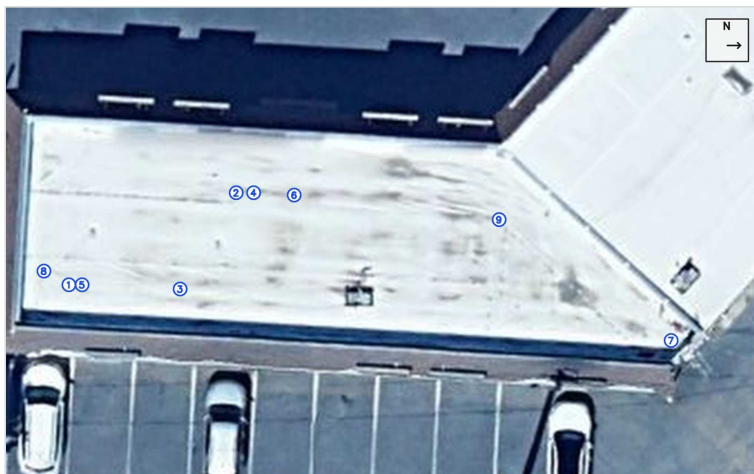
**Figure 2.47.** Section 2 — Ridges capture locations

| Total Defects | <b>12</b> |
| Repair Priority | <b>Low</b> |

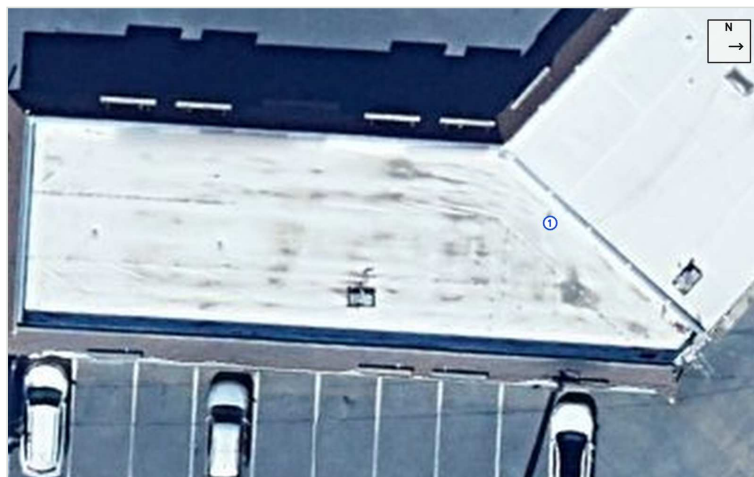
**Figure 2.50.** Section 2 — Splits capture locations

| Total Defects | 1 |
| Repair Priority | High |

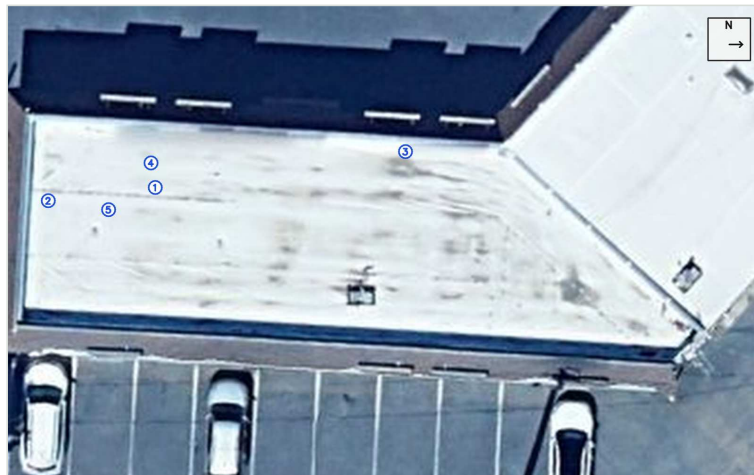
**Figure 2.52.** Section 2 — Defective Seams capture locations

| Total Defects | 8 |
| Repair Priority | Medium |

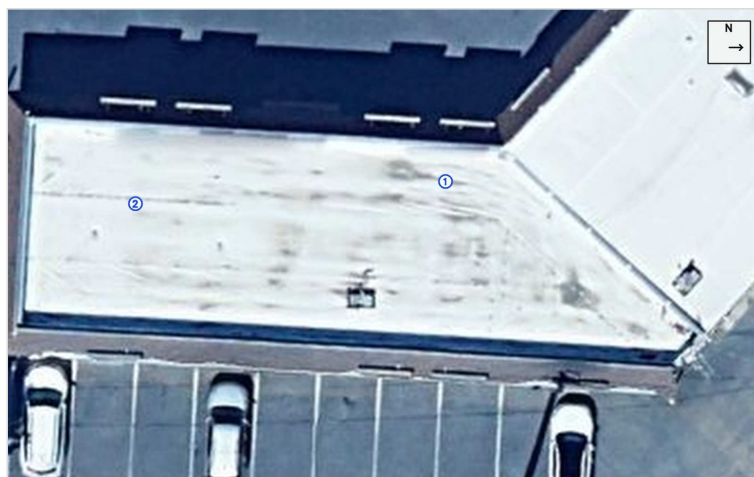
**Figure 2.54.** Section 2 — Surface Deterioration capture locations

| Total Defects | 2 |

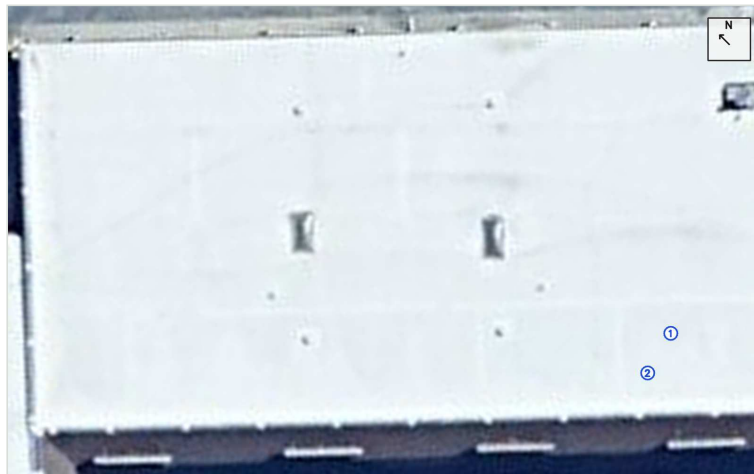
**Figure 2.56.** Section 3 — Debris And Vegetation capture locations

| Total Defects | 2 |
| Repair Priority | Medium |

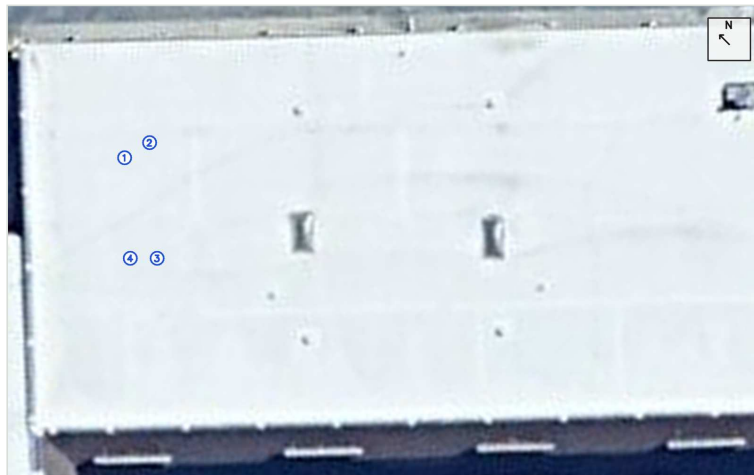
**Figure 2.58.** Section 3 — Improper Equipment Supports capture locations

| Total Defects | 5 |
| Repair Priority | Low |

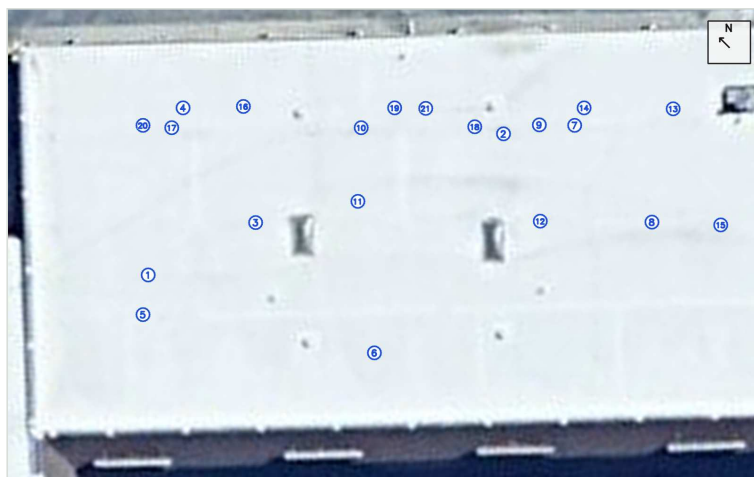
**Figure 2.60.** Section 3 — Patching capture locations

| Total Defects | 28 |
| Repair Priority | Medium |
