# Full-scale fatigue testing of a cast-iron wind turbine rotor shaft

Hans Kyling<sup>1</sup> · Muhammad Omer Siddiqui<sup>1</sup>

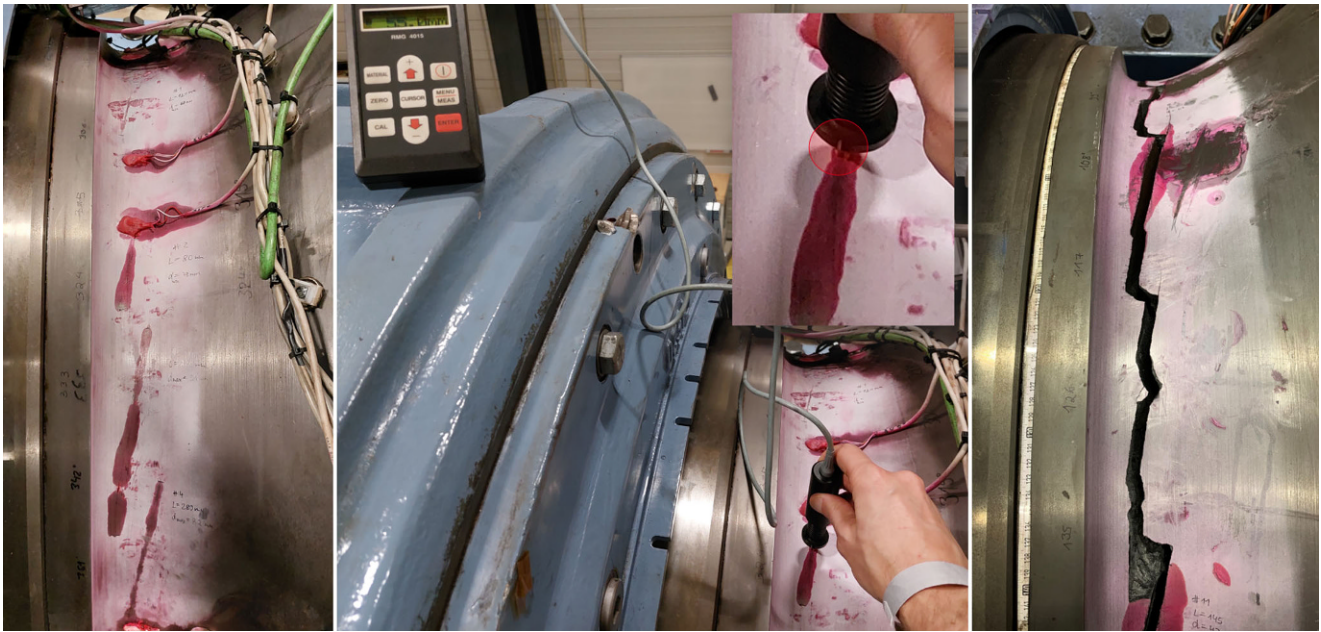
**Fig. 8** Exemplary results from the dye penetrant testing method applied to angular section 18–27° at various load cycles on load stage 3

ble crack or its progress based on strain measurement, but with the help of the non-destructive dye penetrant testing method (PT) in accordance with [6]. The first cracks were identified during an inspection after 1.723 mio. load cycles with the naked eye and confirmed by PT testing as shown in Fig. 8.

Due to the high density of SGs in the critical notch area and the limited accessibility, the PT method could not be used regularly. From the PT testing it can be derived that already after 1.5 mio. load cycles a crack initiation could be assumed. This crack initiation was not identified as such earlier due to the inclined crack front. The load situation with a very dominant bending load compared to the driving torque necessary to achieve the desired rotational speed (approximately factor of 1,000 between bending and torque load) led to an assumed vertical crack front, i.e. a crack front parallel to the shaft shoulder.
