# DRAFT DRAFT DRAFT Everything That Went Wrong For UBC Solar At FSGP 2025

Christopher Kalitin Blog (<https://ckalitin.github.io/posts/ubc-fsgp-2025/>)

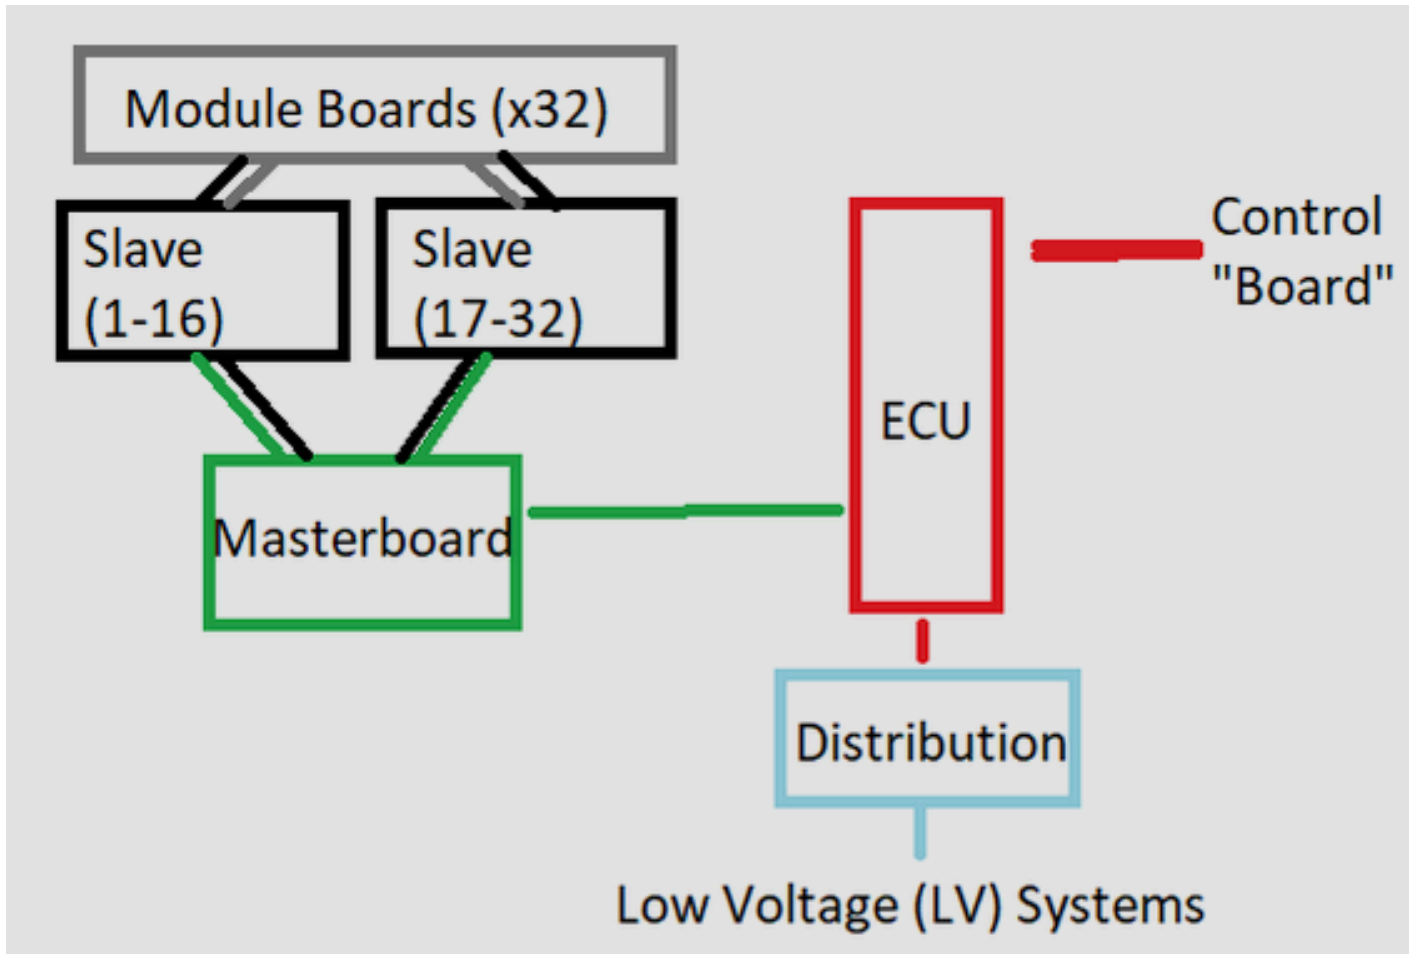
Our BMS architecture.

- We make our own house Battery Management System (BMS)
- We use a masterboard-slaveboard-cellboard architecture.
- Cellboards have a voltage tap on each module and a thermistor.
- Slaveboards read from cellboards using an LTC6813 microcontroller and send data over isoSPI to the masterboard.
- The Masterboard aggregates all data and does computations like trigger a fault if we are at too high a temperature.
