# DRAFT DRAFT DRAFT Everything That Went Wrong For UBC Solar At FSGP 2025

Christopher Kalitin Blog (<https://ckalitin.github.io/posts/ubc-fsgp-2025/>)

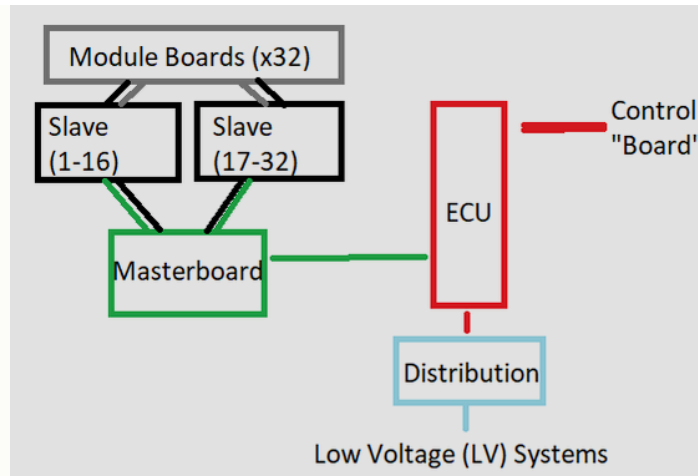
Our BMS architecture.
