NASA/TP-2009-214769

A Summary of NASA and USAF Hypercolic Propellant Related Spills and Fires

*B. M. Nuffer
Kennedy Space Center, Florida*

June 2009

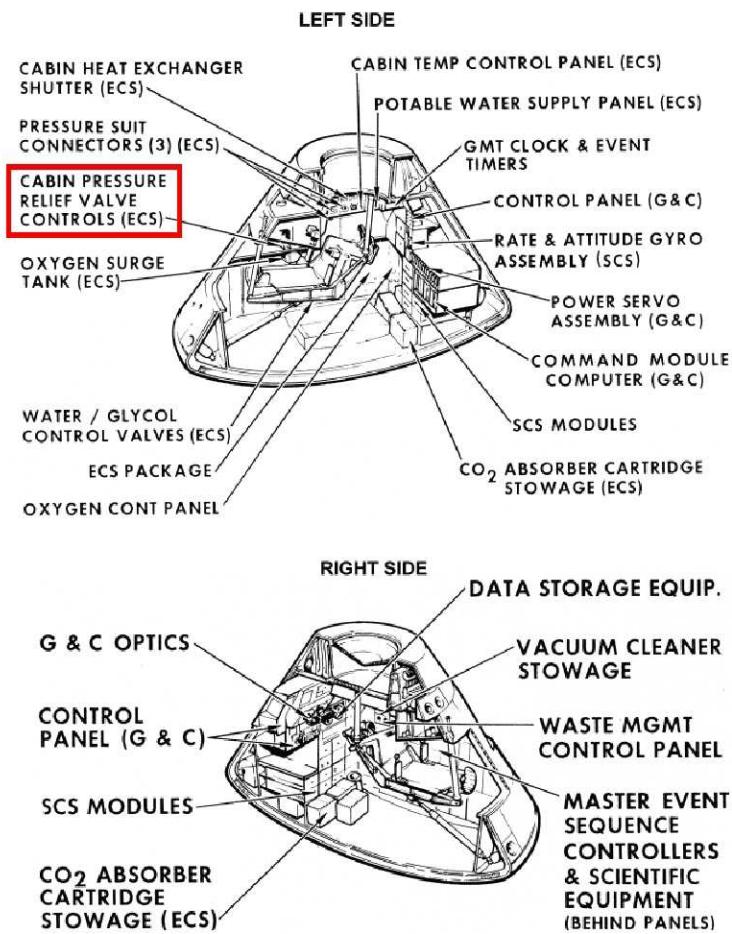
Figure 3-2: Apollo Command Module Interior Cutaway

The exposure greatly altered the astronauts' abilities to complete assigned tasks in a timely manner; therefore, they experienced a very rough landing along with the poor luck of having the capsule splash-down in the "Stable 2" configuration, which meant it was inverted in the water. Following splash-down, the crew was forced to don their oxygen masks, but in the interim before Stafford could retrieve and distribute the masks, Brand (who was sitting closest to the relief valve, see Figure 3-2) lost consciousness.

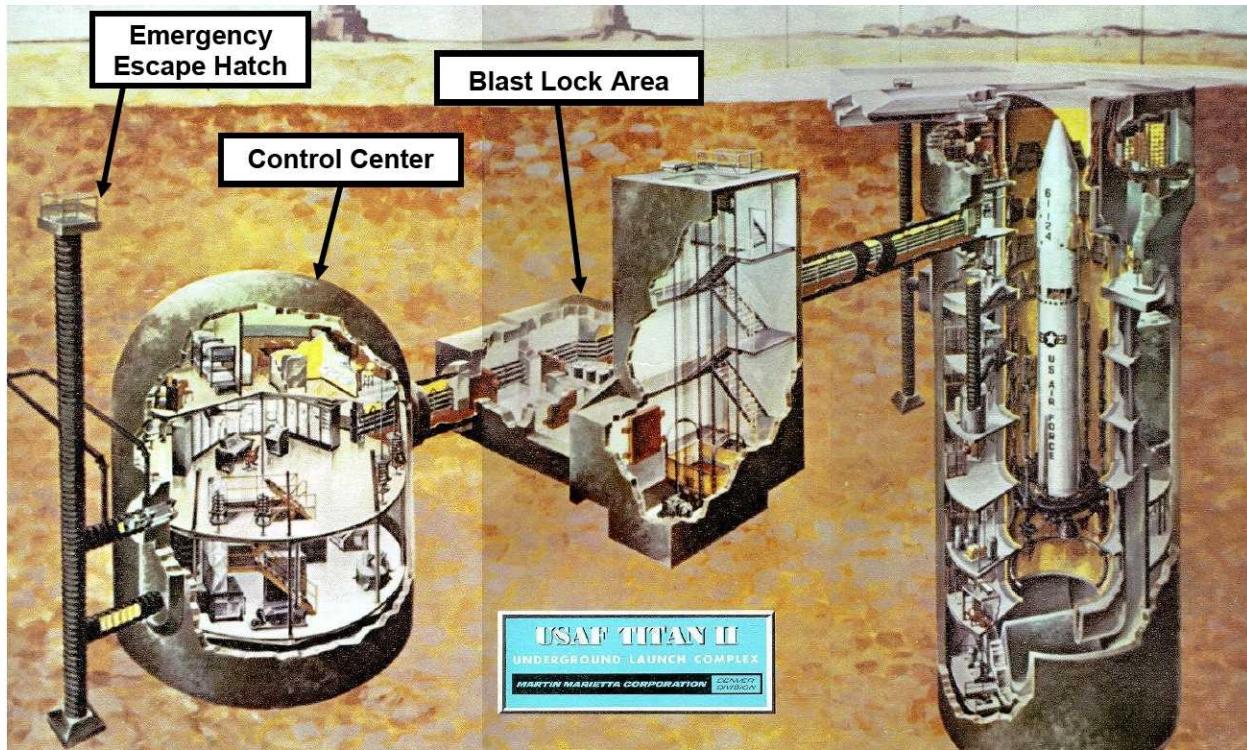
Figure 5-1: Underground Titan II Missile Complex

Very high concentrations of NO₂ vapors traveled from the silo into the connecting cableway to the blast lock area, which was located just outside of the control center where several personnel were located (see Figure 5-1). All the personnel located in the blast lock area managed to escape the vapors by exiting through the access portal at ground level. The personnel in the control center would normally be isolated from the silo; however, two technicians involved in the spill opened the airlock door to try and obtain assistance for their supervisor who was in need of immediate medical attention. The two technicians and four other control center personnel then evacuated through the emergency escape hatch, once they realized the immediate danger of the situation. The nearby town of Rock, Kansas had to evacuate about 100 people as a result of the vapors that were escaping from the silo (see Figure 5-2).

At about 8:00 PM the control center was evacuated (see Figure 5-1 for a view of the launch silo and supporting facilities) and, therefore, the capability to remotely monitor the silo and rocket system data was lost. The entire missile complex and the surrounding area were then evacuated and a team of specialists that were knowledgeable of the Titan II rocket system were called in from Little Rock AFB (the missile's main support base). Also, at around this time, local residents within a one-mile radius of the missile silo were evacuated. Local law enforcement officers closed the nearby State Highway 65, and alerted anyone entering the area.

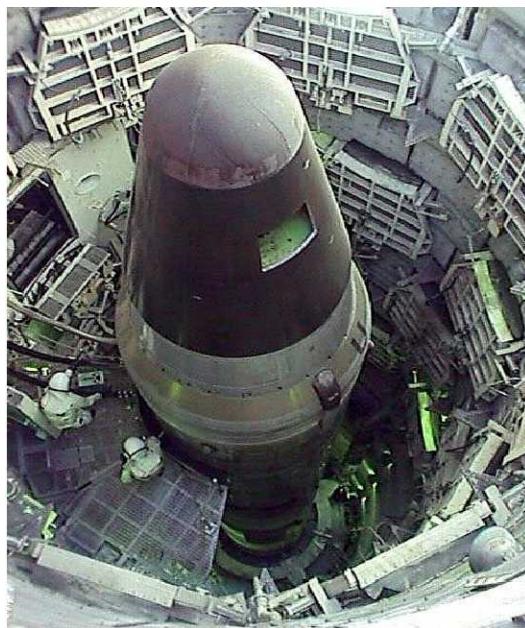
Figure 7-1: Technicians Working on Fold-Down Platform in Titan Silo Level 2

At about 6:30 PM on September 18, 1980, an airman was conducting a maintenance operation on level two (see Figure 7-1) of the underground silo when he accidentally dropped a large wrench socket. The standing platforms were hydraulically-controlled, flip-down structures with a rubber boot mounted between the platform and the rocket. The socket fell hitting the standing level two platform and bounced in the direction of the rocket where it slipped through the small gap between the rubber boot (which had become pliable over the years) and the Titan II rocket. It fell about 70 feet before hitting the thrust mount near the base of the rocket. The socket then bounced into and ruptured the stage one fuel tank (proximate cause). Approximately 11,140 gallons of A-50 drained into the bottom of the silo. Fuel vapors heated up the silo and caused the pressures in the non-ruptured propellant tanks to rise substantially.

- All workers should wear a belt with lanyards to attach tools
 - Operational human error is, therefore, the root cause
- Cloths should be placed on the platforms to prevent tools from bouncing off the metal

- The Titan II missile silo platforms should be renovated to increase safety
- The training and qualification program was insufficient prior to the incident (a root cause)

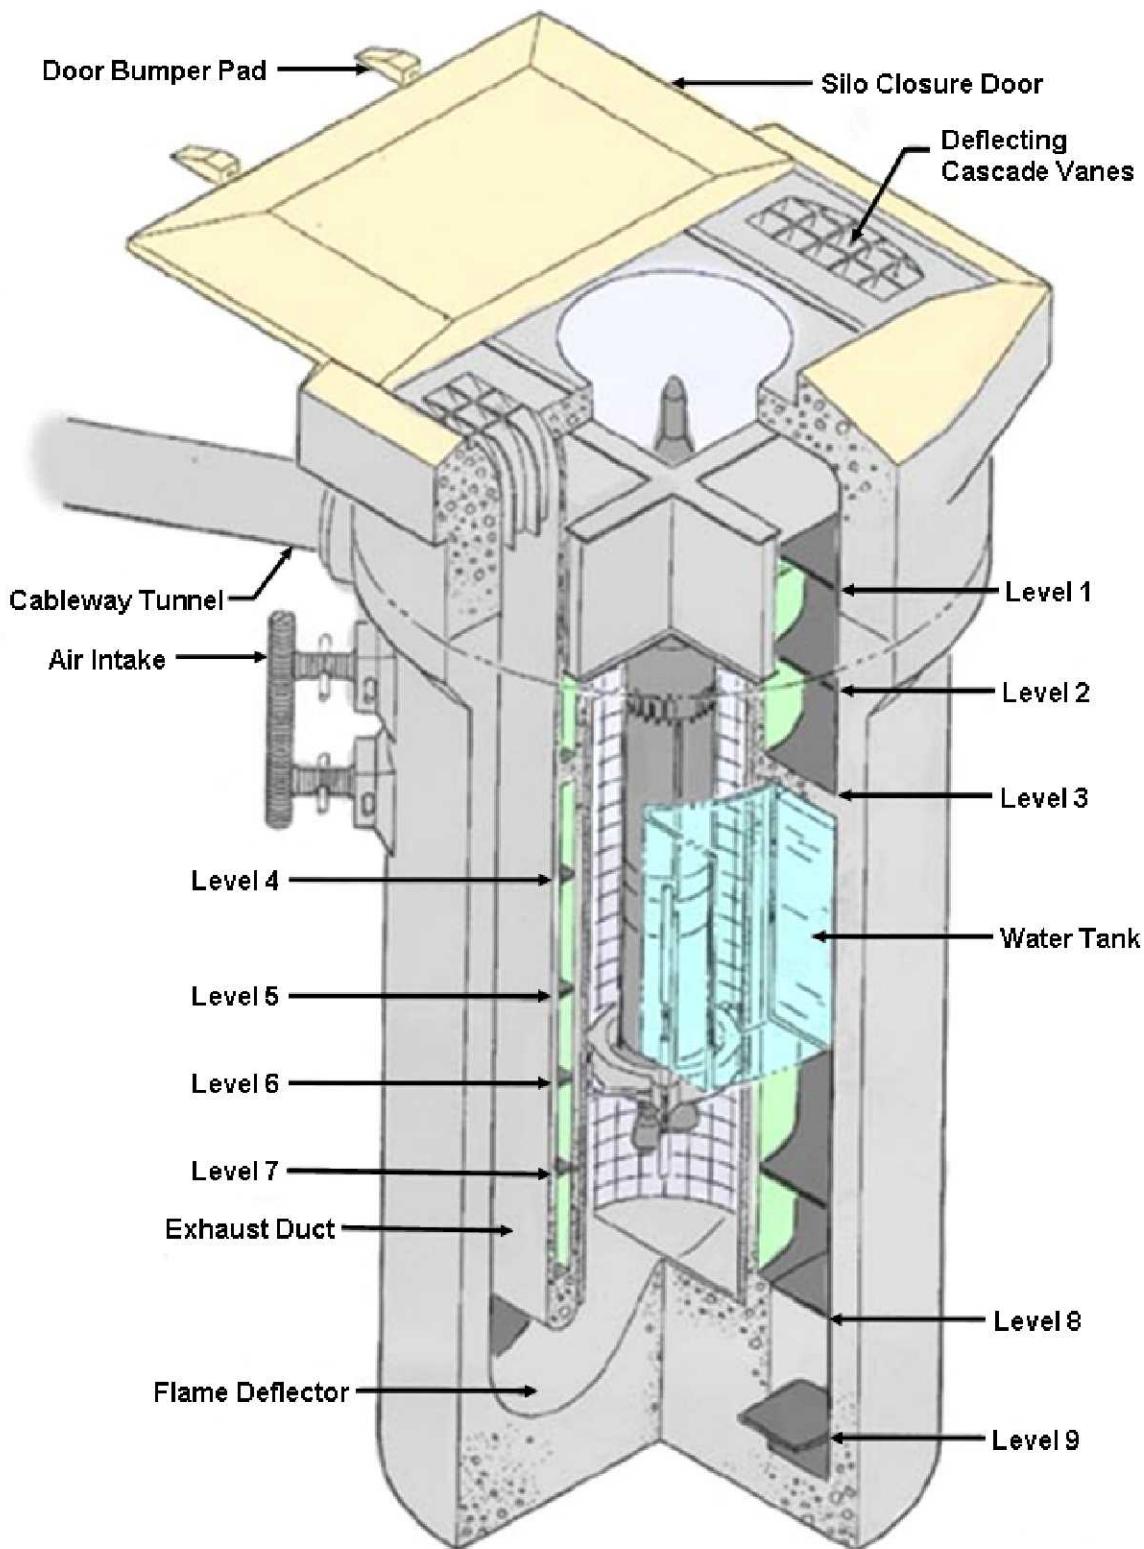
Figure 7-2: Titan II Missile Silo

It was reported that the explosion blew the 740-ton reinforced concrete and steel silo door (see Figure 7-2 for a depiction of the Titan II missile silo) 200 feet into the air and 600 feet from the silo. The rocket's second stage, with the W53 thermonuclear warhead attached, was launched out of the silo following the explosion of the first stage. The second stage then supposedly blew up in midair, (it contained about 1,730 gallons of A-50 and 3,120 gallons of N₂O₄) sending the undetonated warhead several hundred feet from the silo. The W53 warhead had a mass of 8,136 lb and a yield of 9,000 kilotons (the Hiroshima bomb "Little Boy" was estimated at about 15 kilotons). Luckily the warhead's safety features operated as they were designed. There was no reported loss of radioactive material.

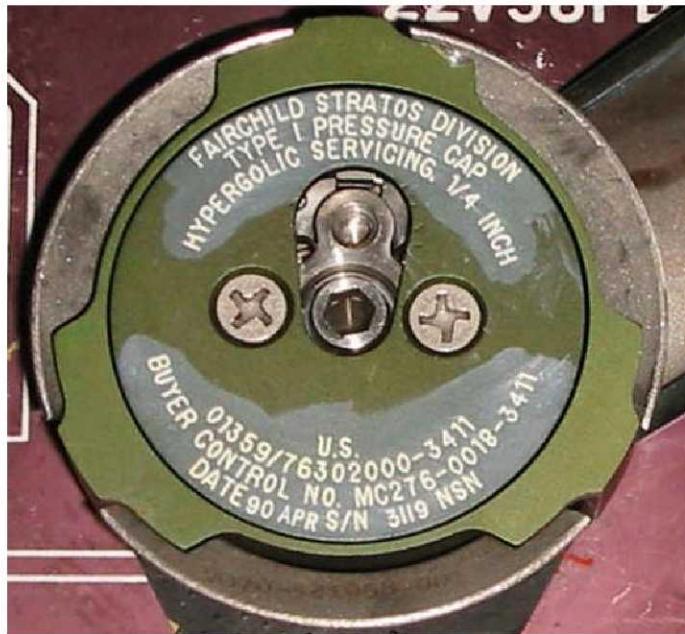
Figure 8-2: Fairchild ½-inch Flight Cap

During the MD338 flight cap installation procedure, on roughly July 14, 1981, the work step correctly called for the installation of a ½-inch cap (part number MC276-0018-2811) onto the AHC. The cap that was staged for installation was the misidentified ¼-inch cap. When a ¼-inch cap is placed onto a ½-inch

AHC, the dimensions of the stem allow for the actuation of the ½-inch AHC poppet (reference Figure 29-1 for an illustration of this) if the proper force is applied to the cap and poppet. This is exactly what happened. An oxidizer vapor release was reported when the technician tried to install the ¼-inch cap (proximate cause). The root causes are human error, improper configuration management, and improper vehicle design. The original flight cap design should not have enabled this type of incident to occur. The technician received minor injuries from exposure to NO₂ vapors. Close attention needs to be paid to the identification of flight caps and other hardware to prevent an event like this from occurring again (which it does on November 4, 1992 at WSTF).

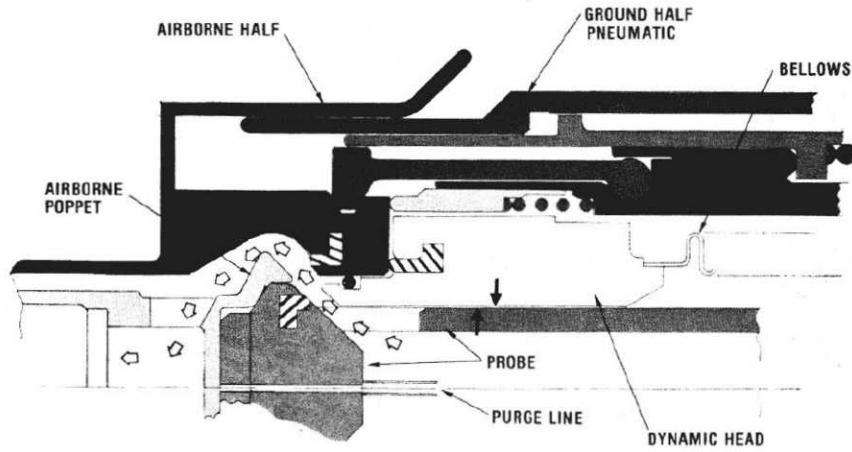
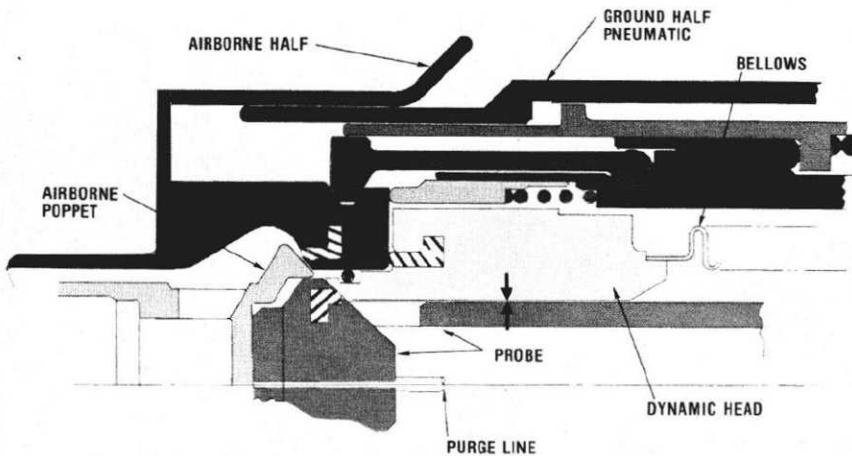
At 1:13 AM on September 22, 1981 an N₂O₄ spill occurred at Pad 39A. The proximate cause of the spill was a failed ground half coupling (GHC), MD162, at the AP28-12 door on FRC2 of OV-102 (Columbia). Failure of the GHC was a result of iron nitrate build-up between the probe and the dynamic head of the GHC along with the tight tolerances of the GHC. See Figure 11-1, Figure 11-2, and Figure 11-3 for a description of the AHC and GHC flow paths and also the failure location. Between 15 to 20 gallons of oxidizer was released into the attached scupper, which subsequently overflowed onto the vehicle. Damage to thermal tile adhesive resulted in the removal of 370 tiles (shown in orange in Figure 11-4). The photograph in Figure 11-5 shows the thermal tiles and the underlying vehicle structure along with the scupper and QD flexhoses going into the AP28-00 door (second FRCS oxidizer servicing door just beneath the AP28-12 door when the vehicle is in the vertical orientation).

Figure 11-1: AHC and GHC in Open Position

Figure 11-2: AHC and GHC in Closed Position

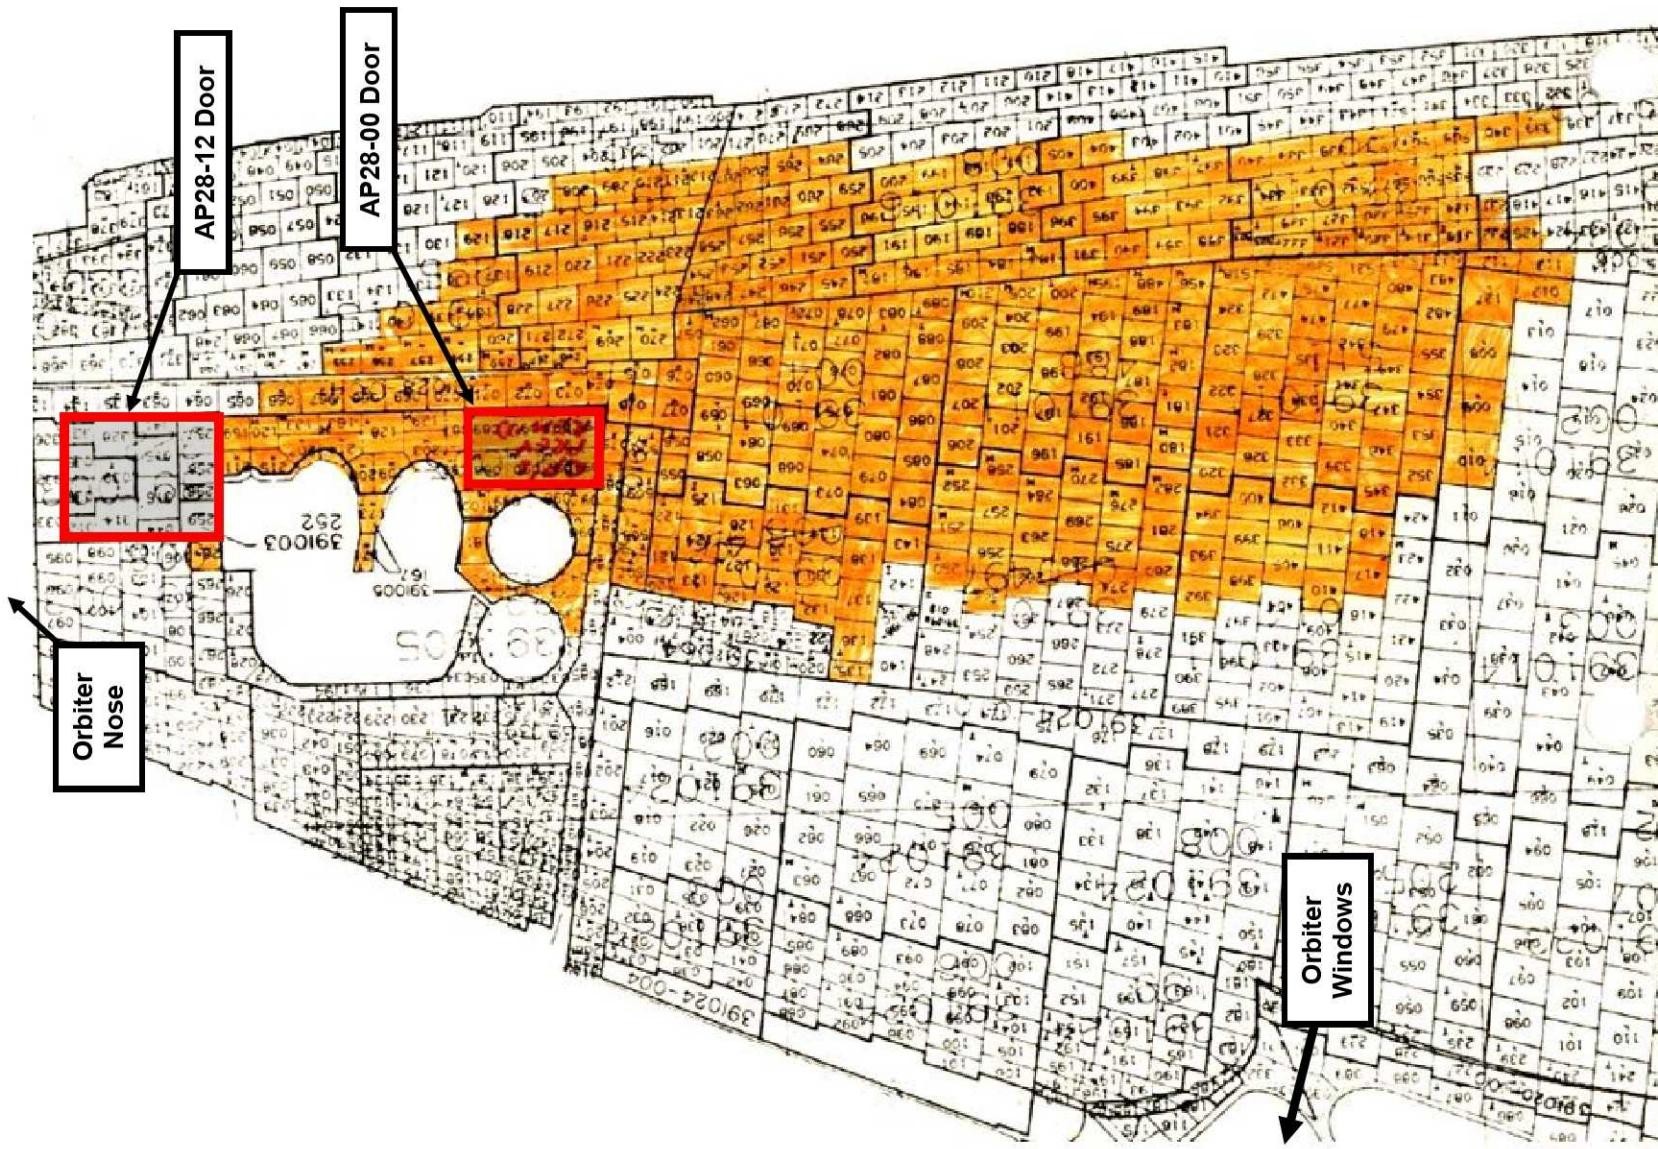
Figure 11-4: Removed Tile from OV-102 Following STS-2 N₂O₄ Spill

Corroded structural components that had been exposed to oxidizer vapors were later found in the internal portion of the FRCS module. It is believed that the vapors entered the forward module through small test ports located at the external doors. Many years later it was also found that the oxidizer vapor reacted with several electrical connector backshells within the FRCS.

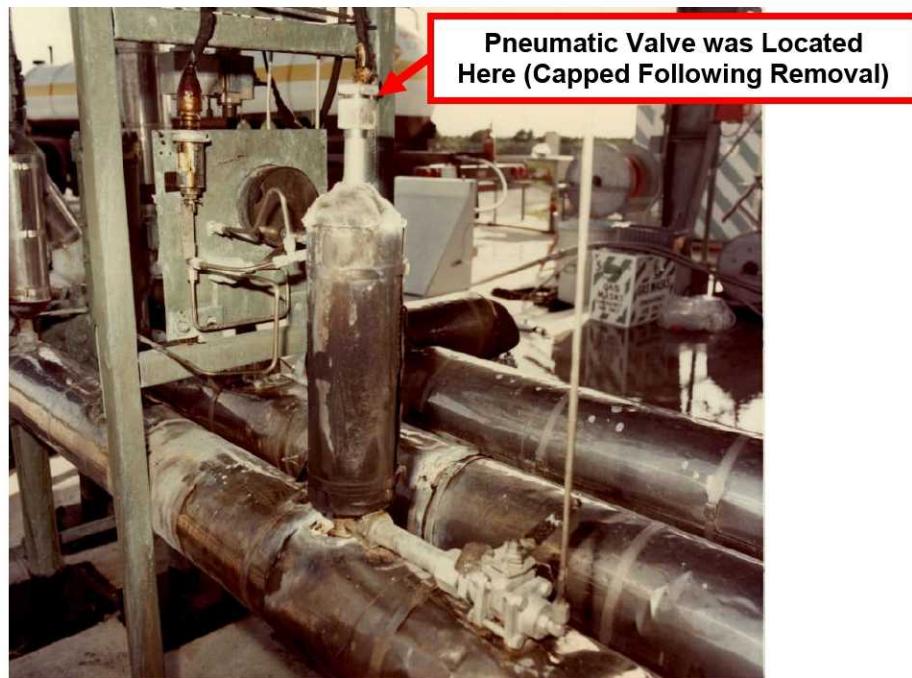
Figure 12-1: Photograph of Fuel Farm Following Fire

- The procedure was not written or reviewed by an experienced engineer prior to the task
- The engineer on console was making changes to the procedure real-time while monitoring another task in parallel
 - Improper adherence to the procedure and the procedure approval process are also root causes of this incident
- There was only one engineer on console supporting the hazardous operation
 - The engineer had to leave the communications channel to talk to the test conductor and in doing this missed some reports from the personnel at the fuel farm
- There was not a charged water line nearby when the fire occurred

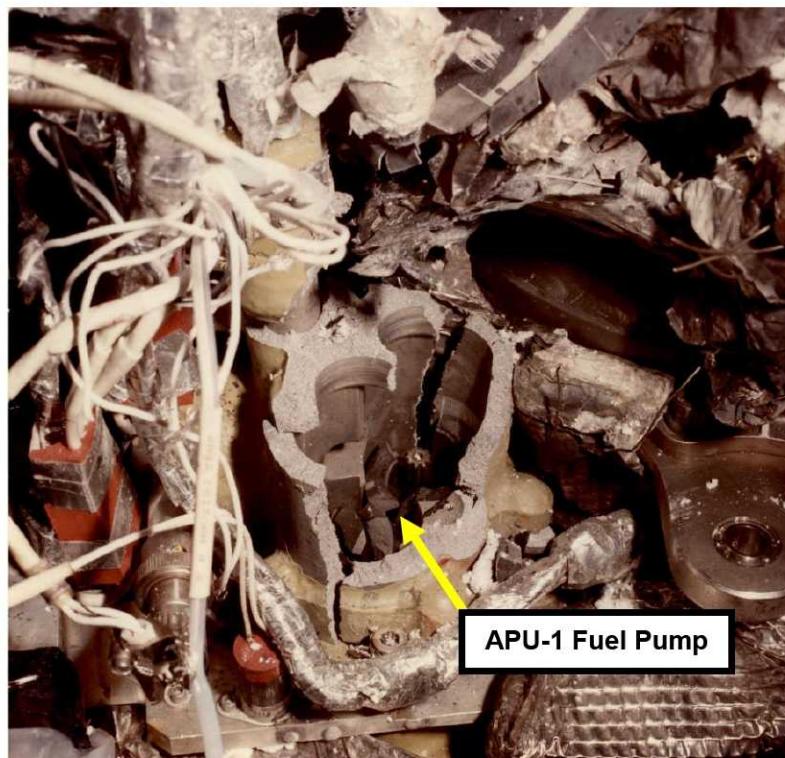
Figure 15-1: APU 1 Fuel Pump Explosion Following STS-9

The APU failures most probably resulted from a crack in the injector stem caused by corrosion of the sensitized inside diameter surface. The corrodant is probably carbazic acid or some similar substance which can be derived from air, moisture, CO₂, hydrazine and/or ammonia. The corrosion is time dependent and the crack progressed under sustained stress levels from the inner diameter surface toward the outer diameter surface until mechanical or thermal fatigue conditions could [complete] the crack rupture."

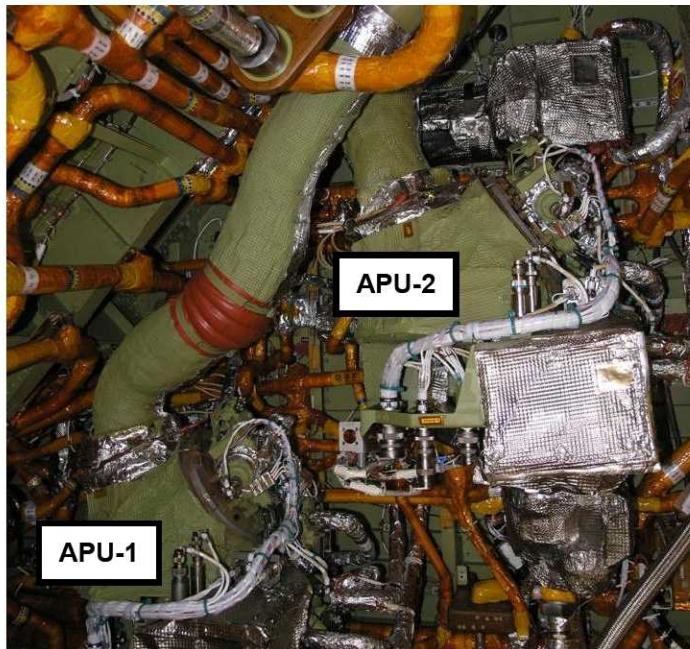
Figure 15-2: APU-1 and -2 in a Nominal Configuration

On December 8, 1983, Space Shuttle Columbia landed at EAFB at 3:48 PM pacific local time, concluding the STS-9 mission. About seven minutes after landing, an unusual series of events occurred. First, APU-1 shut down prematurely in response to a sensed turbine “underspeed” condition. About four and a half minutes later an explosion occurred in the APU. Figure 15-1 shows what remained of the APU-1 fuel pump following the explosion along with the resulting collateral damage. At the instant of the APU-1 explosion, APU-2 spontaneously shut down. Fifteen minutes later it exploded. Figure 15-2 is a photograph of APU-1 and APU-2 in the aft of OV-105 (similar to the OV-102 configuration). APU-3 ran nominally.

Following the STS-9 flight, several changes were made to the APU subsystem, including soaking of the carbon seals in hydrazine prior to installation, chromizing the injector stems to prevent corrosion, and minimizing stresses on the injector stems during manufacturing and installation. These design flaws are believed to be the root causes of the incident.

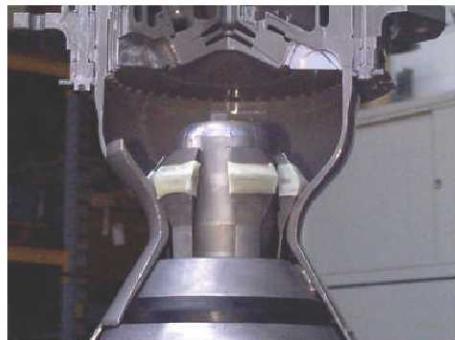
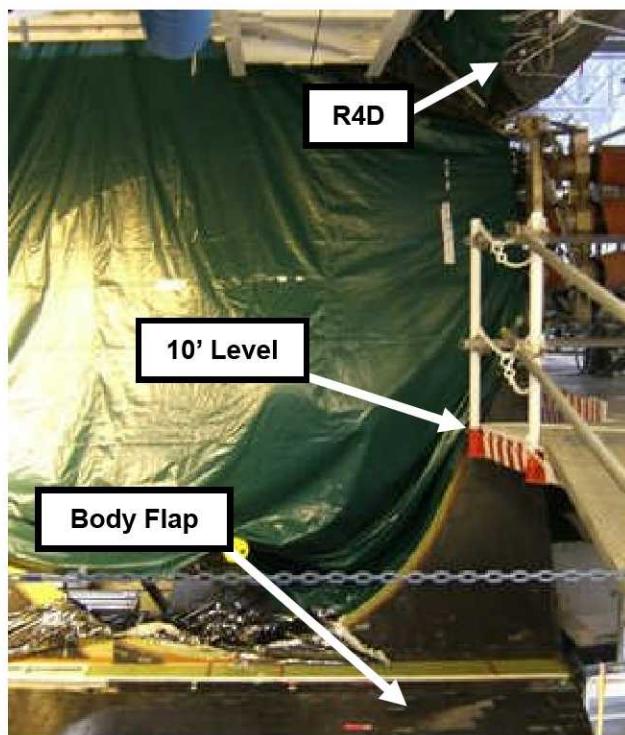
On May 24, 1985, while preparing for the removal of R4D (down-firing thruster on the Space Shuttle right pod) from OV-099, there was an MMH spill in OPF1 on the 10-foot level west side. R4D was being removed as a result of an in-flight anomaly related to a heater failure on the thruster. The manifold had been drained of its propellant and it was thought that a purge through the MD348 line (which connects to the manifold) and out the thruster nozzle purge adapter was sufficient to remove the liquid and most of the fuel vapors. Figure 18-1 shows a purge adapter in a cutaway of a primary thruster nozzle. During the part of the procedure where the purge adapter was being removed, approximately one cup of liquid MMH spilled from the thruster and down onto the body flap (which is illustrated relative to thruster R4D in Figure 18-2). The body flap was partially covered with spill protection sheets. The OPF1 hypergol exhaust fans were activated and the facility was immediately evacuated. It was recorded that some of the liquid MMH had saturated the body flap tile filler bar. It is unknown if the tile had to be removed. Unlike N₂O₄, which was known to breakdown Koropon primer (from the STS-2 N₂O₄ spill mentioned previously), the effect of MMH on Koropon was not well known in 1985.

Figure 18-1: Space Shuttle Thruster Chamber Cutaway with Purge Adapter Installed

Figure 18-2: View of Bottom of Right Pod with Orbiter in OPF

There are three possible proximate causes to this spill. A combination of two or more of the following causes is also possible. The first involves an improper configuration in which the flexhose that was being used for the procedure had previously been utilized for a similar operation on the left pod thruster L1U's manifold. This flexhose was several feet longer than the flexhose that was normally used for the right pod manifold evacuations. It was routed from the R4D thruster purge adapter to the 19-foot level above, then down to the eductor on the 10-foot level. This excessive length in hose may have allowed for a "u-shaped" low point trap to be formed in which liquid MMH could have collected. The second possible proximate cause involved a procedural error made by the engineers on console. The evacuation could have created a pressure differential across the liquid MMH. When the eductor was deactivated and removed, this pressure differential may have pushed the liquid into the thruster chamber. The third possible proximate cause was the liquid had collected in the thruster chamber (see Figure 18-1) and the purge was of insufficient duration to remove all the liquid MMH or the liquid trap may have prevented the vacuum source from evaporating all the residual fuel that remained around the purge adapter. A definitive proximate cause was never determined.

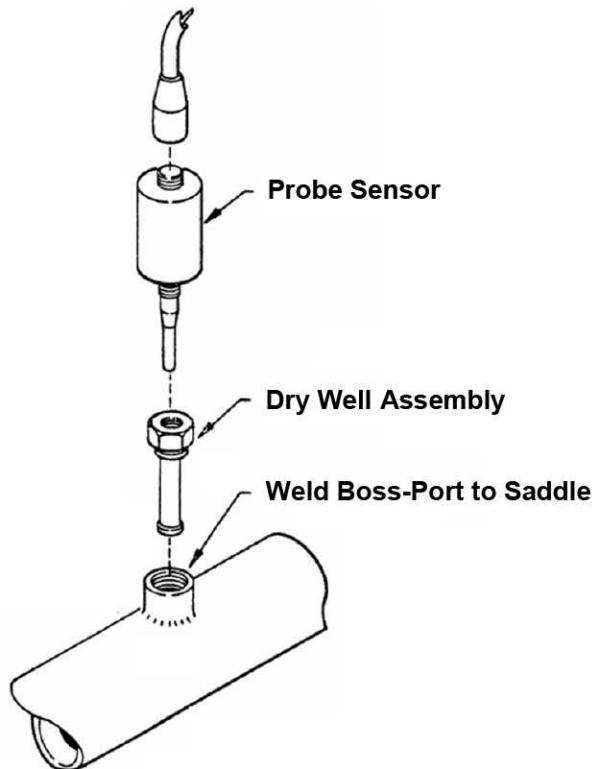
Figure 20-1: Transducer and Dry Well Assembly

This incident took place during an annual calibration of temperature transducers and other components, using an OMI. The technician was correctly informed by the engineer on console to remove a specific temperature transducer from the MMH return line. The technician mistakenly removed the dry well and temperature transducer assembly (shown in Figure 20-1) rather than the temperature transducer alone (proximate cause). If the temperature transducer was removed properly, there would not have been a spill. The following is a quote from the mishap report that explains the incident:

"The LSOC hypergolic mechanical technician actually performing the task of transducer removal used incorrect shop practice and loosened the wrong nut. Instead of using a one-inch wrench to retain the dry well in place while loosening the transducer lock nut that threads into the dry well, he used the wrench to loosen the dry well. He then used his hand to unscrew the transducer thinking he was extracting the transducer from the dry well while he was actually unscrewing the transducer dry well assembly from the three-inch MMH line. A mixture of fluid and vapor MMH immediately erupted from the line sending a column 10 to 12 feet in the air."

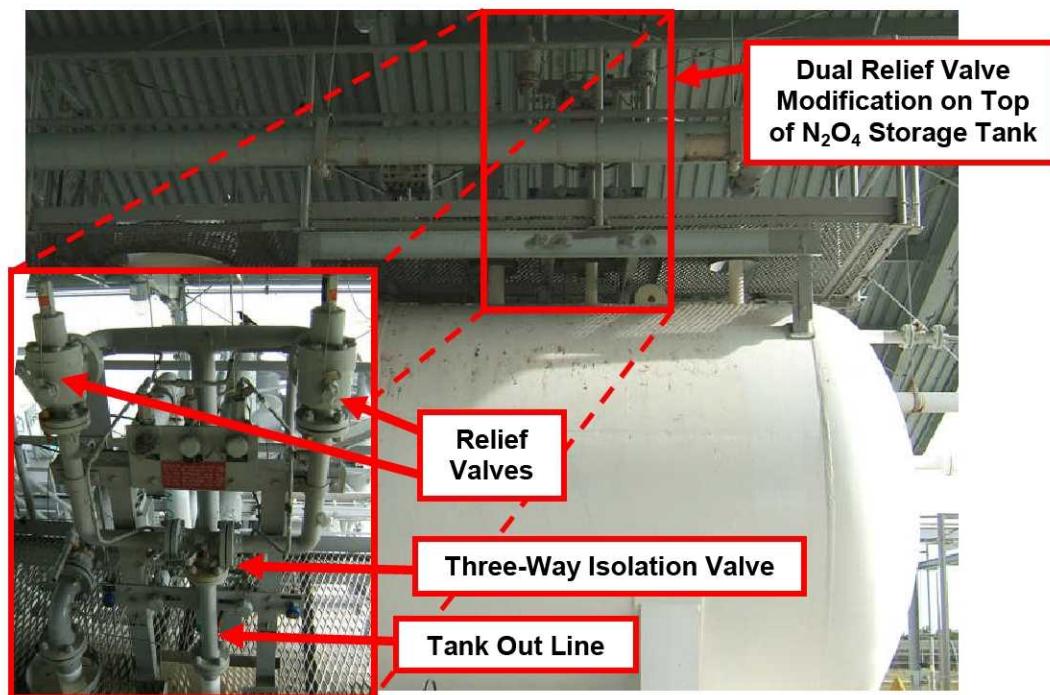
Figure 21-1: Dual Relief Valve Modification Location

An improper GSE design and operational human error were the root causes of this incident. About ten months prior to this relief valve removal and replacement operation, a formal request had been submitted by engineering to install a dual relief valve system onto the storage tank with a three-way isolation valve to prevent a vapor release during component removal. This request was denied. Following the large vapor release, the modification was implemented at both launch pads, greatly reducing the possibility of any future hazard. This dual relief valve modification allowed for isolation during the relief valve annual maintenance. The modification was also implemented on the fuel storage tanks at both launch pads. Figure 21-1 is a photograph of the relief valve locations on the top of the N₂O₄ storage tank with a close-up photograph of the relief valve three-way isolation valve modification.

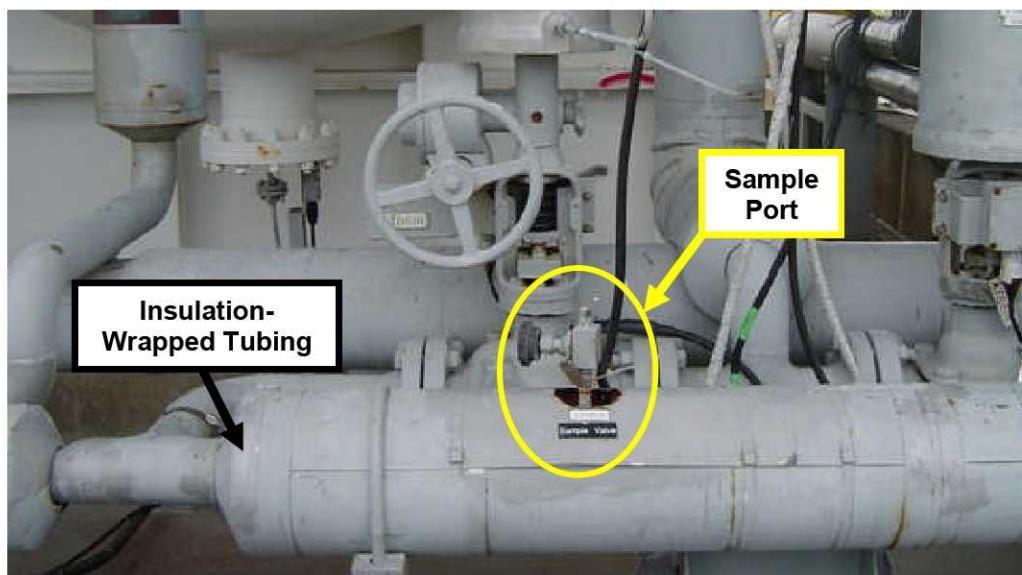
Figure 23-1: Photograph of Sample Port

On May 25, 1988, at the Pad 39B oxidizer farm, technicians were completing an N₂O₄ sampling operation. During the operation, the technicians detected a small leak at the interface between the sampling valve and the tubing (see Figure 23-1). The sampling operation was delayed until the leak could be fixed. The repair was finally scheduled to be worked about a month later during the afternoon of June 23, 1988. The removal of some local insulation was required to fix the leak along with re-torquing the fitting that connected the sample valve to the tubing. This was all completed that afternoon.

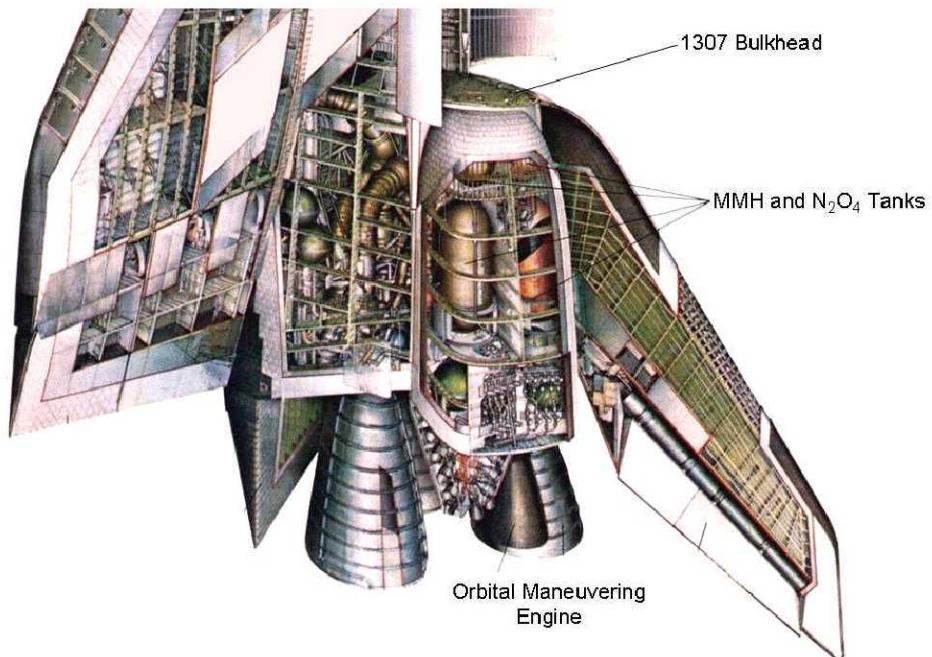
Figure 24-1: Cutaway View of Space Shuttle Orbiter Aft

First, the exact location of the leak within the pod had to be found (a cutaway view of the Space Shuttle OMS pod can be seen in Figure 24-1). This was difficult because the internals of the aft pods and forward module are not meant to be accessed while the vehicle is at the launch pad. The location of the leak had been isolated to the LRCS N₂O₄ system or the associated tubing through monitoring of the instrumentation in the LCC. The leak was measured to be 0.26 psi per hour (about 800 standard cubic centimeters per hour) and a TVC found the concentration of NO₂ vapor to be 15 ppm at the vehicle vent door. This later decreased to 3 ppm. An access door was removed on the pod's outer skin and several internal thermal blankets were removed. A long section of PVC pipe was then inserted into the pod to function as a guide for a borescope. Using a borescope, the leak was finally isolated (after a six hour search) to a ½-inch dynatube fitting on the MD224 leg (the N₂O₄ propellant tank ullage vent). A cross-section view of a dynatube is shown in Figure 24-2 and a photograph of the leak location can be seen in Figure 24-3.

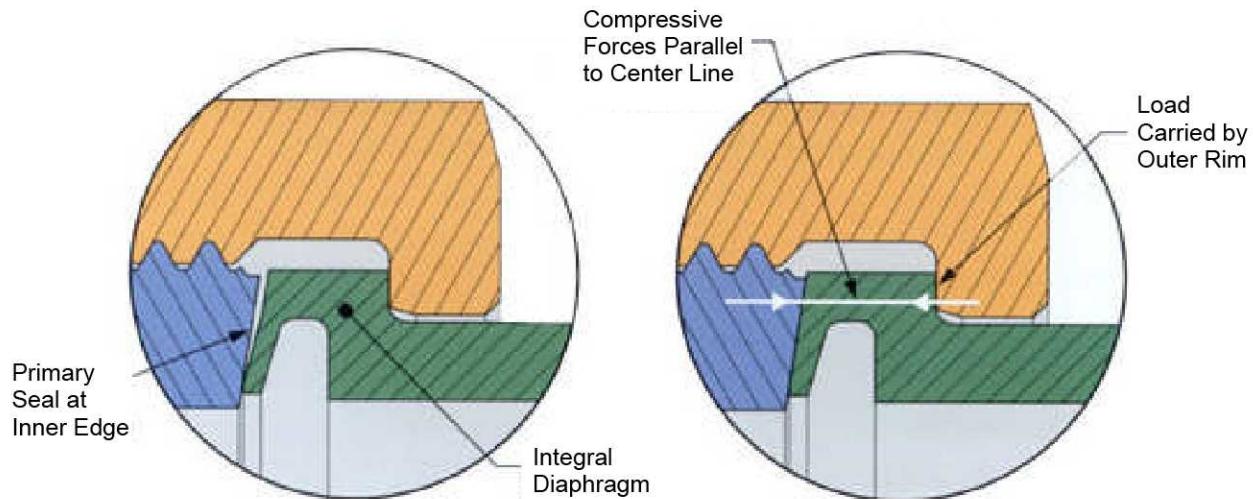
Figure 24-2: Cross-Section of Dynatube Sealing Surface

The proximate cause of the leak was found to be a scratched dynatube. This was discovered during ground processing two missions later when the pod was removed in the OPF and sent to the HMF for repair. It was determined that the scratch must have occurred either when the dynatube was disconnected in October of 1987 to allow access to a nearby valve for a removal and replacement or when it was reconnected in late December of 1987. Following the reconnection, the dynatube fitting passed all leak checks. Transport vibrations may have "altered" the state of the connection between the HMF, OPF, and launch pad; however, this is highly unlikely since dynatubes do not typically change mechanical state, especially with safety wire installed. The Kersey report states that "The most probable cause was that the mass spectrometer probe operator probed the wrong RCS propellant system (i.e. MMH instead of N₂O₄). Operational human error was the root cause of this incident along with improper training. This categorization was given as a result of the incident being a consequence of either an inadequate inspection of the dynatube sealing surface or an error made during the leak check of the dynatube.

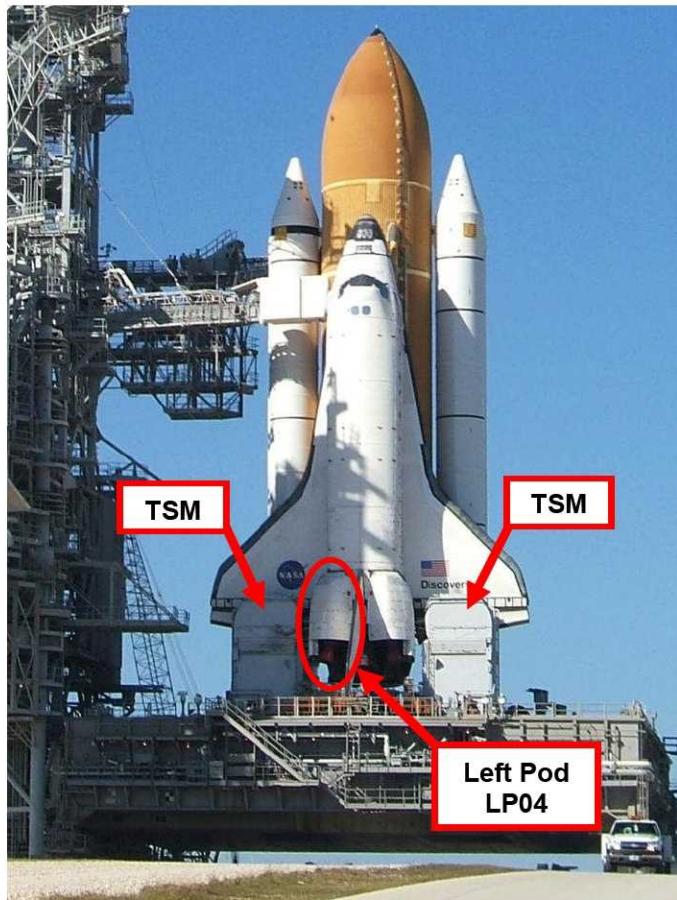
Figure 24-4: Location of Left Pod on Space Shuttle

On July 14, 1988, about three days after the loading of N₂O₄ onto Discovery at Pad 39B for the STS-26R Return to Flight mission, a small N₂O₄ (NO₂) vapor leak was detected in the left OMS pod (LP04) of Discovery. STS-26R was the first flight following the Challenger disaster on January 28, 1986. The leak did not result in any injuries or hardware damage, but it did impact the launch date of Discovery. Along with several other Return to Flight actions, the launch team at KSC was required to test fire the three main engines on Discovery while it was at the launch pad. This was known as the Flight Readiness Firing (FRF) and was scheduled to occur on July 26, 1988. The Space Shuttle Program decided to complete the FRF regardless of the known oxidizer vapor leak; therefore, the engineering team assigned to assess the leak had a couple weeks to study possible solutions, while other groups were preparing for the FRF.

After a week of deliberation, the “clamshell” was selected as it was the least invasive method to stop the leak prior to launch and it could be completed at the launch pad. Furmanite FSC-6B was used as the sealing compound as a result of it having the best compatibility characteristics with N₂O₄. The FRF was finally completed on August 10, 1988 following a few hardware-related delays. The repair of the oxidizer vapor leak began on August 17, 1988 with the cutting of two holes in the aft 1307 bulkhead (the bottom of the payload bay with the orbiter in the vertical orientation) and the top of the pod beneath the bulkhead. The dynatube’s safety wire was removed and a “clamshell” (shown in Figure 24-5) was placed over the leak. The Furmanite sealing compound was then injected. The leak was eliminated; therefore, the Space Shuttle Program cleared Discovery for launch, which successfully occurred on September 29, 1988, a few weeks later than the original launch date of September 6, 1988. The delay was a result of multiple items including the FRF test delays, return to flight SRB testing delays in Utah, and the N₂O₄ leak on LP04.

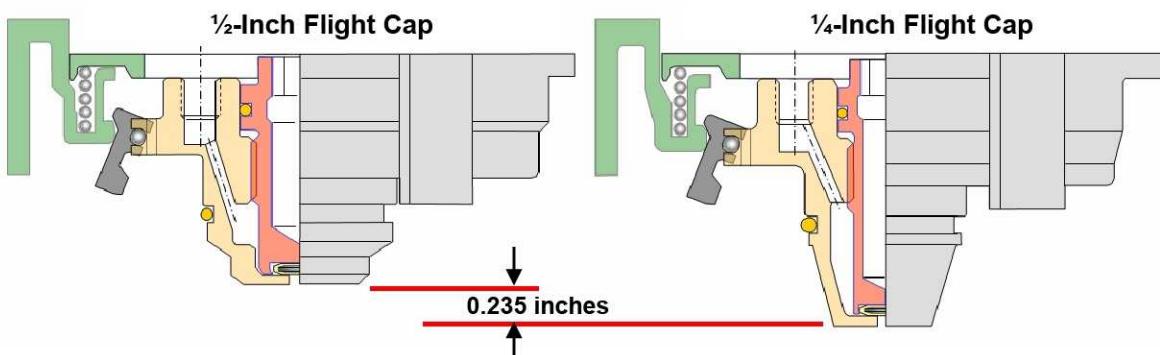
Figure 29-1: $\frac{1}{4}$ -inch and $\frac{1}{2}$ -inch Hypergolic Flight Cap Cutaway View

While installing flight caps on the OMS ground test article at WSTF on November 4, 1992, a technician attempted to install a $\frac{1}{4}$ -inch AHC cap to a $\frac{1}{2}$ -inch AHC. The technician was subsequently exposed to liquid N₂O₄ and suffered minor chemical burns on his hands and forearm. Both the $\frac{1}{4}$ -inch cap and $\frac{1}{2}$ -inch cap have a protrusion that acts as a secondary seal when installed on the AHC. The $\frac{1}{4}$ -inch AHC cap protrusion is 0.235-inch longer than the $\frac{1}{2}$ -inch AHC cap protrusion (see Figure 29-1). This additional length is enough to actuate (depress) a $\frac{1}{2}$ -inch AHC poppet if the proper force is applied to the $\frac{1}{4}$ -inch cap (proximate cause). The only action to reduce the possibility of a similar event occurring in the future (short of a redesign) was more extensive training and certification of the technicians; therefore, this was considered a root cause for this incident along with operational human error and improper vehicle design. Other lessons learned and findings include:

- The appearance of a $\frac{1}{4}$ -inch AHC cap is such that it could be mistaken for a $\frac{1}{2}$ -inch AHC cap to an untrained technician
 - The technician was undergoing on the job training under the direct supervision of an experienced technician, but the distinction between a $\frac{1}{4}$ -inch cap and a $\frac{1}{2}$ -inch cap was not explained to him
- Age and wear made part number identification on the AHC cap difficult
- Work instructions should be written to include positive identification of interface equipment
- AHC cap mating should not be considered a benign activity; therefore, PPE should be used to protect the employees from credible releases of propellants
- Future designs should consider keying of AHC caps to preclude incorrect size/commodity installation

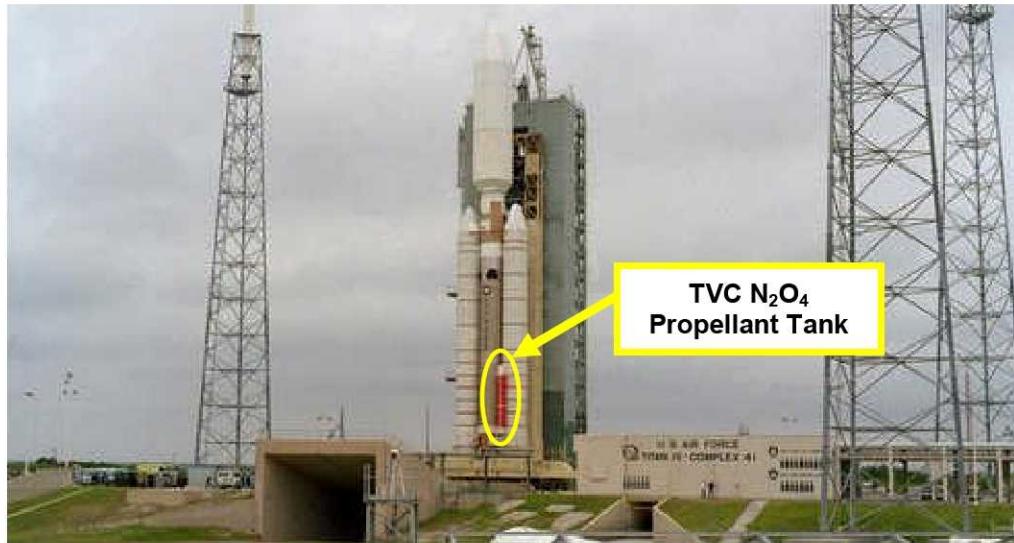
Figure 31-1: SLC-41 with Titan IV A (Servicing Structure Retracted)

On August 20, 1994, at Space Launch Complex 41 (SLC-41) on CCAFS there was a large release of liquid N₂O₄. Oxidizer was being loaded into the Titan IV A's solid rocket motor (SRM) thrust vector control (TVC) system in preparation for the launch of the National Reconnaissance Office's Mercury Electronic Intelligence or ELINT satellite on August 27, 1994. The N₂O₄ was used to alter the combustion in the Titan IV A SRM nozzle and, therefore, provide TVC. A photograph of the SLC-41 launch pad with a Titan IV A is shown in Figure 31-1. A diagram of the Titan IV A's TVC system is shown in Figure 31-2 with the numbered callouts listed in Table 31-1. The incident occurred about three and a half hours after sunrise

when the solar heat caused the pressure to increase in the N₂O₄ tubing while the system was in a static configuration.

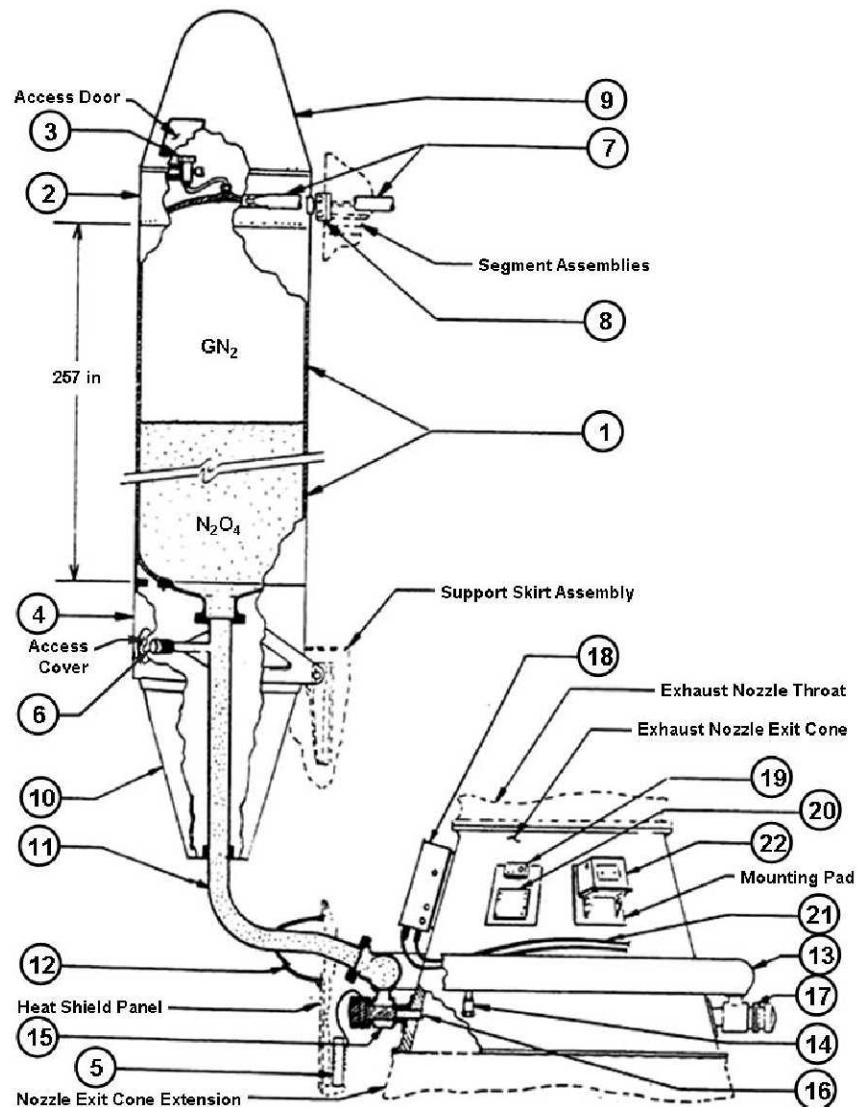
Figure 31-2: Titan IV A TVC System Schematic (see Table 31-1 for references)

The pressure increase went unnoticed by the engineers and technicians. Remote data monitoring was available on the launch vehicle, but not on the propellant transfer systems (GSE). Local dial gauges likely showed the increase in pressure; however, there were no technicians monitoring these particular gauges. The pressure rise eventually caused a weld seam to fail at the base of the transfer system (proximate cause). This portion of the N₂O₄ servicing GSE lacked a relief valve, thus allowing the propellant in the tubing to become “liquid locked” since a drain-back and purge had not been completed (improper design; a root cause). There was no damage to the GSE (excluding the ruptured tubing) or vehicle hardware and there were no reported injuries.

Another root cause of this incident was determined to be frivolous procedure deviations. The loading team and Launch Conductor had experience with successfully delaying the oxidizer drain-back and purge; however, this experience was based on insulated oxidizer tubing. The tubing at SLC-41 had recently been removed and replaced with non-insulated tubing as a result of the moisture trapped in the insulation causing accelerated corrosion. The loading team and the Launch Conductor either did not recall this or they were never told.

There are requirements for launch Pads 39A and 39B to have seamless pipe throughout and to have relief valves in tubing that could become “liquid locked.” Following the incident at SLC-41, the procedures were changed to preclude this sort of incident from happening in the future. The procedure deviation approval rules were also reaffirmed to the loading team and Launch Conductor.

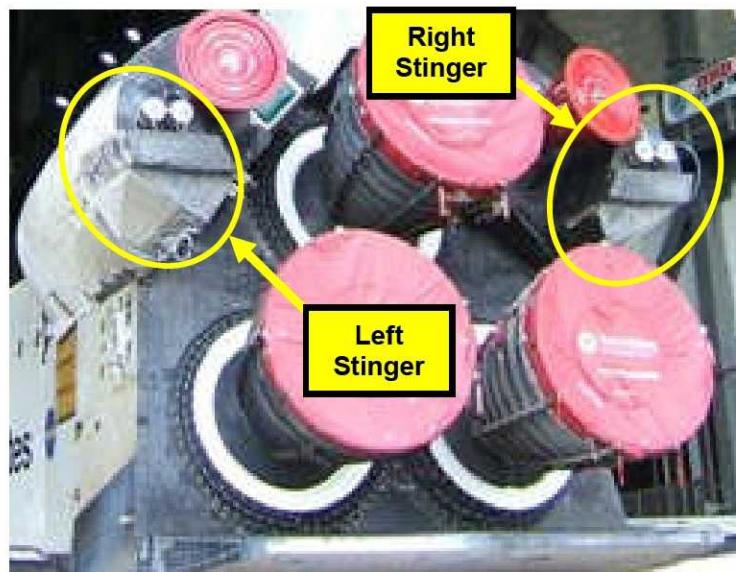
Figure 32-1: Stinger Locations on Orbiter

During the STS-69 OV-105 flow, while performing a thruster L3D removal and replacement, an MMH flame was reported in the Space Shuttle left OMS pod stinger area (see Figure 32-1 for the relative location of the stingers). The technician in SCAPE was preparing to inspect the dynatube (approximately an hour after the thruster was removed) with a mirror when he reported a small flame on the MMH thruster feedline dynatube. Another technician was unable to find any water to put out the fire and mistakenly picked up an alcohol bottle and sprayed the flame which produced a small flash near the feedline, igniting the residual MMH inside it. It is believed that the technician thought the spray bottle was Freon. It was reported that the flame was extinguished by the technician placing his SCAPE glove over the dynatube end. This was probably not the best idea since MMH can react exothermically in a rigid volume and burn in an atmosphere 2.5% to 98% by volume in air.

Prior to the reported fire, the technician removed the Aclar (plastic film) bag from the open end of the thruster feedline fitting. This fitting connects the manifold to the thruster. When he did this, he noted that there was an exceptionally large amount of fuel vapor present and some liquid MMH was dripping from the open line. The technician proceeded to place the aspirator directly on the feedline dynatube (the procedure and known practice was to place the aspirator perpendicular to the dynatube exit). This was likely the proximate cause of the fire. The engineer on console then noted that the manifold pressure dropped from 16 psia indicated to 6 psia indicated in about five seconds (the transducer had a 2 psi offset). The manifold pressure stabilized to 16 psia indicated after a couple minutes. At this point, the technician was instructed by the engineer to remove the aspirator from the dynatube. He did this and then left the area to find a mirror to aid in the dynatube inspection. When he approached the dynatube with the mirror he noted a "cream/yellowish color" flame and "heat waves." As previously mentioned, he proceeded to put out the flame with his glove after the other technician doused the area with alcohol.
